Gainesville Regional Utilities Deerhaven Generating Station

Coal Combustion Residual Units Annual Inspection Report (December 6, 2023 – December 3, 2024)

**Innovative Technical Solutions
3720 NW 43rd Street, Ste. 103
Gainesville, Florida 32606**

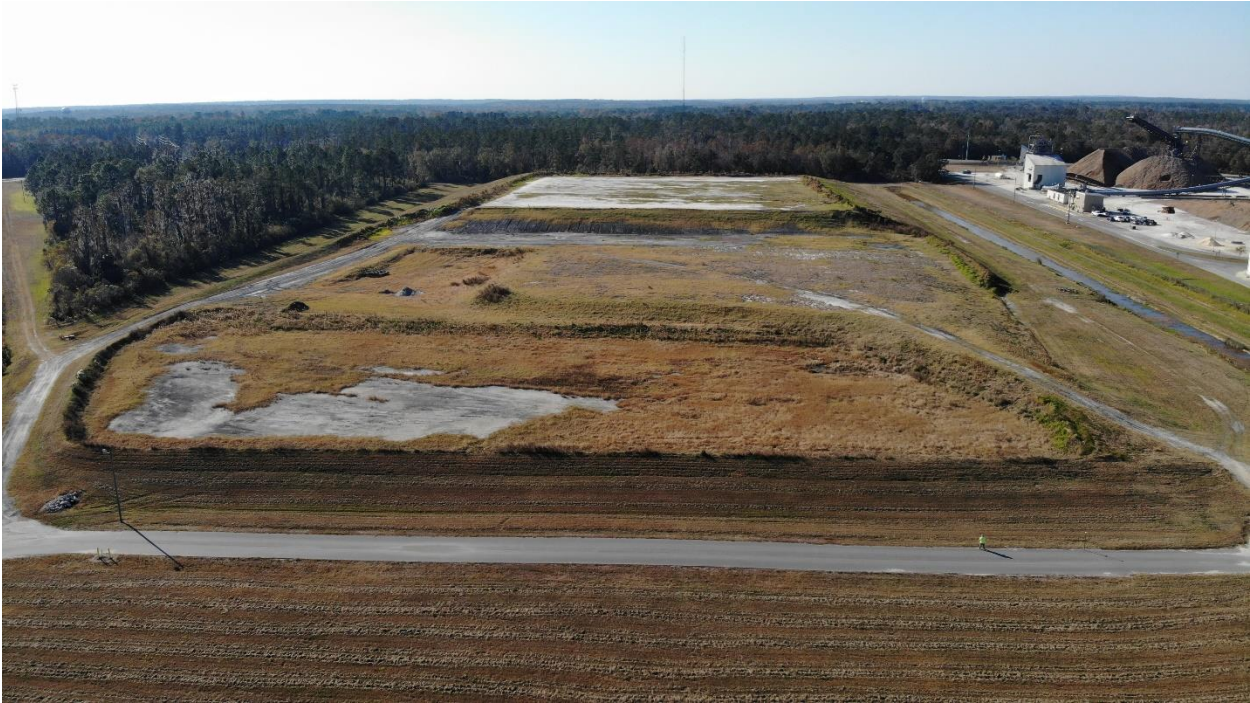
Figure 1. Aerial Image of the CCR Landfill Facing West

A slurry wall containment system, which is keyed into an existing underlying clay layer, encompasses the landfill and the Northern Drainage Ditch. A series of stormwater ditches outside the slurry wall route stormwater to either a wetland area located just west of the landfill or to a stormwater pond located southeast of the landfill. Currently, Cells 1, 2, and 3 of the CCR landfill still accept non-CCR materials. Figure 1 presents an aerial layout of the CCR landfill at the site, facing west.

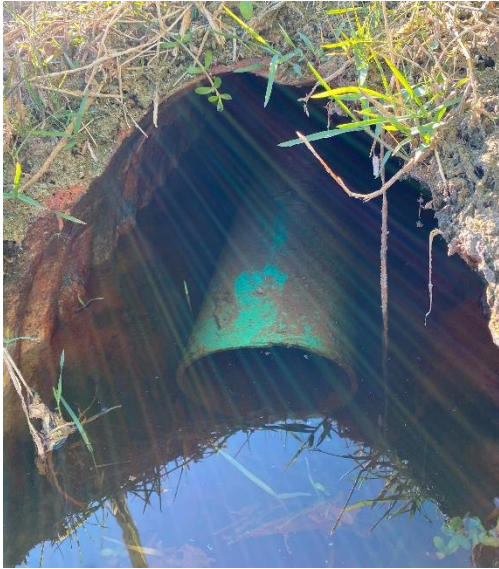
Cells 1-4 underdrains were either partially or completely inundated due to elevated water levels in the Northern Drainage Ditch (Figure 2). GRU should consider draining the ditch and inspect the underdrain pipes for sediment built-up.

Figure 2. Condition of Underdrain Outlets of (a) Cell 1, (b) Cell 2, (c) Cell 3, and (d) Cell 4 on December 4, 2024.

Location	Condition
Underdrains	Underdrains were either partially or completely submerged under water due to elevated water levels in the Northern Drainage Ditch.
Thick vegetation	Near the top of the slopes of Cells 1-3.

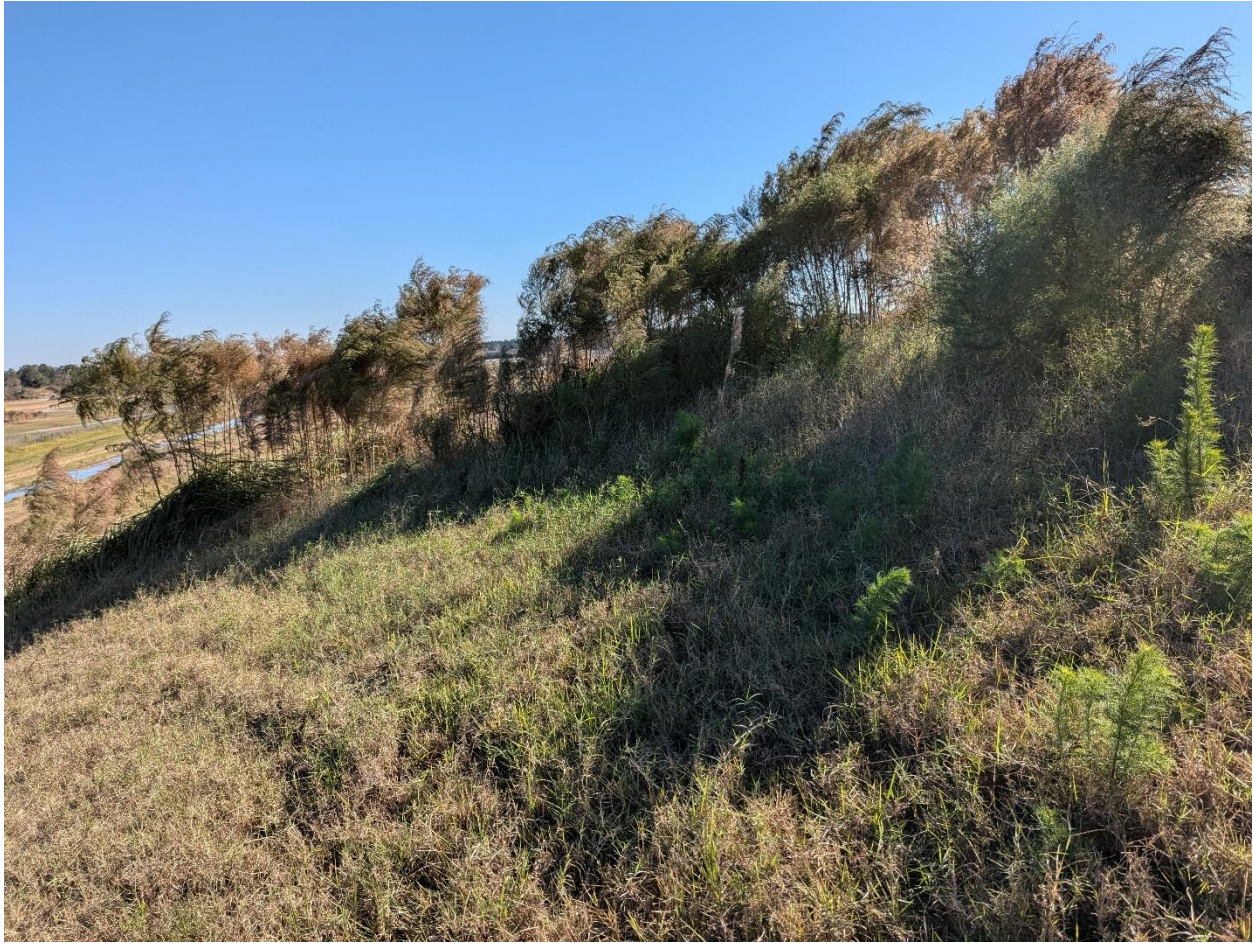
Thick vegetation was observed near the top of the slopes of Cells 1-3. Figure 3 shows an example of an area with thick vegetation.

Figure 3. An Example Area with Thick Vegetation
