I. Executive summary

The planned outage was completed at a cost of \$-----and required 19 days of downtime for Fuel yard and Boiler Outage. There was one safety incident with contractor working in fuel yard and no environmental incidents. All work and findings were routine with the exception of the following issue. The findings, which are warranty issues with the Siemens Turbine, will require further work in the April 2016 outage.

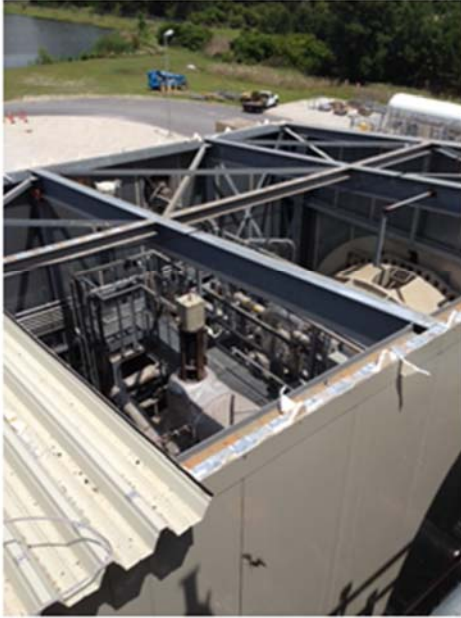
Roof removal for Turbine work

The roof of the turbine building had to be dismantled to access the turbine cap for removal. All hard electrical conduits had to be removed and replaced with flexible conduit for easy access in the future. All piping that was in the way for cap removal access had to be cut and flanged for future access. The top half of the turbine was pulled for piston ring / volute inspection which was found to be in excellent condition. The CV, guide pin was replaced with new one. Turbine cap was cleaned and placed back on; all insulation that was removed was inspected and all replaced with new. Preformed controls checked out by Siemens controls engineer and IC/E Techs. At this time 6/4/ 2015 we have not received the final report from Siemens. Warranty issues are still on going and should be resolved in April 2016 outage

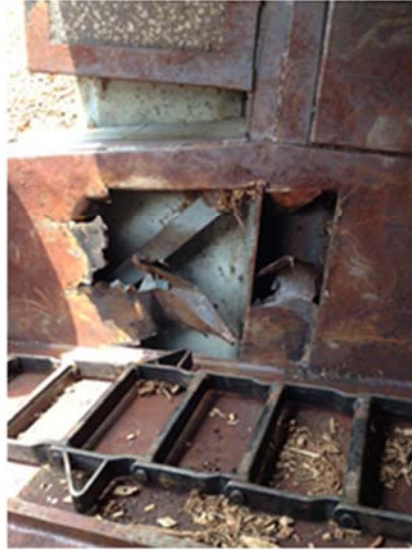
Inspections of fuel chutes findings were done and most all showed wear in impact areas. The under pile # 2 had the worst wear on both sides of bin. Skirtings' were replaced on all drop points and most of them had wear. All wear areas got AR 400 plate. Inspected all tripper bays, findings were good. Modified the chain guards on the oil bath system all three bays due to wear on bottom half's of guards. Seventy five impact rollers were replaced, and the bearings and shalt were replaced on # 5 take up

#2 Underpile worn through

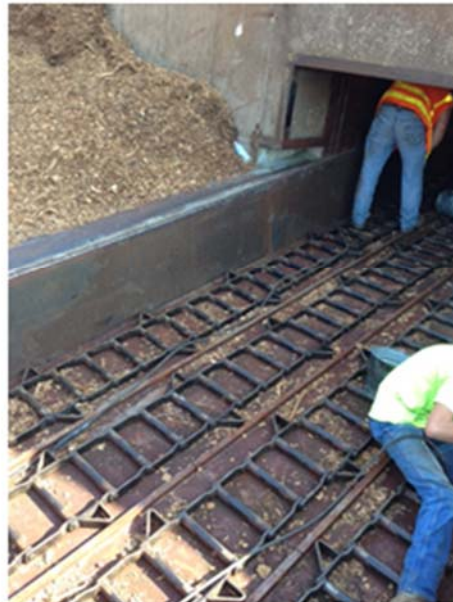
#2 Underpile, installation of wear plate

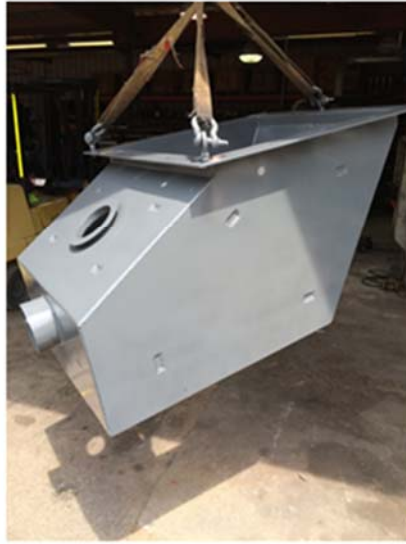
#10 chute, new piece #2, with Tricon hard plate

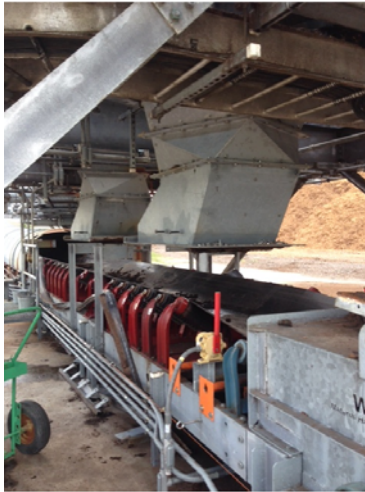
#9 conveyor side plates removed for replacement, both sides

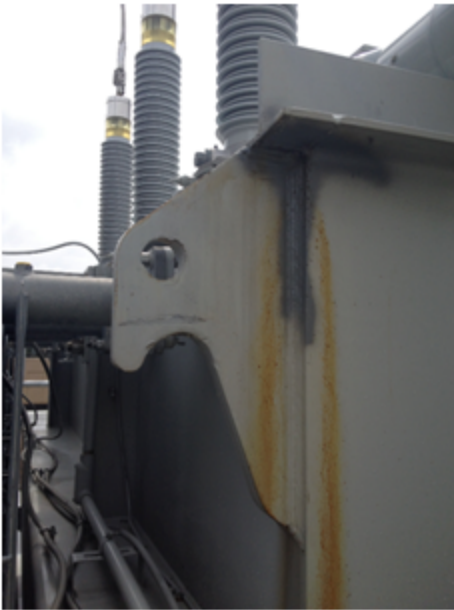
**EHA GSU TRANSFORMER CASING LEAK,
Leak #1 -- NW corner**

Before:

Performed motor circuit evaluation offline motor testing; Equipment tested was ID Fan motor, PA Fan motor, SA Fan motor, FGR Fan motor, Feed Water Pumps motors A & B. Performed Infrared Thermography for all 480 volt motor controllers and breakers that were in service with current load in MCC/PDC rooms .There were no problems found while testing motors, all test data is within specs for motor tested. Worked annual PLC PM Inspections; Worked annual transformer PM inspections ; Worked annual generator step- up transformer PM; Worked 2 year generator PM inspection; Worked EMA SST common alarm back in, Sudden Pressure . Cleaned all MCC/PDC rooms.....Checked the slip rings on both fuel silo's A &B. Repaired GSU Transformer casing oil leak.

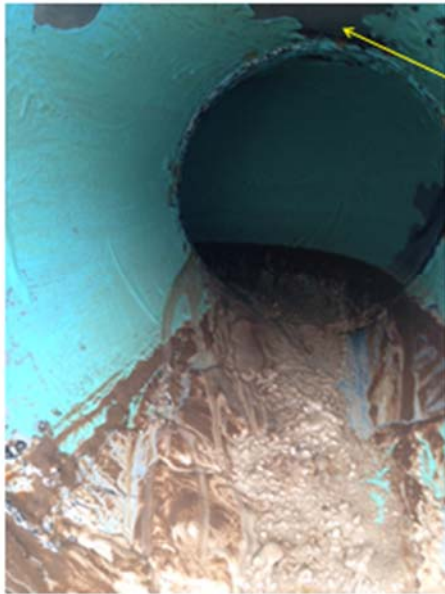
ZDS U-bend piping

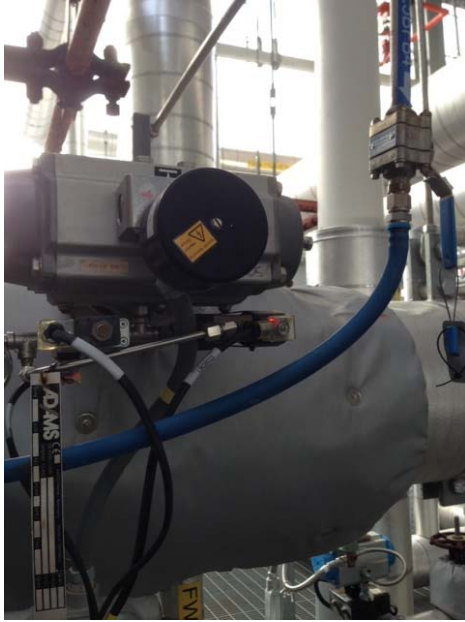
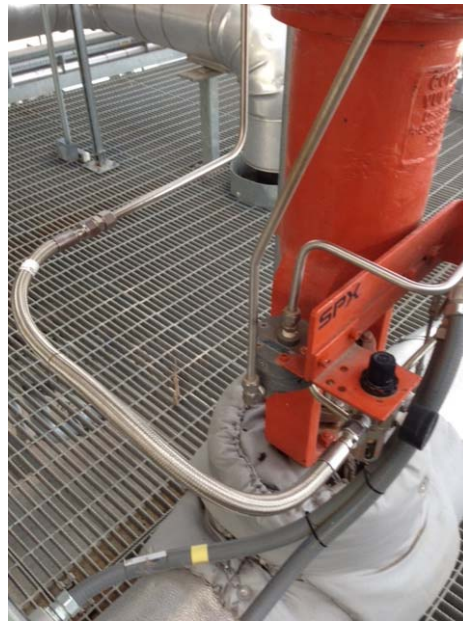
Removed blue rubber hoses and installed stainless steel braided hose on most all air actuators in the boiler island that time constraints allowed. (119 of 126)

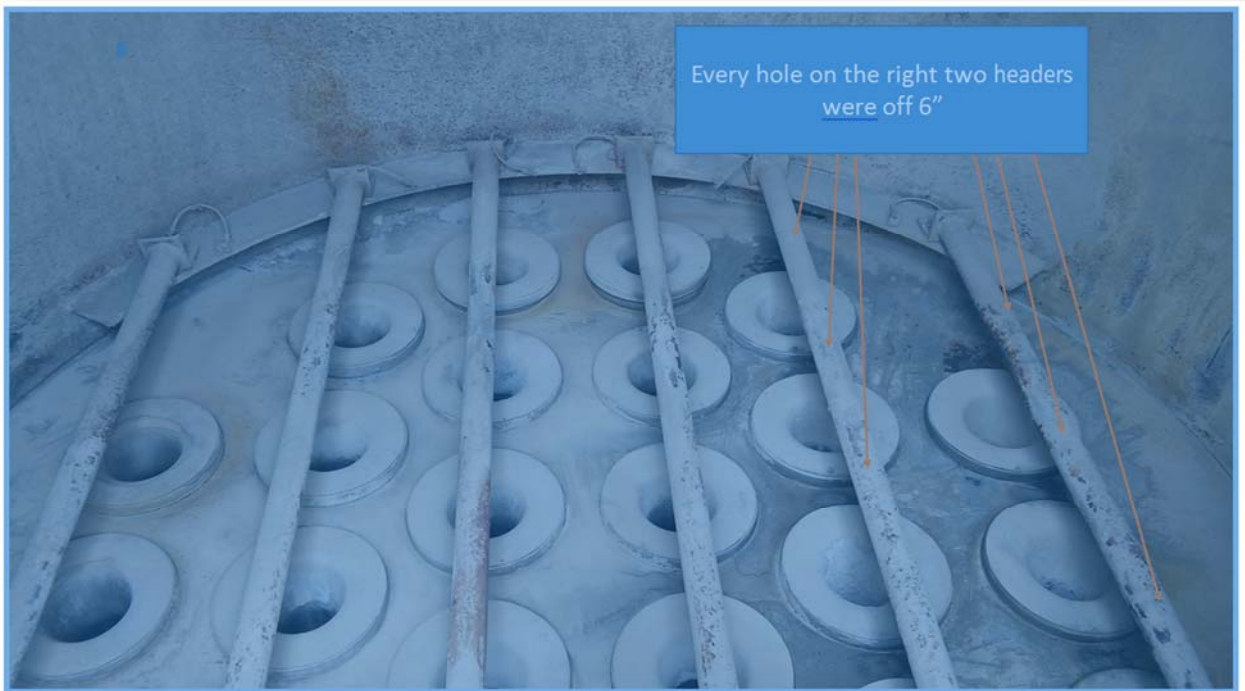
Equalizer Valve

- Replaced sandblast hose and fittings from equalizer valve to tank.
- Greased equalizer valve actuator.
- Opened, inspected and greased slide gates at transition from bag house to silo.
- Opened up ash silo bag house and repaired the two right side headers.
- Bag house was in good condition.

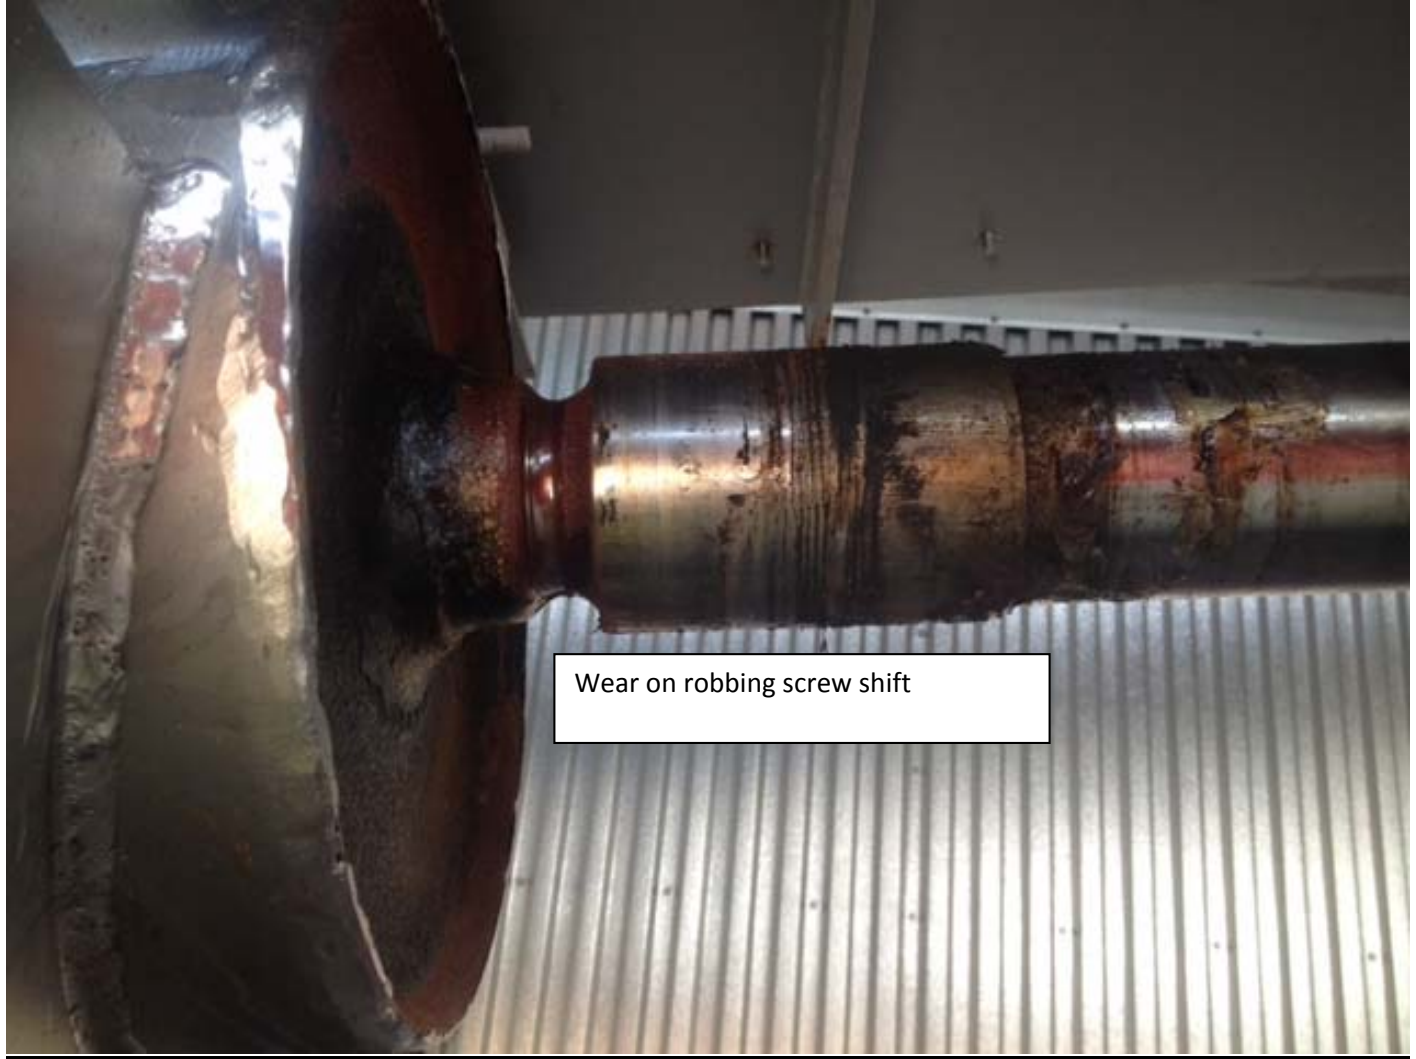
Wear on robbing screw shift

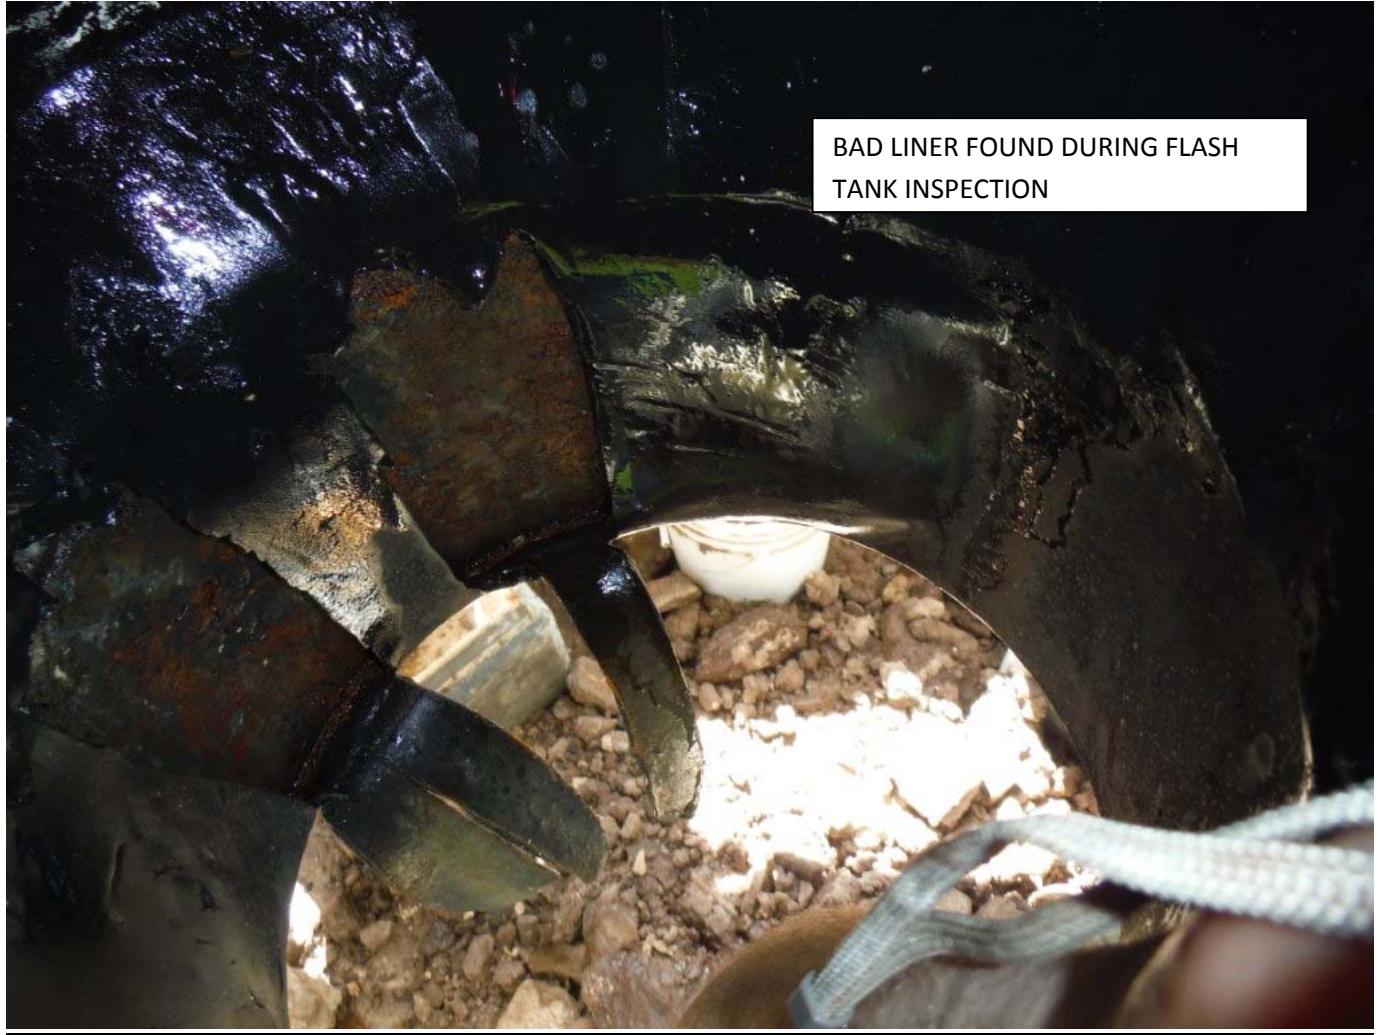
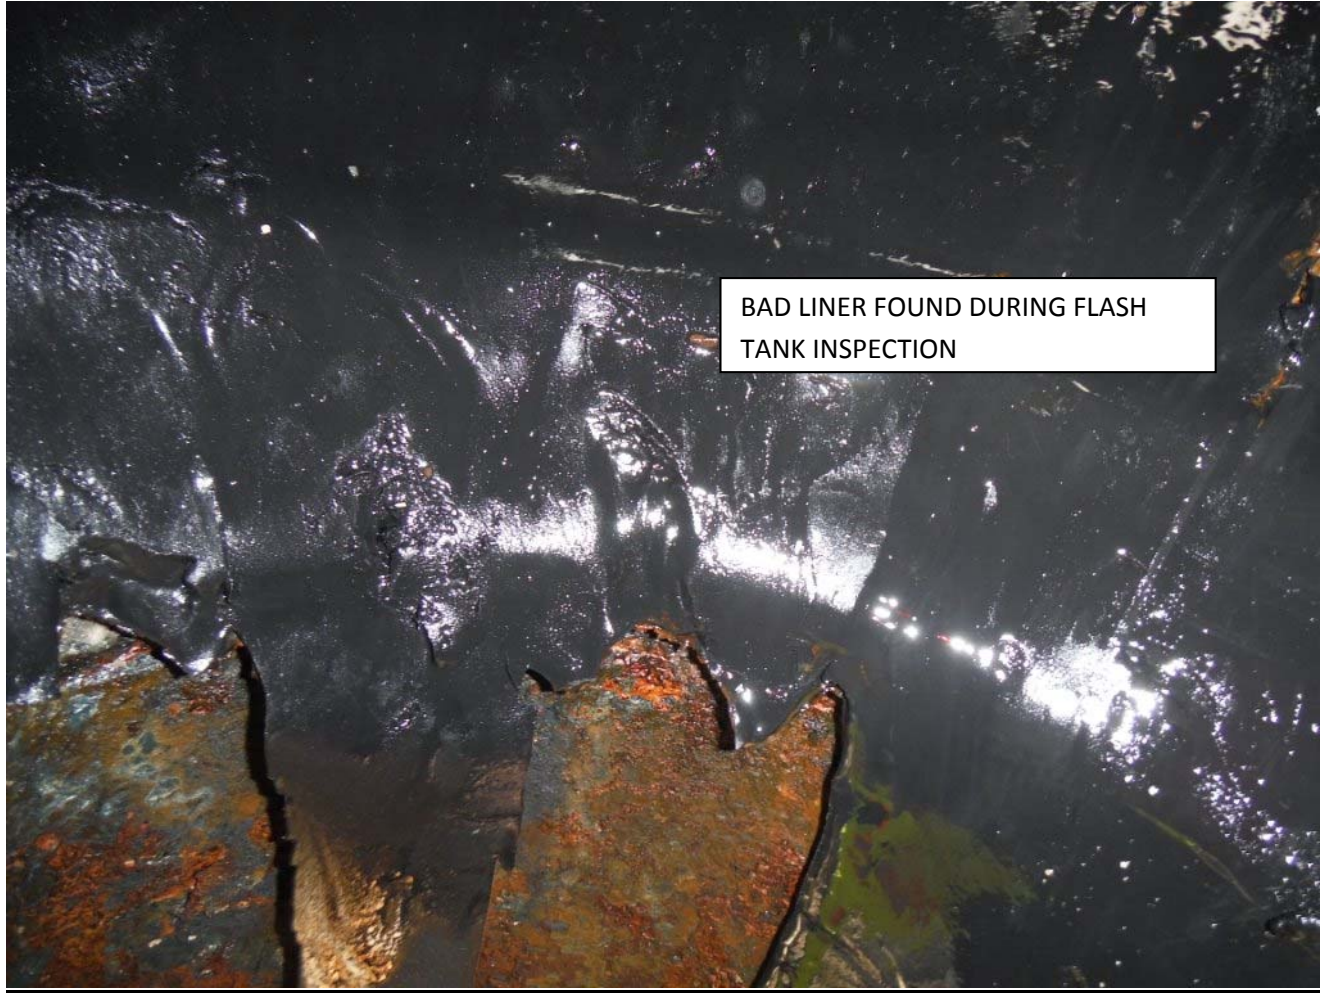
FOUND THE RUBBER LINING TO THE FLASH TANK COMING APART, HAD RUBBER SEAL REPAIRED BY CONTRACTOR.

BAD LINER FOUND DURING FLASH
TANK INSPECTION

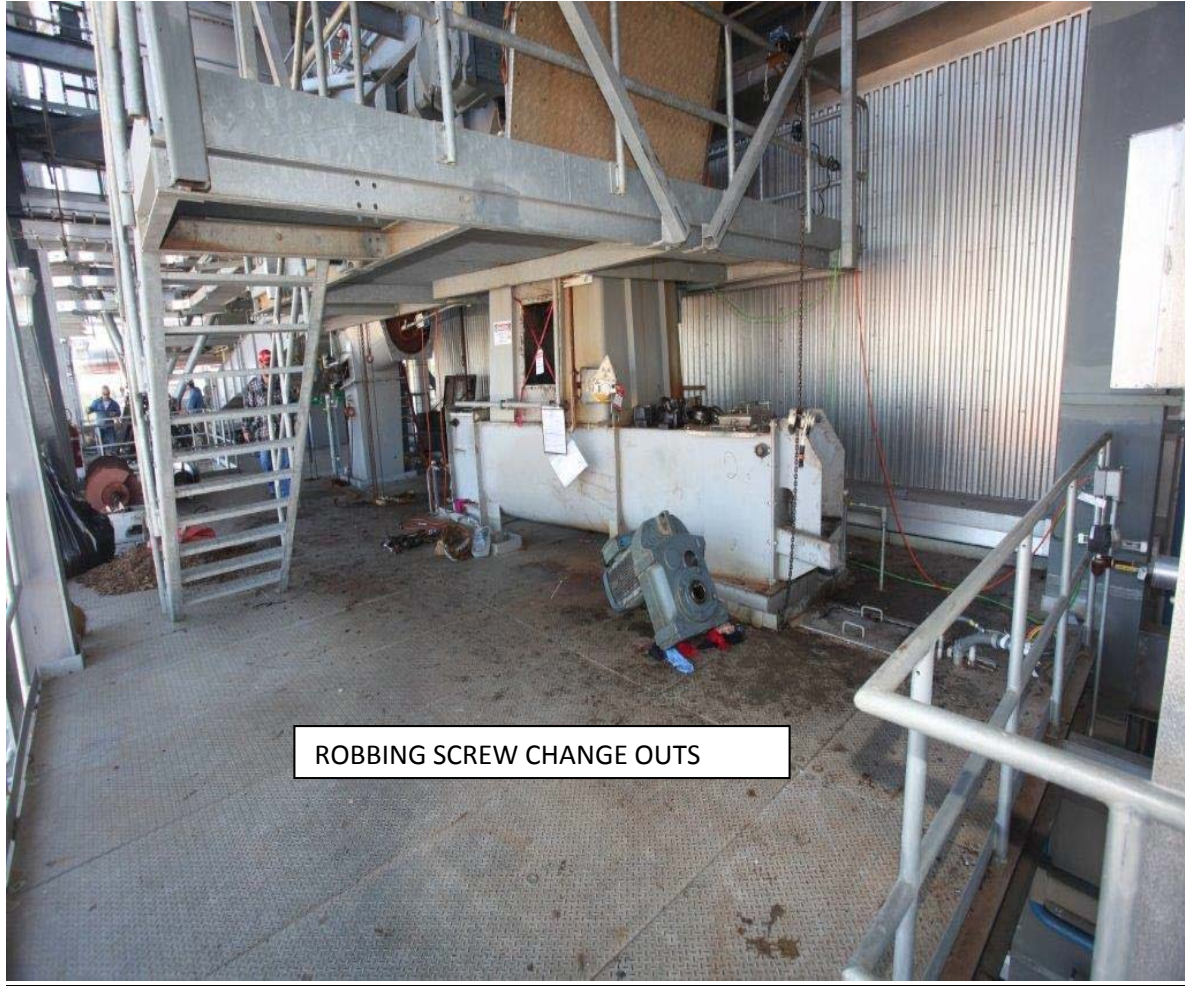
WEAR IN ROBBING SCREW BIN
