# May 2017 Outage Report

## **A. Executive summary**

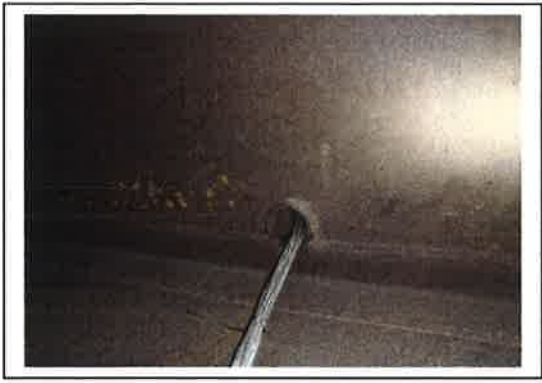
**OPEN PORT TO WIRES – UPPER  
ECONOMIZER**

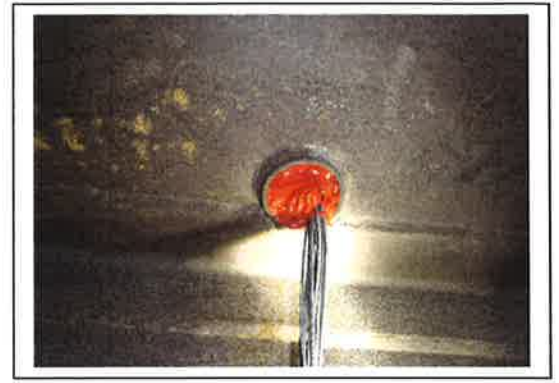
**WIRES SEALED – UPPER  
ECONOMIZER**

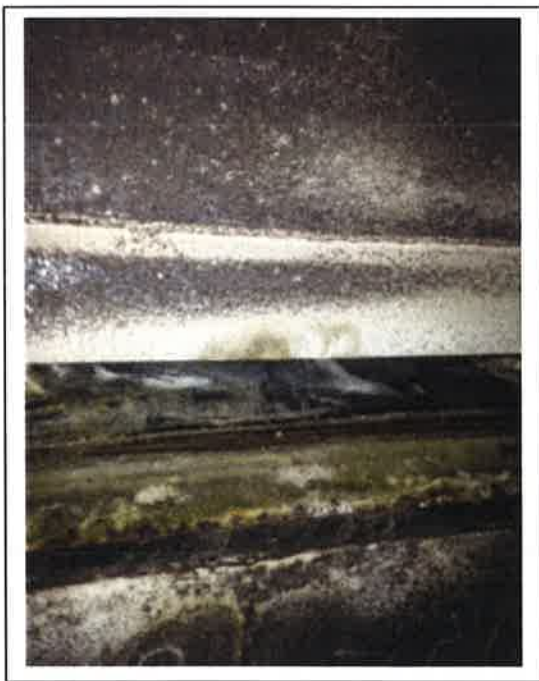
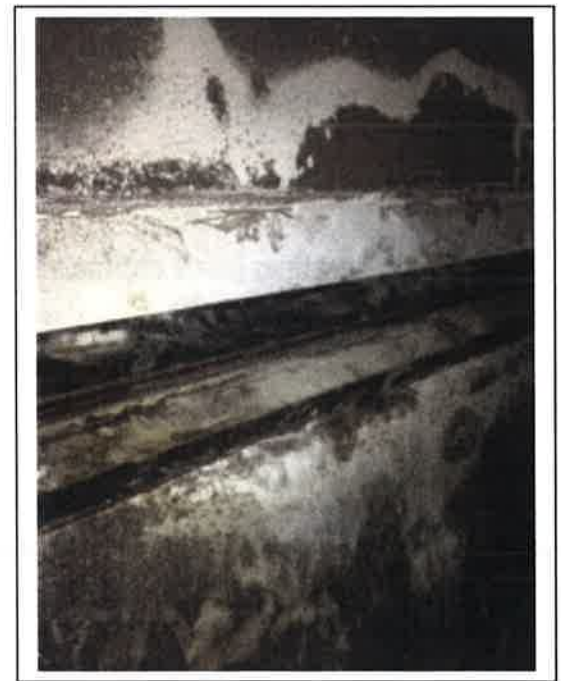
**LEAK OF EXPANSION JOINT  
DISCHARGE BAG HOUSE – EAST  
UPPER SIDE**

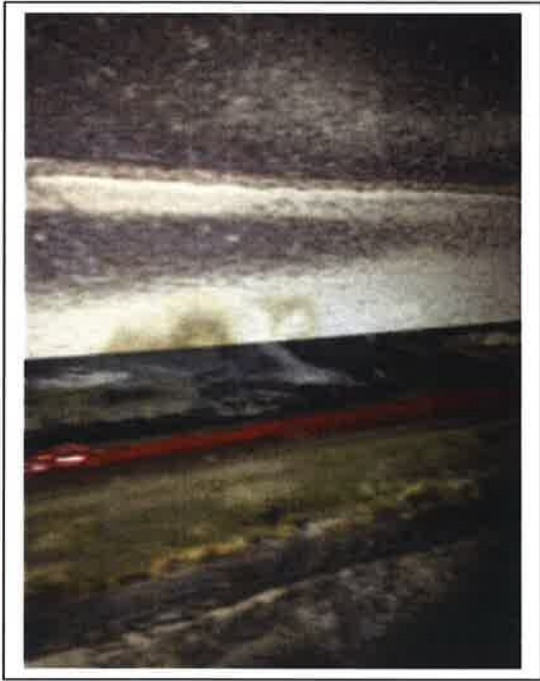
**LEAK OF EXPANSION JOINT  
DISCHARGE BAG HOUSE – EAST  
UPPER SIDE**

**REPAIR LEAK OF EXPANSION JOINT  
DISCHARGE BAG HOUSE – EAST  
UPPER SIDE**

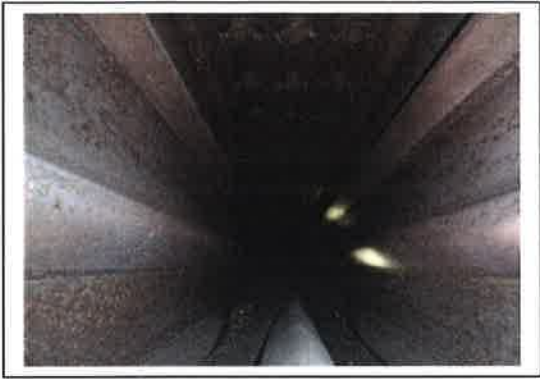
**BOILER ASH @ HYDROBEAM**

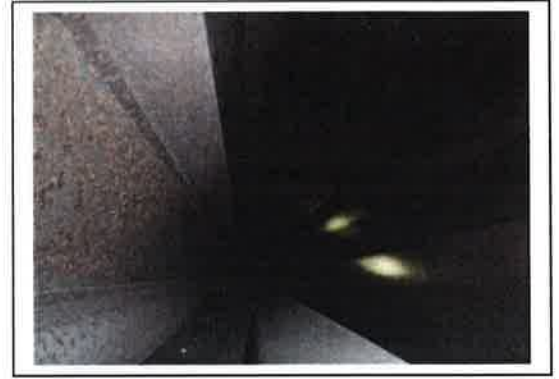
**BOILER ASH @ HYDROBEAM**

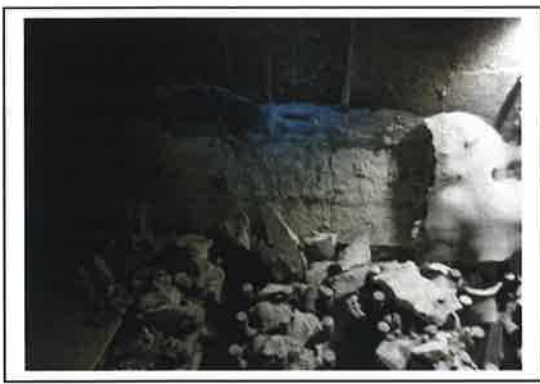
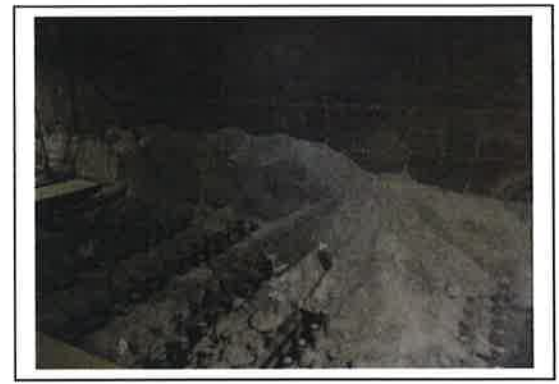
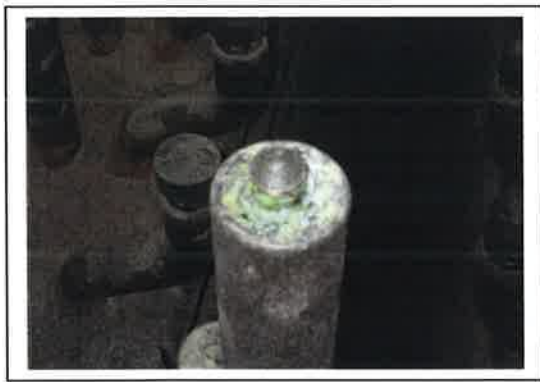
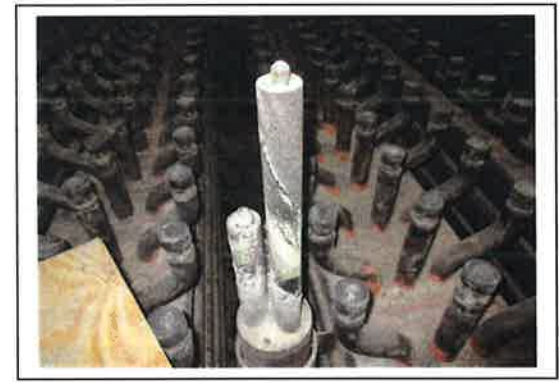
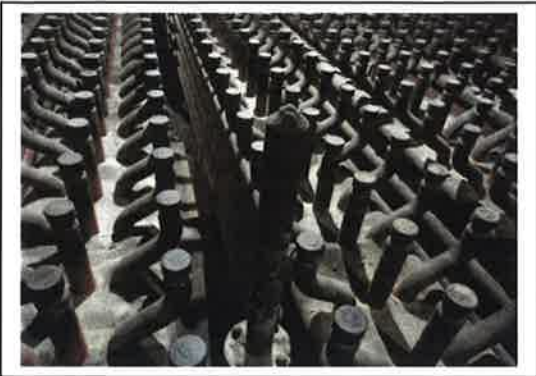
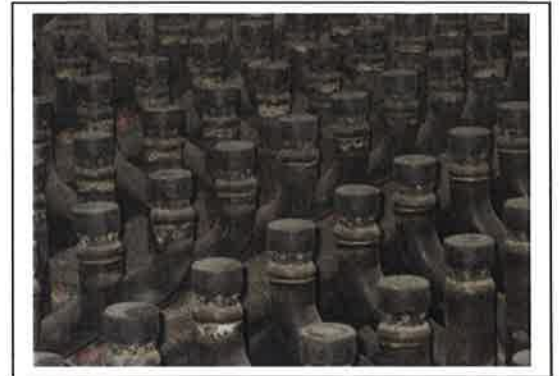
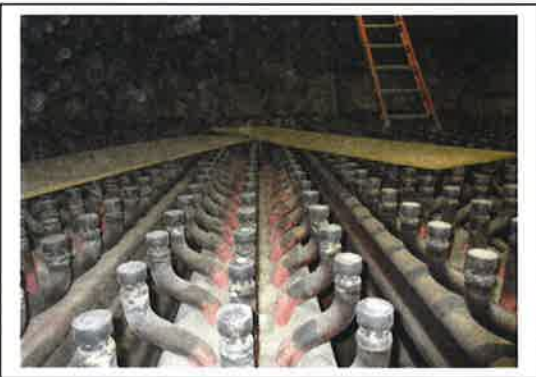
**THERMOCOUPLES**

Three thermocouples were replaced due to overheating or glassing. This happens when the bed the temperature gets high in the corners where they are located. It's been brought to our attention by another vendor that the material is not designed for the high temperature. Recommendation is material made of Inconel. In the process of quoting this material for future remedy with vendor.

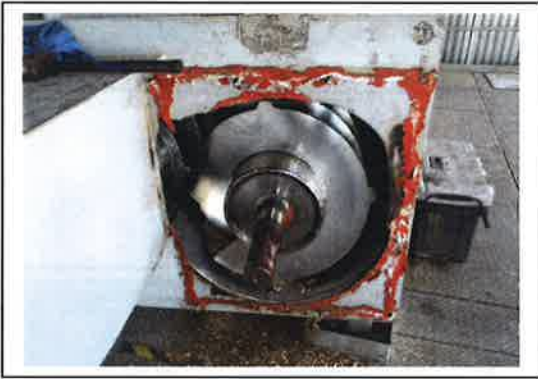
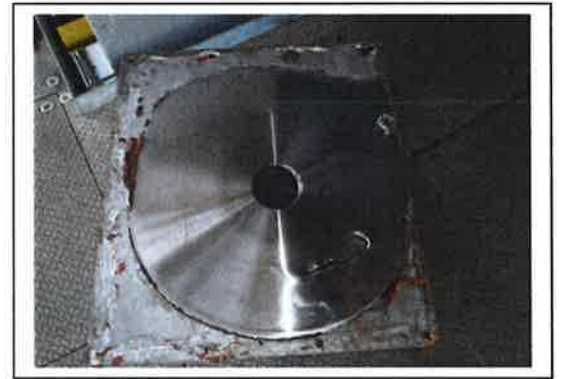
**ROBBING SCREW**

- Inspection of fuel feed system was minor due to limited run time. The most repair work was at the robbing screws on each side of boiler.

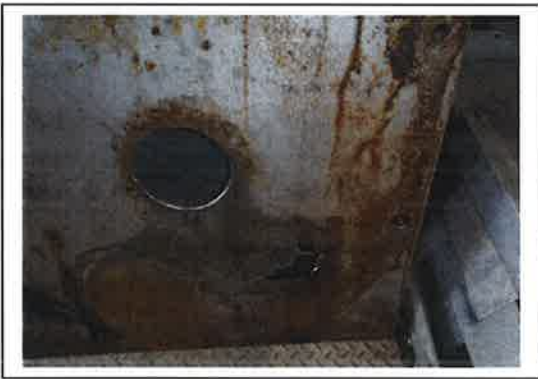
**STAINLESS PLATE WEAR**

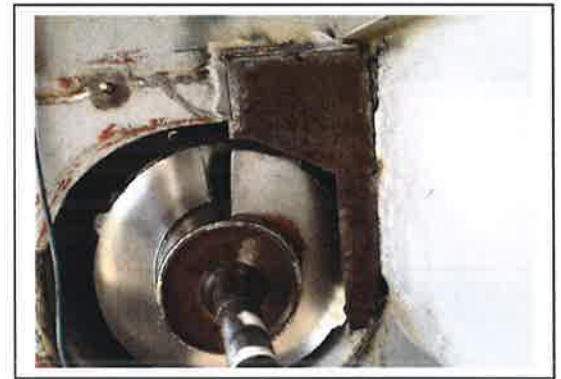
**STAINLESS PLATE WEAR**

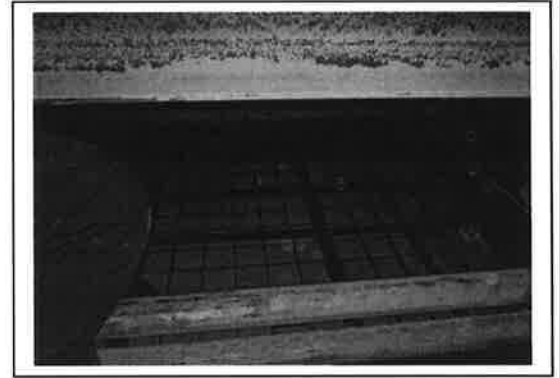
**ASH @ TUBES & BEAMS**

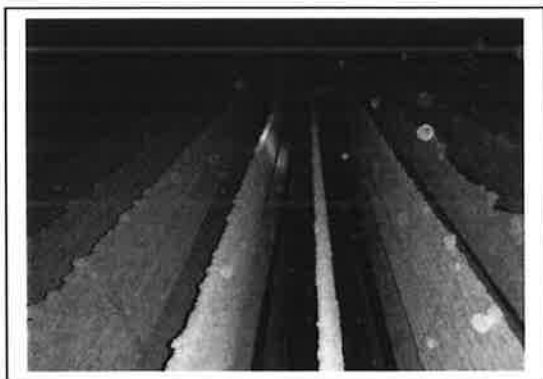
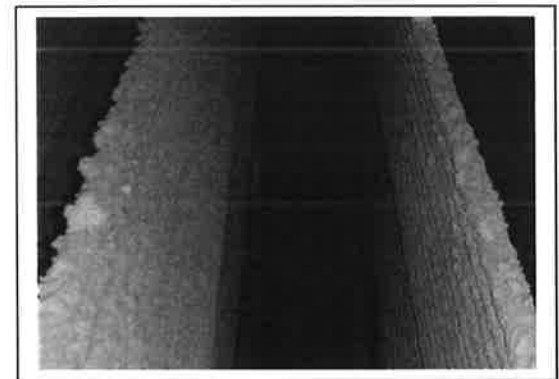
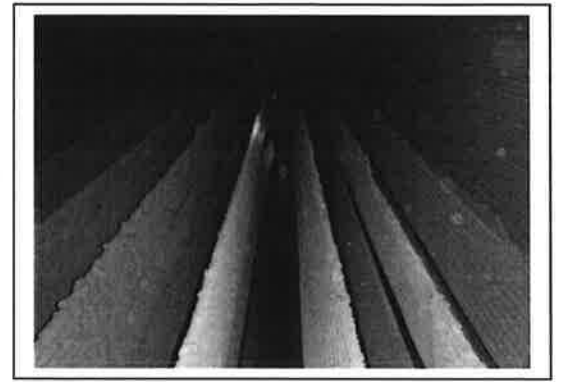
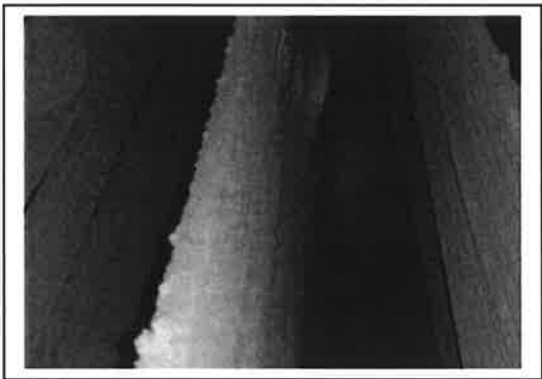
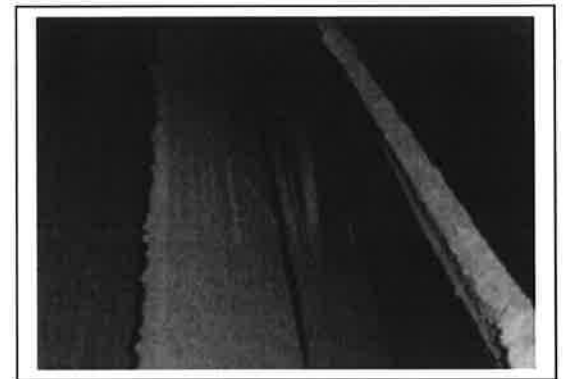
**SECONDARY BANK**

The planned outage was completed at an estimated cost of \$420,000 and required 7 days of downtime for Boiler Outage. There were no safety incidents and no environmental incidents. It took twenty-six loads of sand roll offs to empty the boiler bed. All work and findings were routine and lessons learned on removing bed thermocouples. (Bed thermocouples are easier to remove from the boiler side than under the boiler.) Normal wear in the fuel feed system was minor, most wear at the metering/robbing screws. Noticed some bent tubes in the secondary super heater sections, Valmet to report findings on in their report.

- Inspection revealed some sections of tube binding at top of sections. Valmet to review with their process engineering group.
