Report of Findings

EMI Testing

at Gainesville Renewable Energy Center

EMI DIAGNOSTICS REPORT

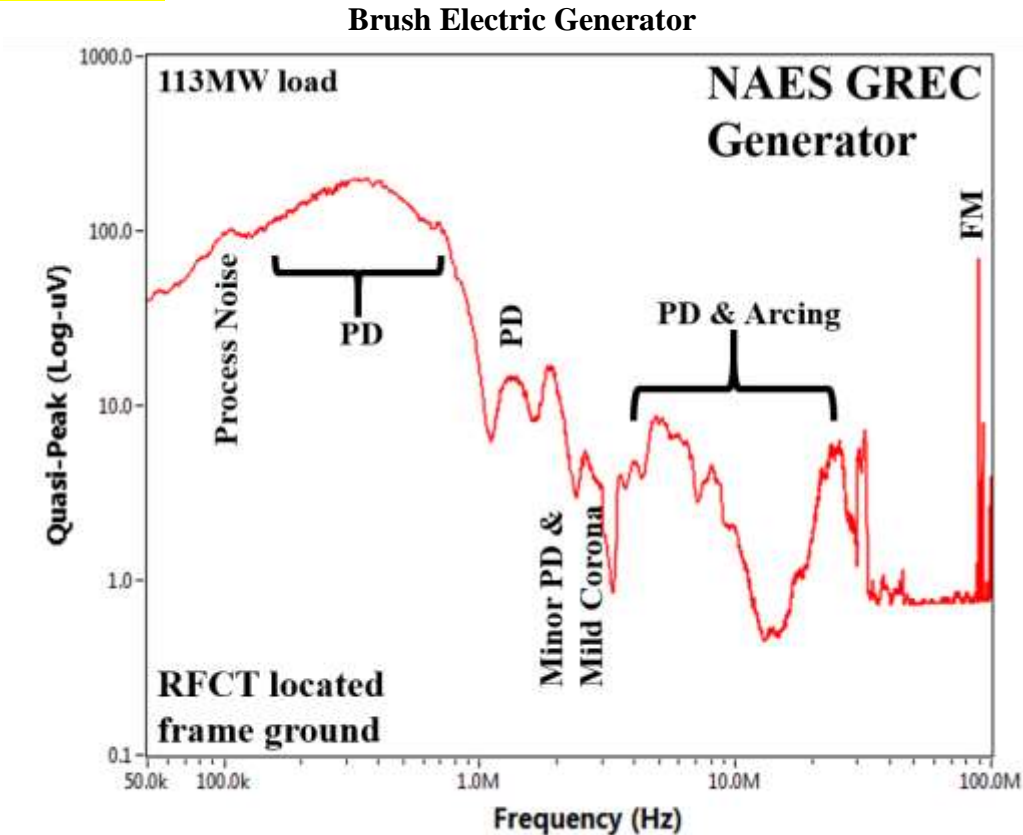
Figure 1: EMI Signature for Generator.

This was the first EMI evaluation for this Brush Electric 13.8 kV, 136 MVA, 3600 RPM, 3 PH, 60, Hz, 0.85 pf, air cooled generator, SN: 921007.010. The test was performed with EMI data collected from an RFCT (radio frequency current transformer) placed around the generator frame ground. A photograph of this location can be found at the end of this report.

PD, mild corona and arcing and were noted in the spectrum. High radiated EMI levels were noted at the generator connection box. Levels were highest at the generator side of the connection box. **Recommend inspecting the cable connections for looseness, proper assembly and torque during the next scheduled maintenance period.** Very high radiated EMI levels were noted from the lube oil piping at the turbine. Static discharges in lube oil systems can cause oxidation of the oil and result in oil breakdown and contamination. **Recommend oil analysis be conducted. If oil is darkened and breaking down the source of the static discharges should be resolved.**

Recommend retesting following repairs. Track and trend this generator.

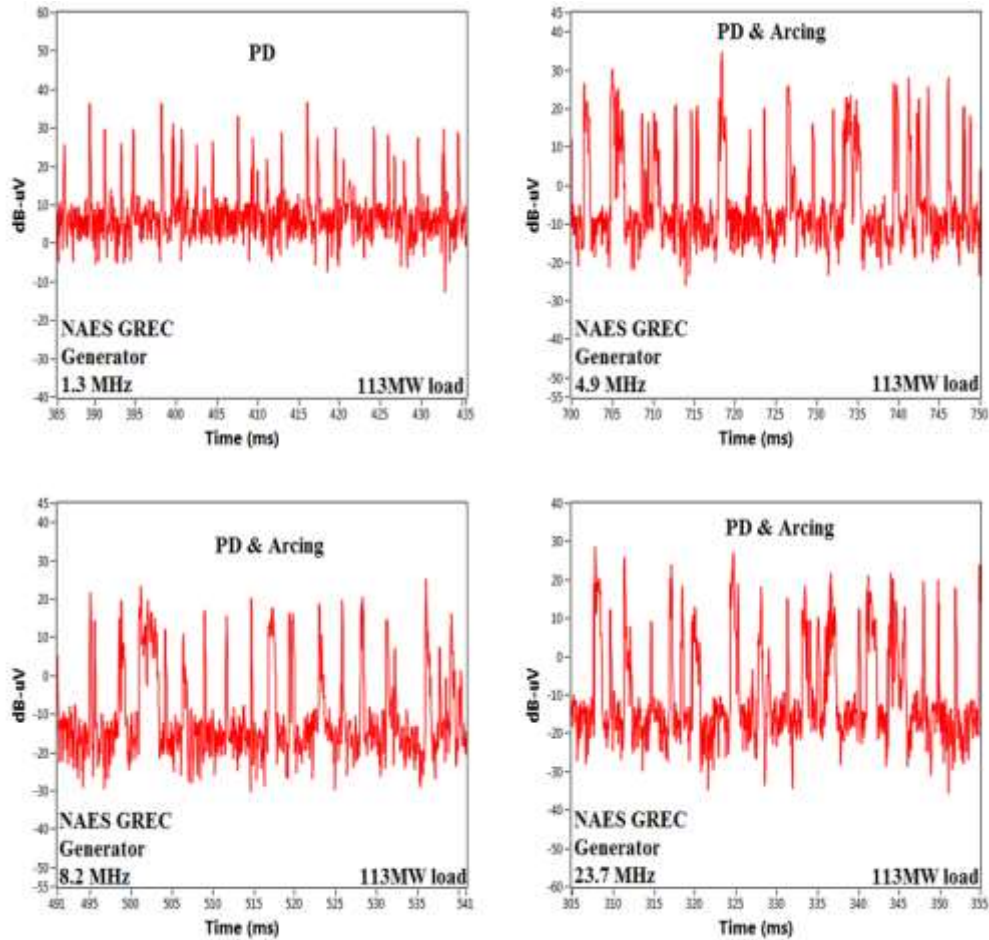
Figure 2: Generator EMI patterns in the spectrum.

Figure 2 shows PD and arcing in the spectrum. Arcing is an indication of loose connections. The source of this activity and recommended actions are discussed above.

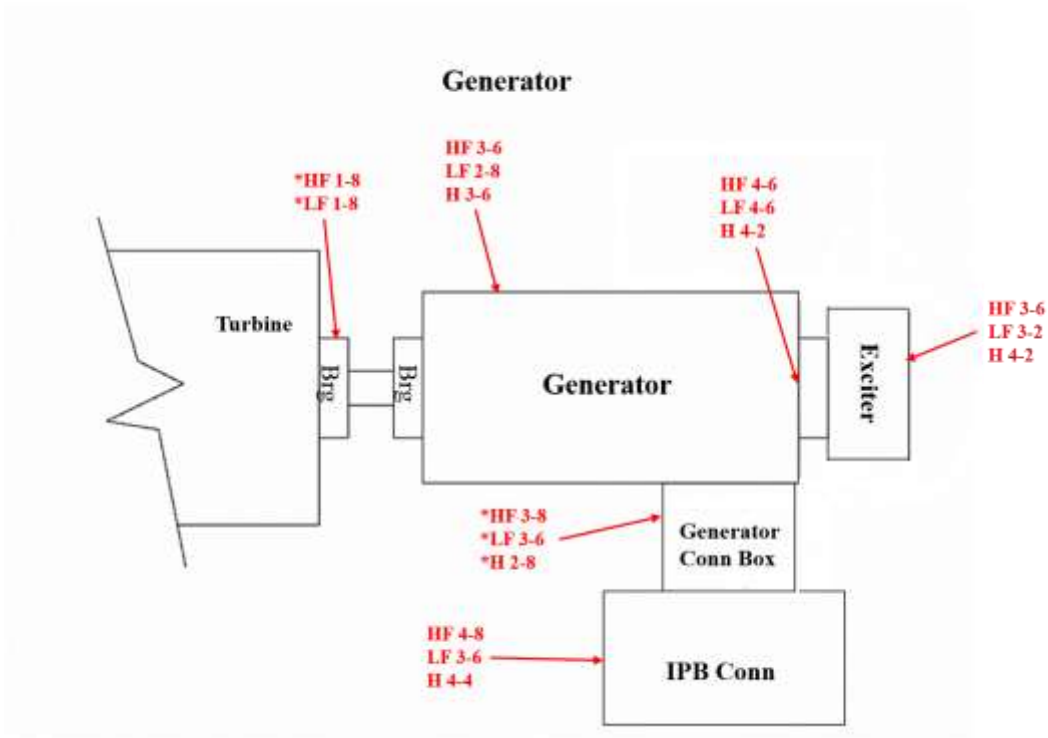
Figure 3: EMI Sniffer Evaluation for Generator

A scan for radiated EMI shows activity in the turbine bearing and lube oil piping, as well as radiated EMI from the Generator Connection Box. Sparking in the lube oil system should be investigated and corrected. Discussion of the causes and recommendations is listed above.

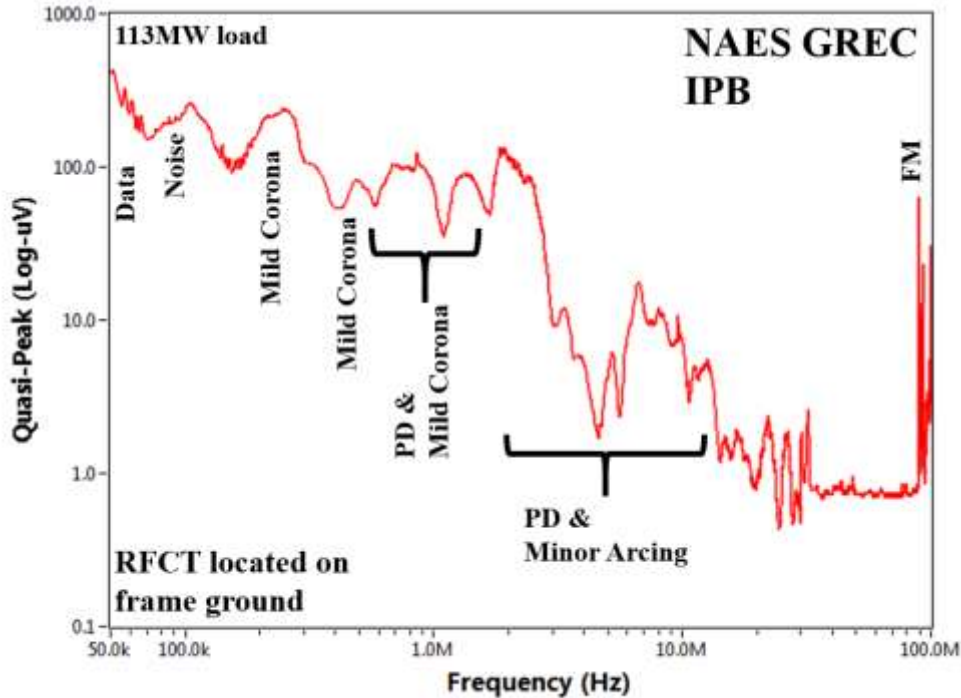
Figure 4: EMI Signature for Isolated Phase Bus.

PD, data, FM radio signals, minor arcing and mild corona were noted at several frequencies throughout the spectrum on this bus. Radiated EMI levels were moderate throughout the bus but were higher in the vicinity of the generator connection box. Activity noted is most likely from the generator as discussed above. No corrective actions are recommend at this time.

Track and trend this bus.

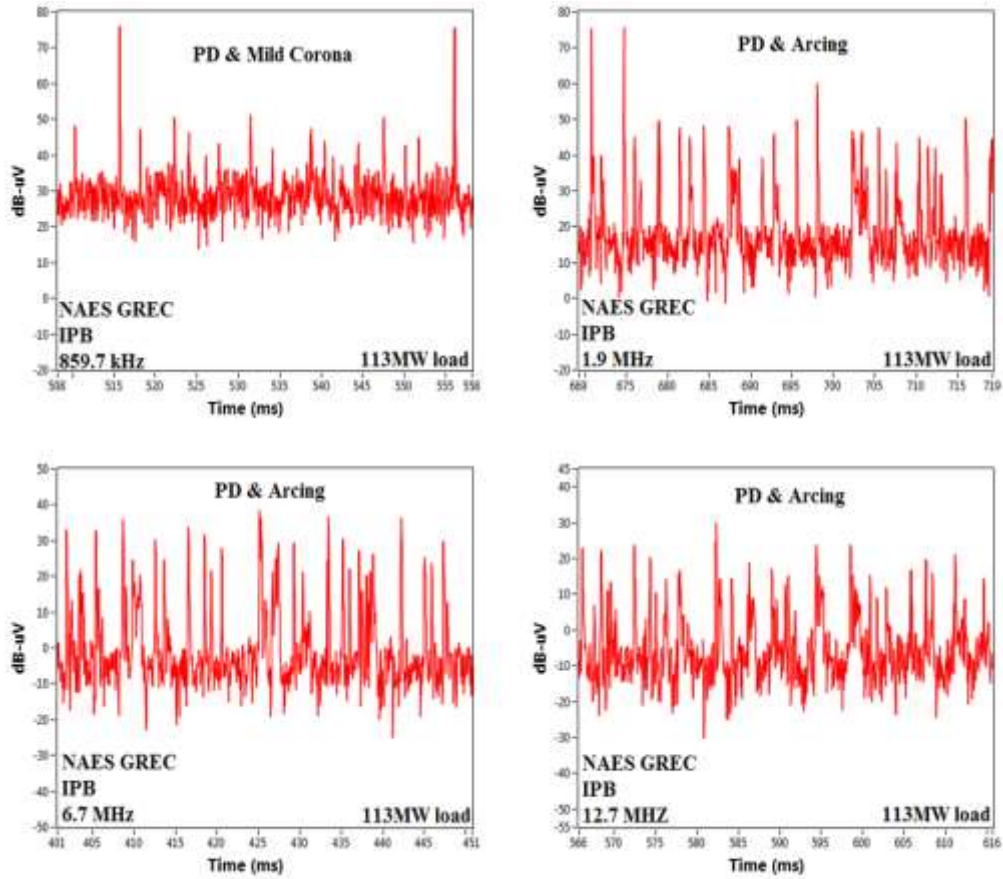
Figure 5: Isolated Phase Bus EMI patterns in the spectrum.

Figure 5 shows Arcing, mild corona and PD patterns. Arcing and PD observed in the above waveforms is likely from the generator. Those actions are addressed above.

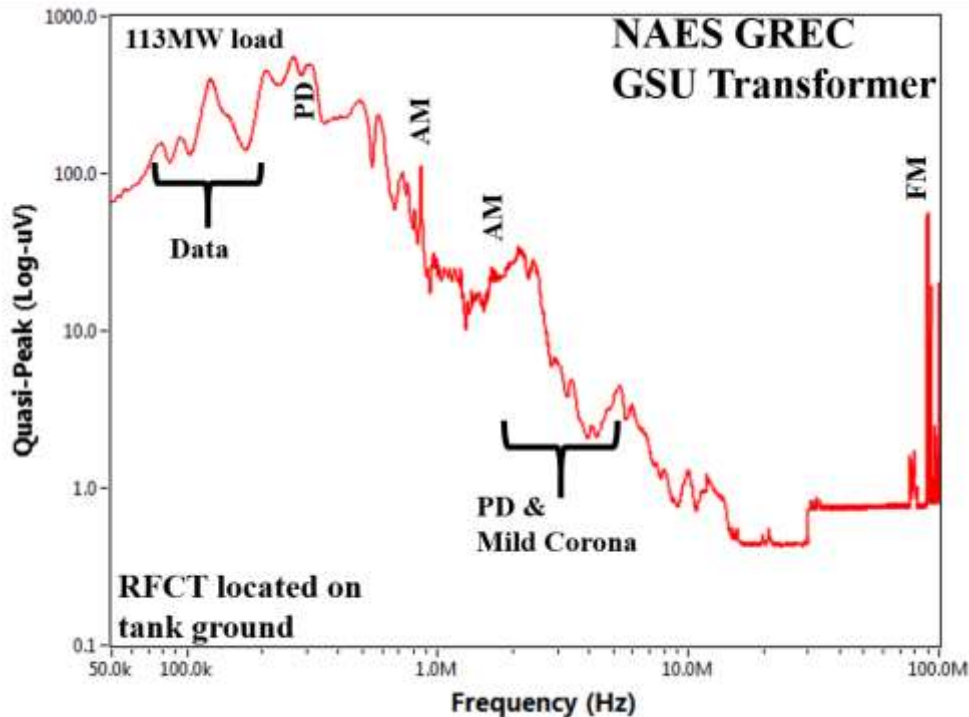
Figure 6: EMI Signature for GSU Transformer.

PD, data, AM radio, noise and mild corona were noted at several frequencies throughout the spectrum this transformer. Radiated EMI was low throughout the transformer. Levels are low and not of concern at this time.

Recommend track and trend this transformer. Continue schedule oil analysis.

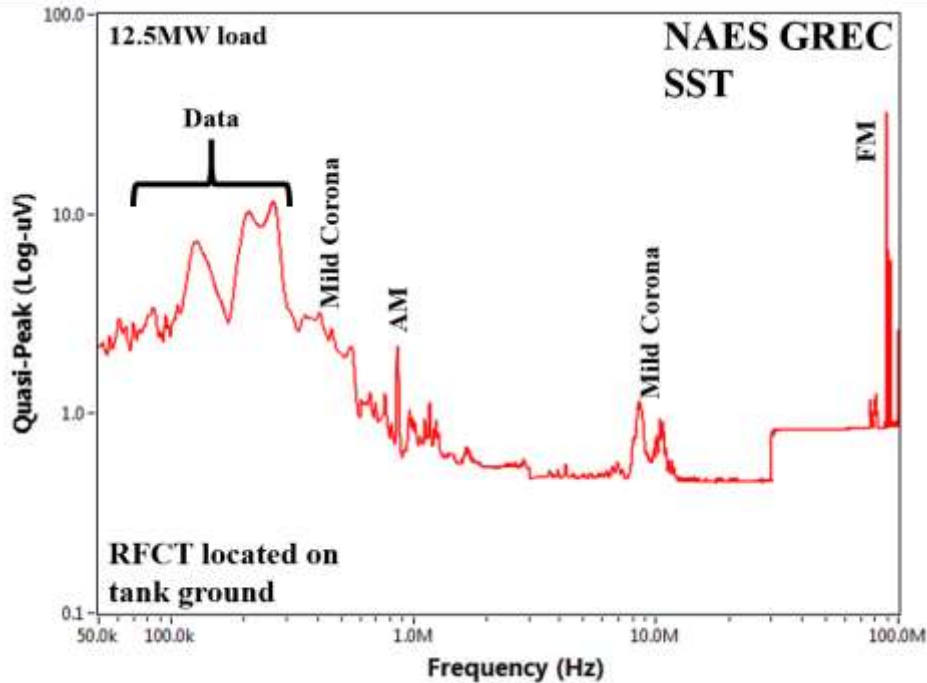
Figure 8: EMI Signature for Station Service Transformer.

PD, data, AM/FM radio, noise and mild corona were noted at several frequencies throughout the spectrum this transformer. Radiated EMI was low near the transformer. EMI levels are low and not of concern at this time.

Recommend track and trend this transformer.

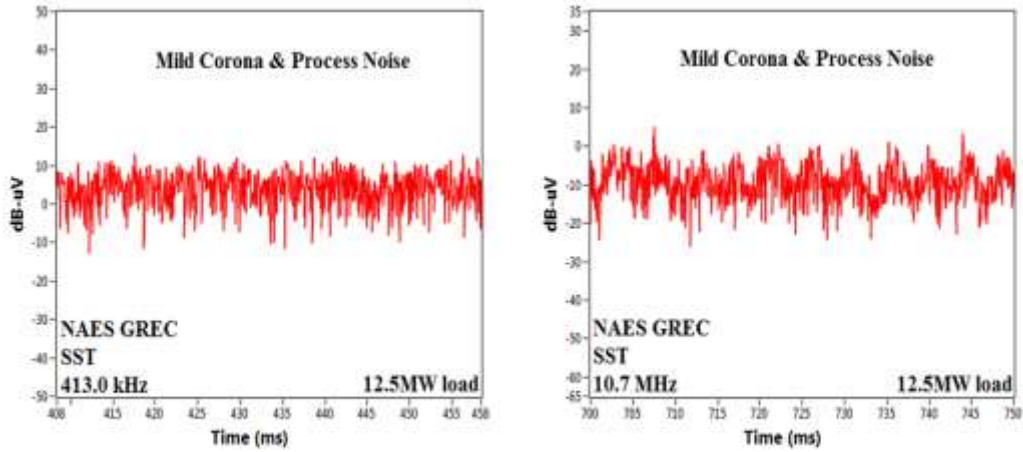
Figure 9: Station Service Transformer EMI patterns in the spectrum.

Figure 9 shows process noise and mild corona. These levels are very low and not of concern at this time.

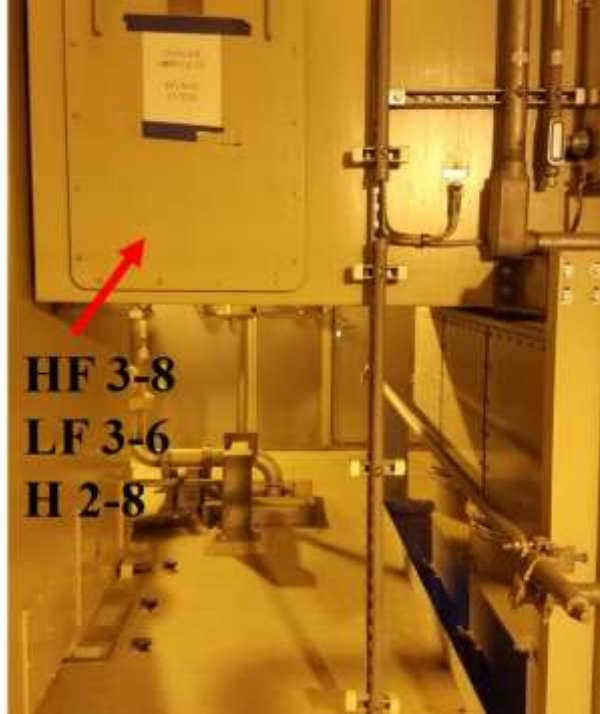
Photo 5: Generator Connection Box Sniffer Results.
