NAES – GAINESVILLE RENEWABLE ENERGY CENTER

*Provide Supervision to Site Mechanical Maintenance Personnel With Troubleshooting and Repairs to “B”
Boiler Feedwater Pump.*

SERVICE REPORT

6x14 WXH 7 stg.

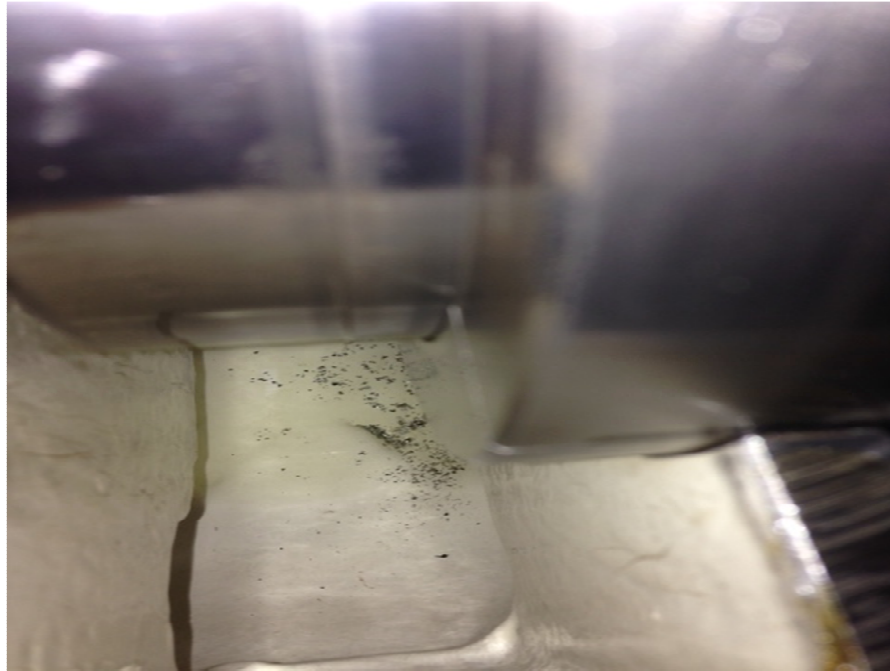
- Thrusted pump inboard hard against the active thrust shoes. Set the dial indicator at zero. Removed the active thrust shoes and moved the shaft towards the motor to check the balance drum setting. The pump did not move. Balance drum is against the balance disc.
- Removed active thrust shoes and active thrust shoe cage. No visual damage or smearing of babbitt noted. Cages are free to pivot.
- *There is a significant amount of "metallic" material in the base of the NDE bearing housing.*

Root Cause Analysis: *The metallic material noted in the oil filters was, in fact, babbitt from the NDE sleeve bearing. There was some smearing of babbitt noted on this bearing only. The DE and thrust bearings showed no damage.*

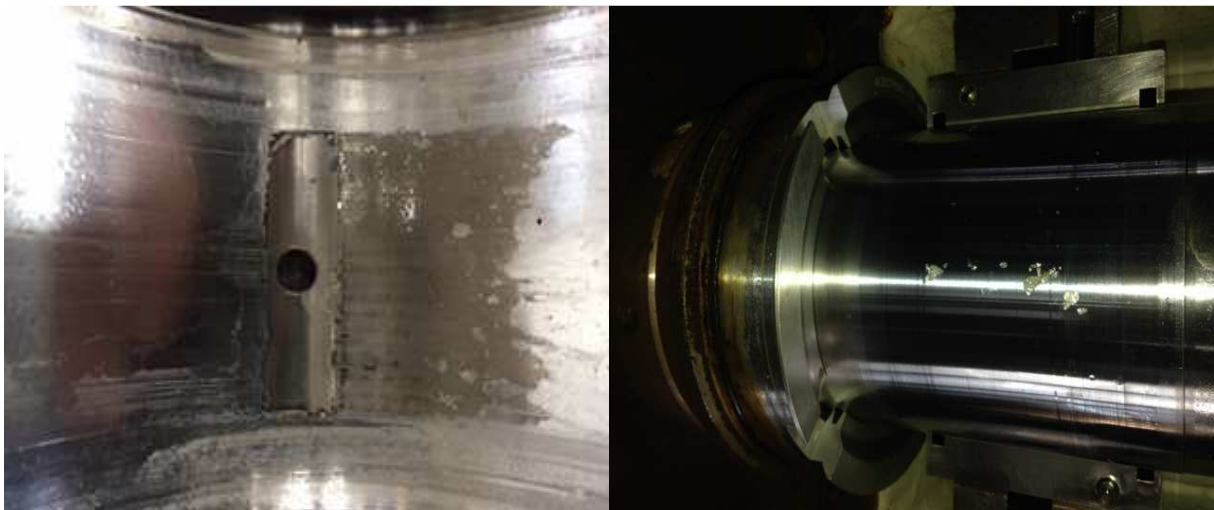
- Removed the NDE sleeve bearing upper half. *There is babbitt smearing on the sleeve bearing upper half and babbitt found on the pump shaft.*

The NDE sleeve bearing damage was caused by water emulsion in the oil system. In journal bearings, the incompressibility of water relative to oil can result in a loss of the hydrodynamic oil film that in turn leads to excessive wear. As little as one percent water in oil can reduce the life expectancy of a journal bearing by as much as 90 percent. Damage was only noted on the NDE sleeve bearing. This is because the NDE sleeve bearing is the first bearing in the oil system flow path and, due to the infrequent operation of the pump, the water and damage was identified early and corrected.

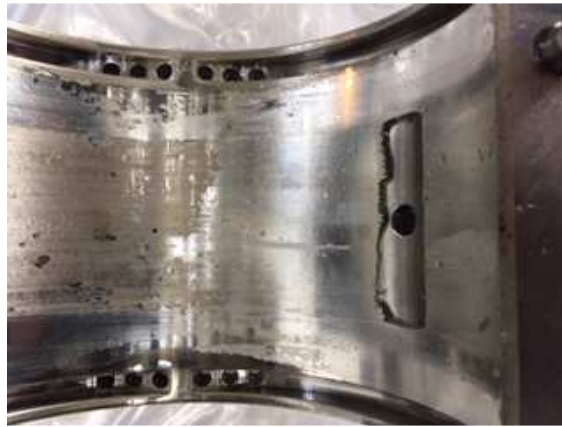
- Rolled out the NDE sleeve bearing lower half. *There is smeared babbitt on the sleeve bearing lower half as well.*

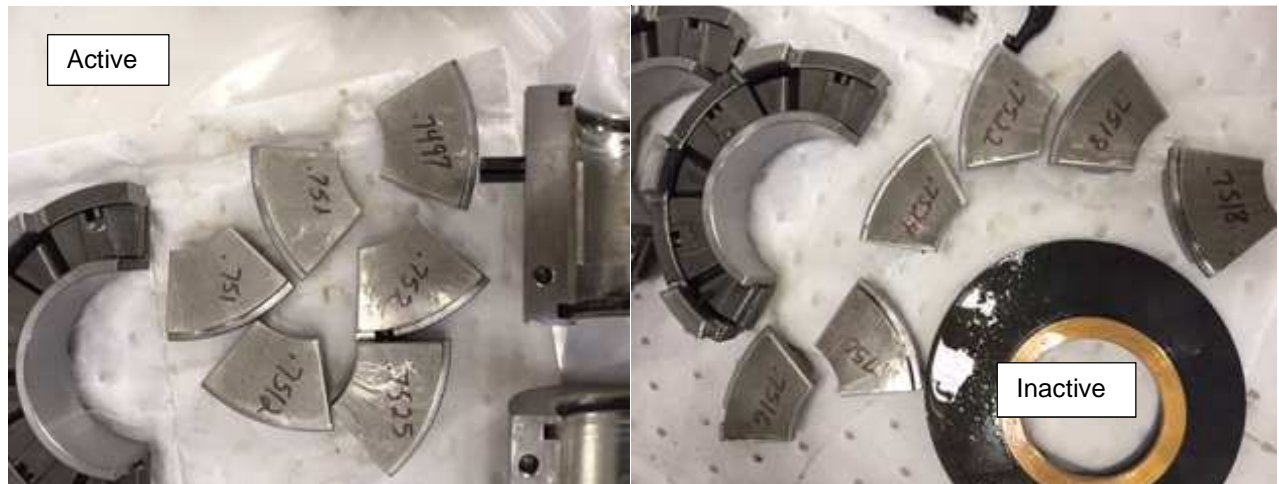
- There does not appear to be any damage to the pump shaft in the bearing area or the prox probe chromed area. Installed a protective coating on the prox probe chromed area.
- Measured the “as found” thickness of the active (0.7497”-0.7525”) and inactive (0.750”-0.7524”) thrust shoes.

- Measured the thickness of the new thrust shoe at 0.754” simply for comparison. I will attempt to pull the thrust shoe drawing to determine “exact” wear found but this simply shows that there is wear as expected but not excessive.
- Pulled a new sleeve bearing from the warehouse and site personnel measured the ID of the new sleeve bearing as follows:

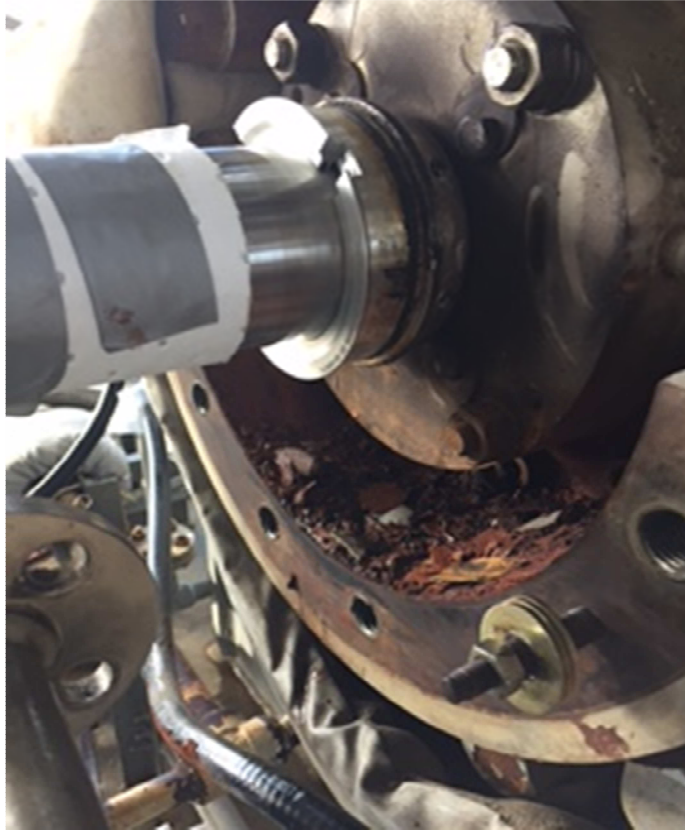
- Removed the DE sleeve bearing upper and lower halves and noted no abnormal wear or damage noted.
- Speaking with Tommy Gardner, NAES maintenance supervisor, we have decided to replace the NDE mechanical seal for preventative maintenance purposes.
