BOILER INSPECTION REPORT

VALMET REFERENCE No. M40001

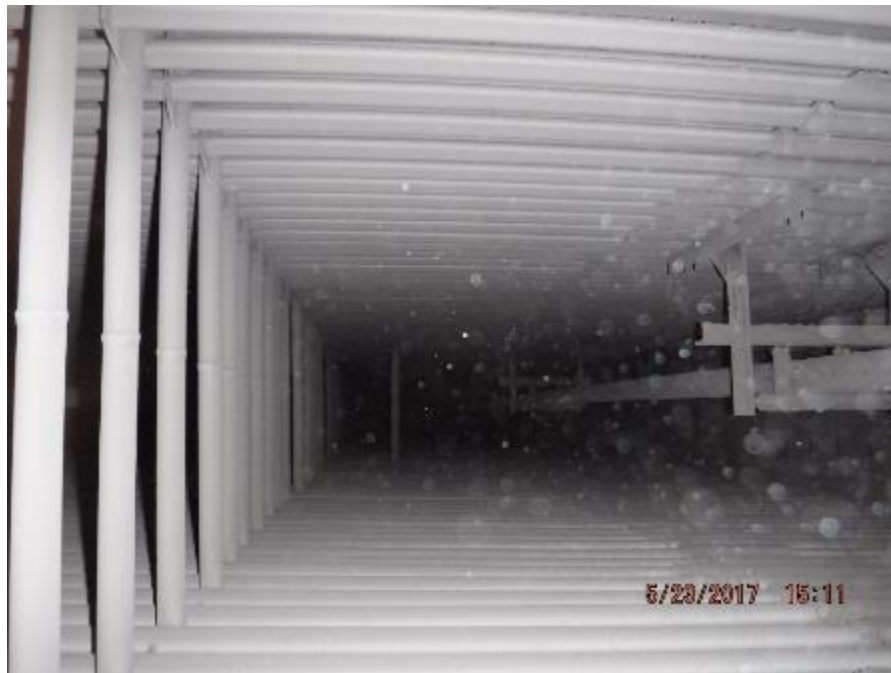
Photo 1 – View is of sootblower lane between P1 superheater and boiler bank. No sagging in boiler bank elements.

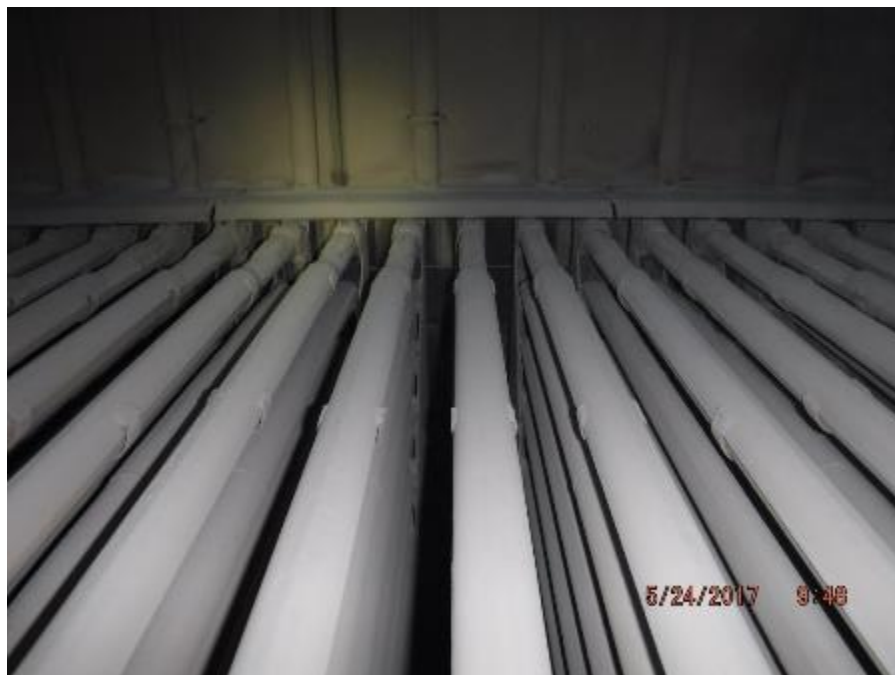
Photo 3 – Top face of boiler bank, elements are straight. No ash deposit build up on tubes or between elements. Tube shields in good condition.

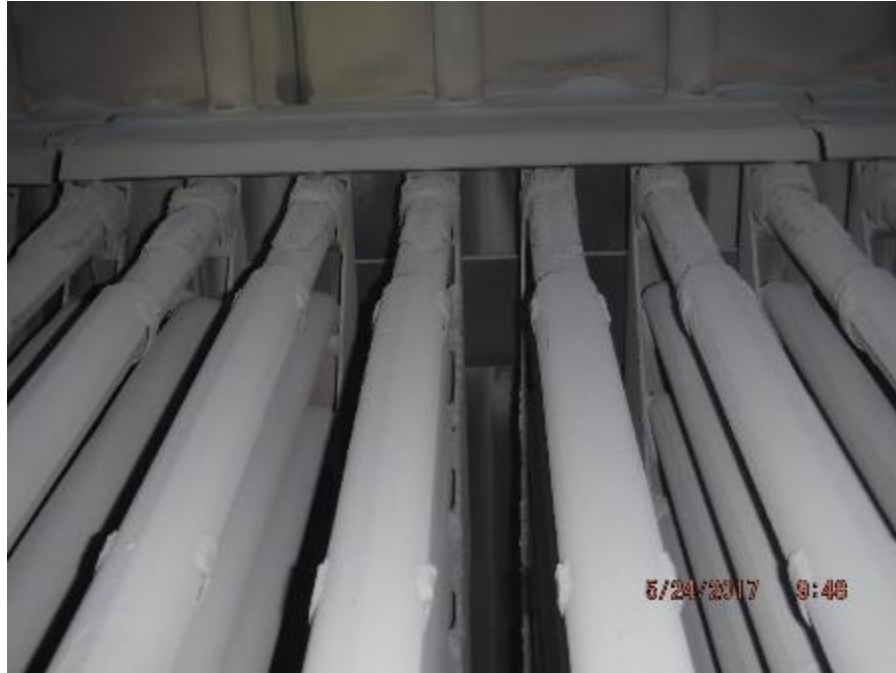
Photo 6 – Front wall supports for boiler bank elements are in good condition.

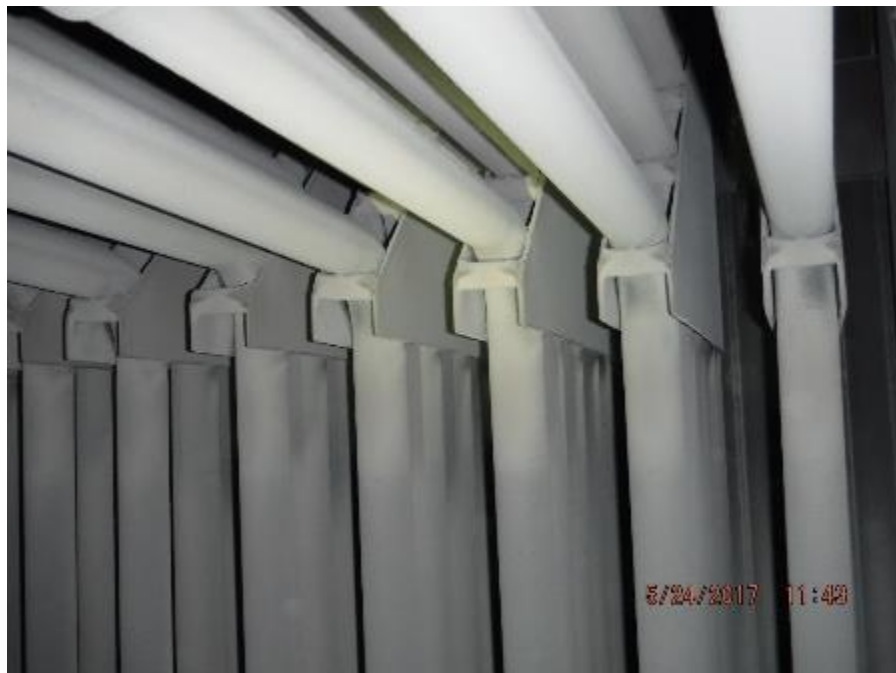
Photo 7 – Rear wall supports for boiler bank elements are in good condition.

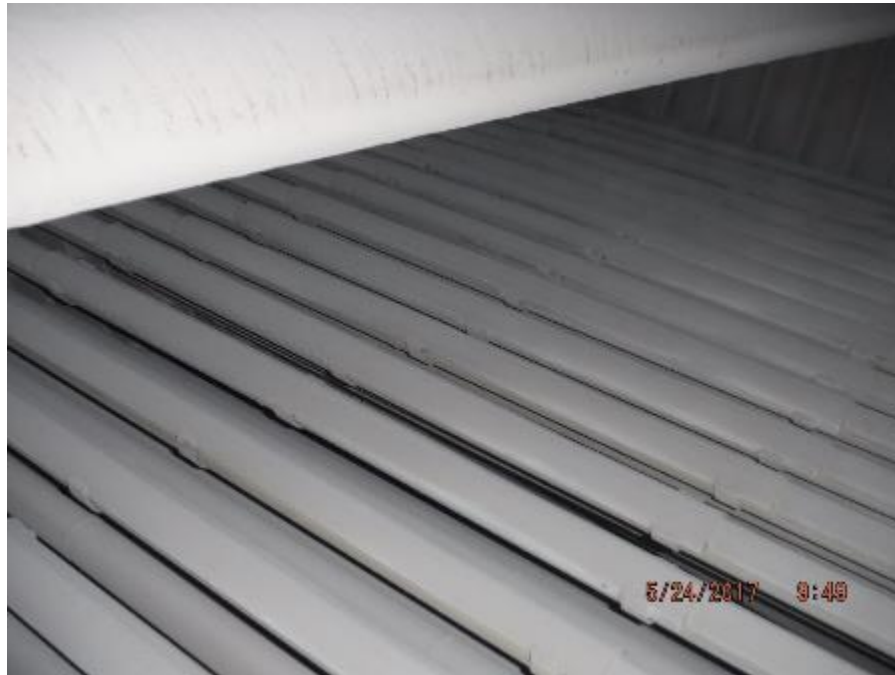
Photo 8– On top face of boiler bank below sootblower lance, tube shields are in good condition, firmly attached and correctly positioned.

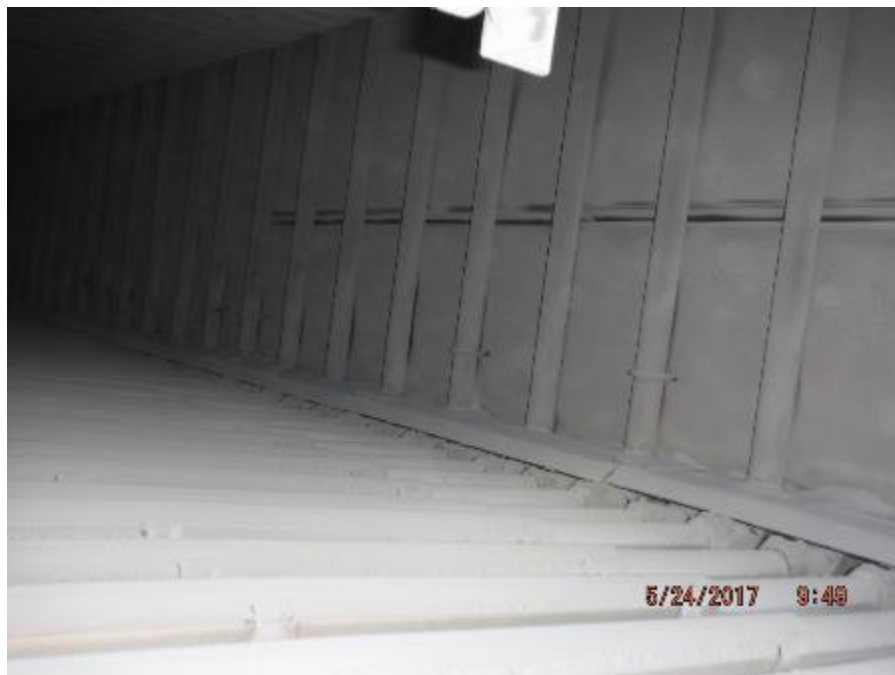
Photo 9 – On top face of boiler bank, front wall erosion baffles in very good condition.

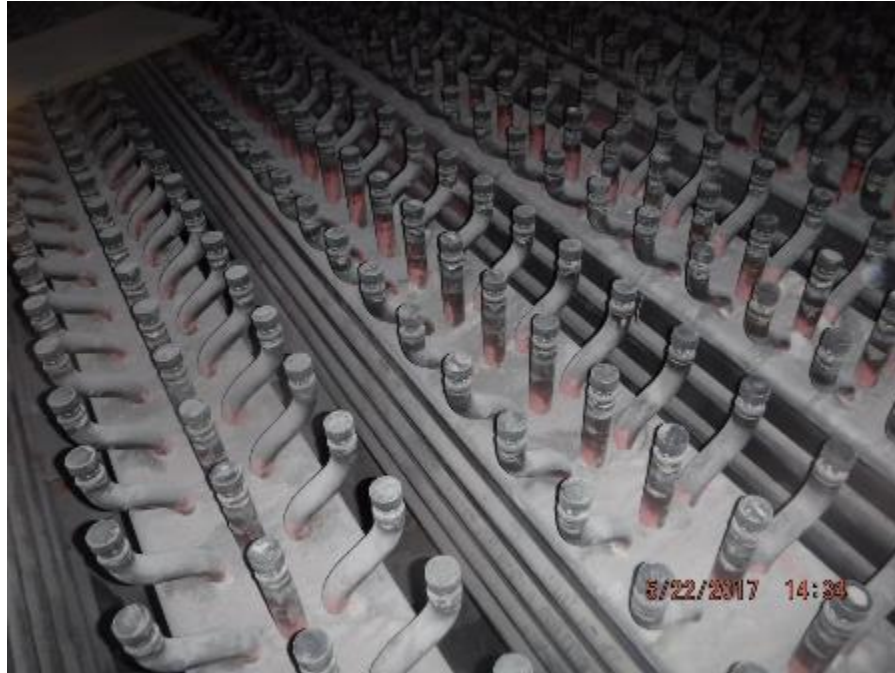
Photo 13 – View of Hybex beam floor tubes.

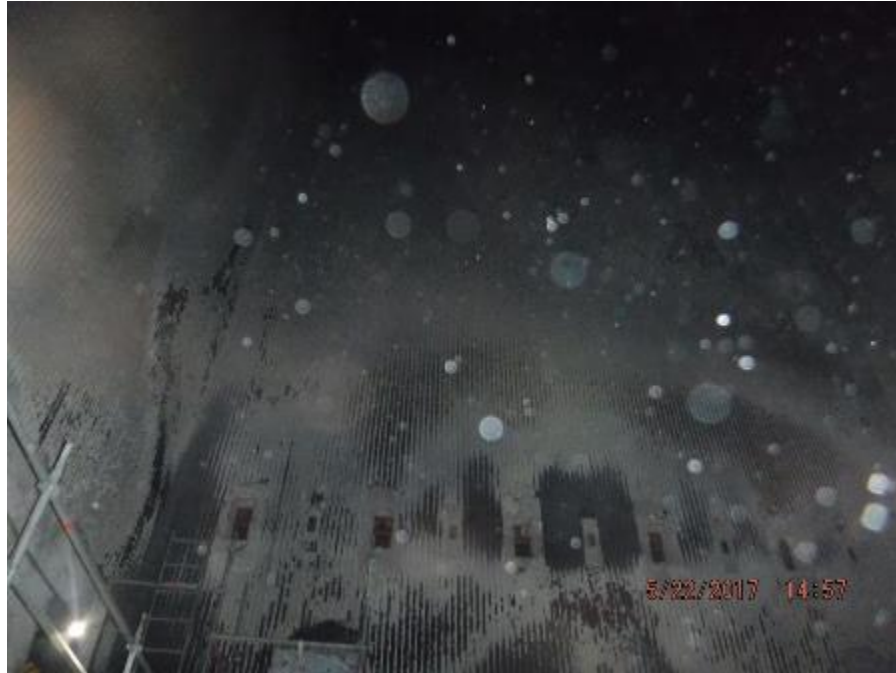
Photo 14 – Lower furnace front wall tube panels are straight with spot areas having slight ash deposits.

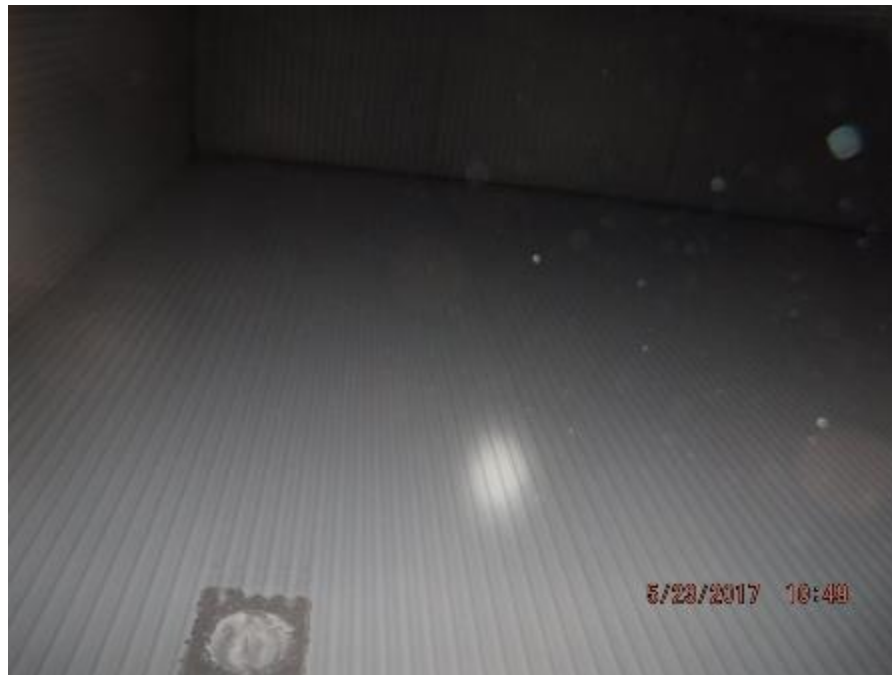
Photo 16 – Upper furnace waterwall tube panels are straight.

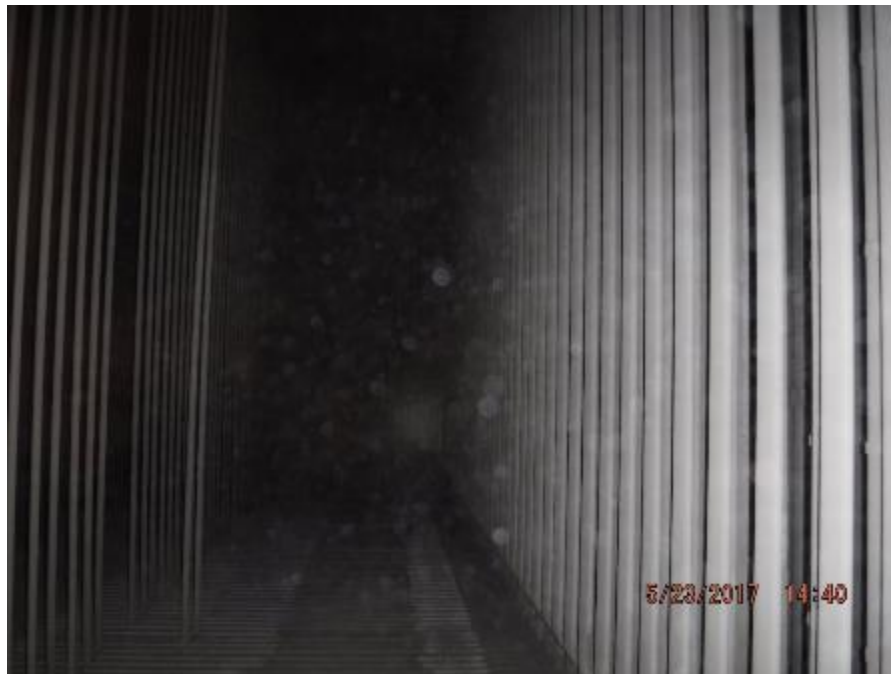
Photo 19 – As viewed from rear side, front to rear alignment of rear wall screen tube rows is good.

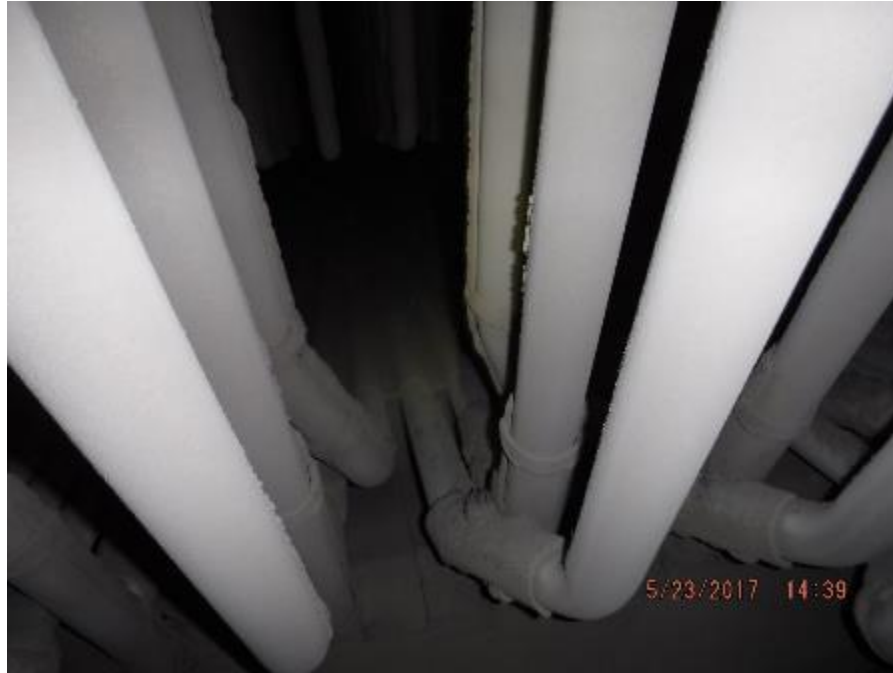
Photo 22 – On screen tubes, tube shields show no heat degradation or erosion thinning and are firmly attached.

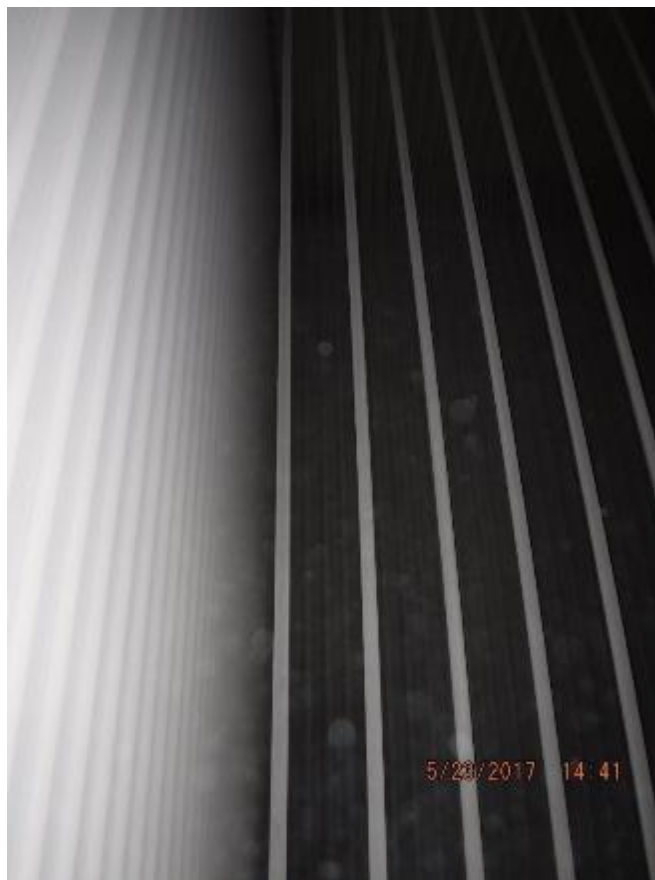
Photo 25 – View of left side wall of back pass superheater enclosure. Tube wall panels are straight.

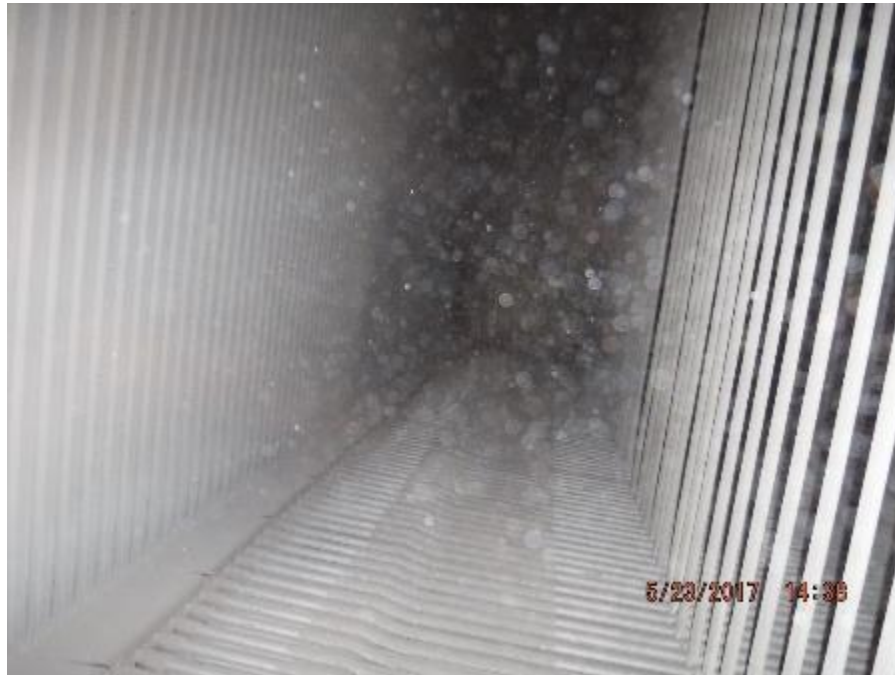
Photo 26 – View of rear wall of back pass superheater enclosure. Tube wall panels are straight. Above P1SH, erosion baffle plates in very good condition.

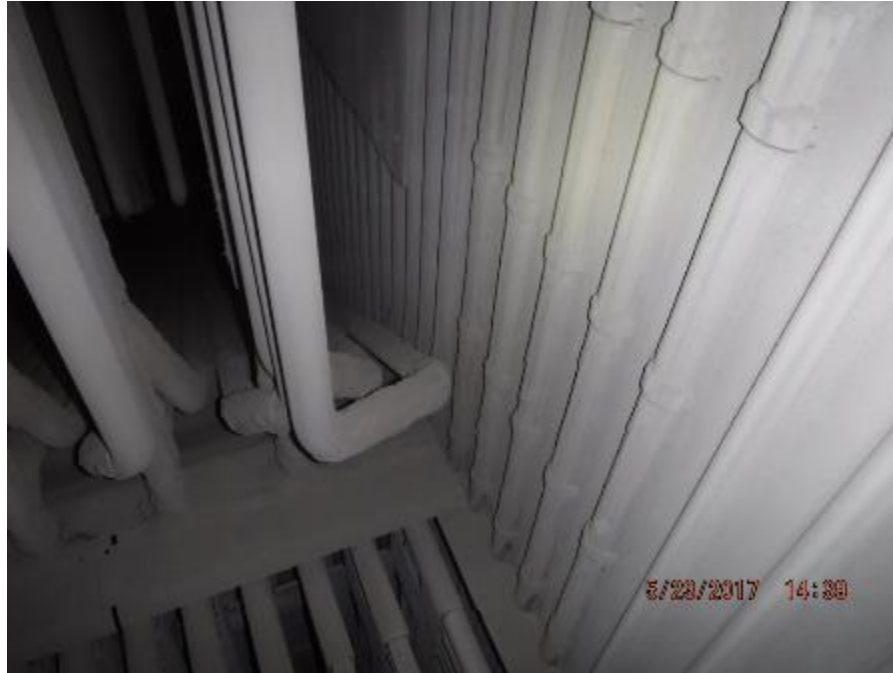
Photo 28 – Tube shields are in good condition on back pass superheater enclosure side wall tubes near rear wall screen.

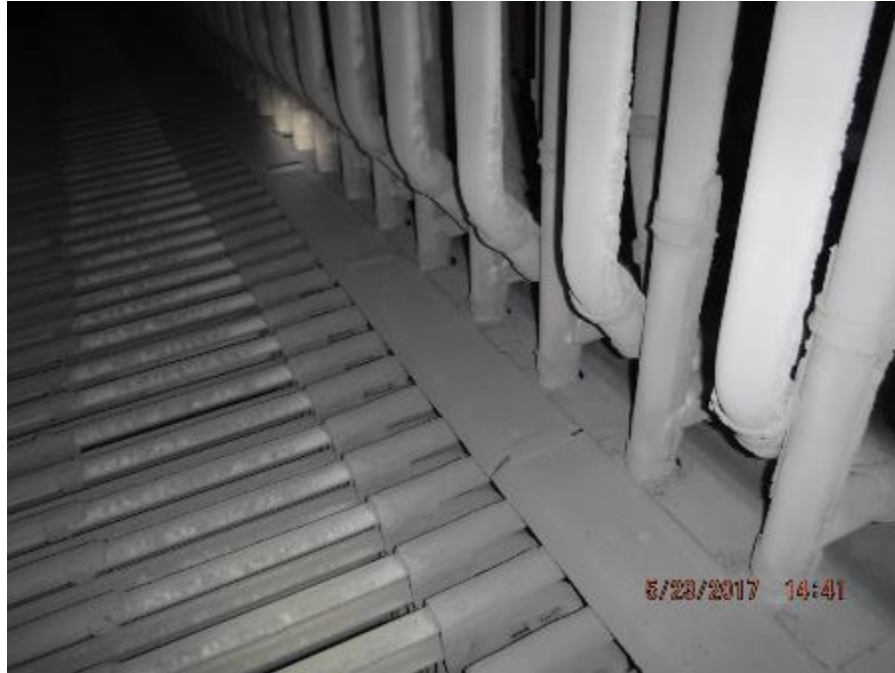
Photo 29 – Directly above P1SH on front wall of back pass superheater enclosure, erosion baffle plates are in very good condition.

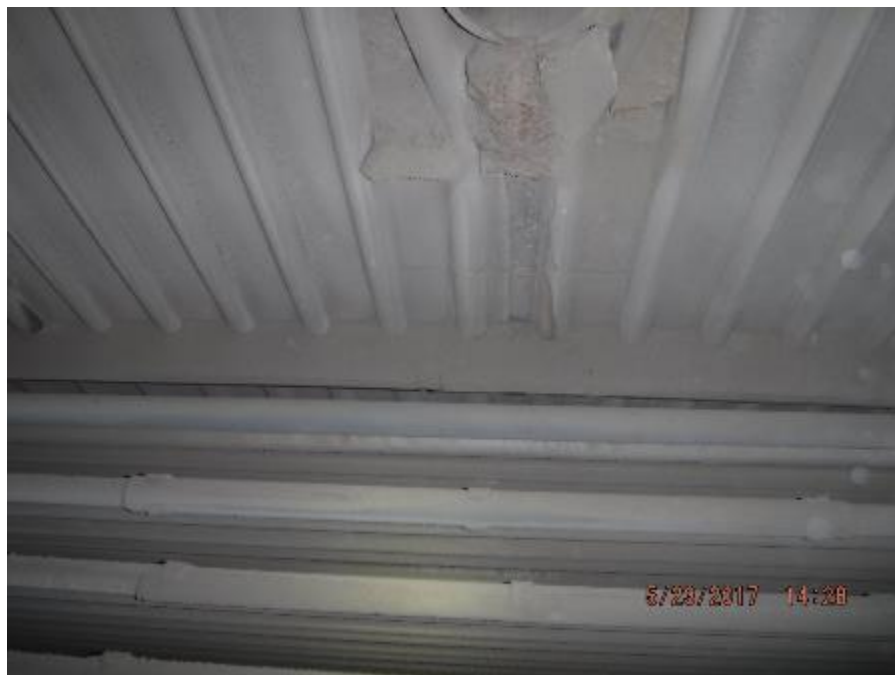
Photo 30 – Directly above P1SH on left wall of back pass superheater enclosure, erosion baffle plates are in very good condition.

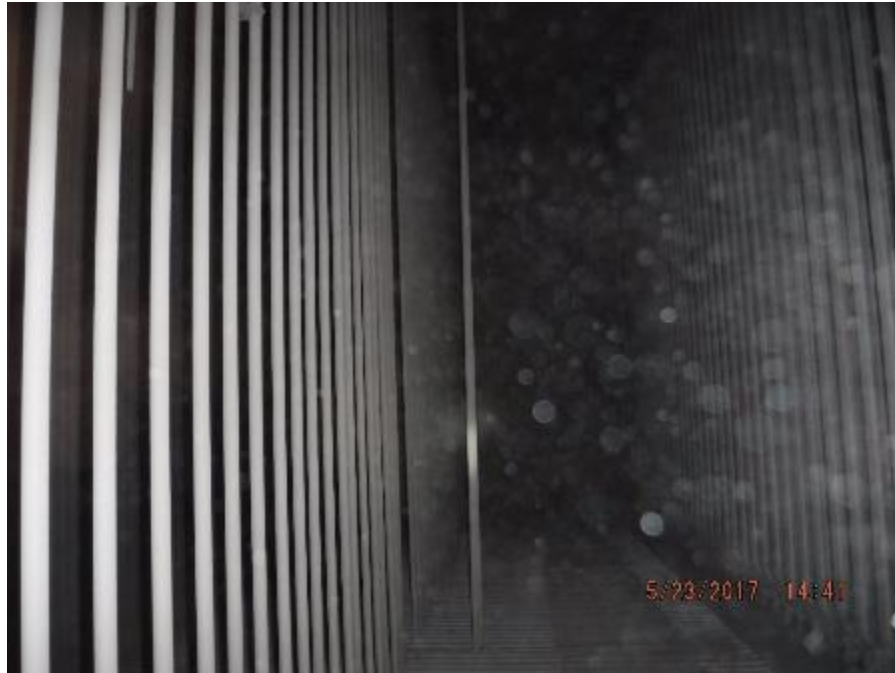
Photo 31 – Front row of SH stringer tubes are straight and in plane.

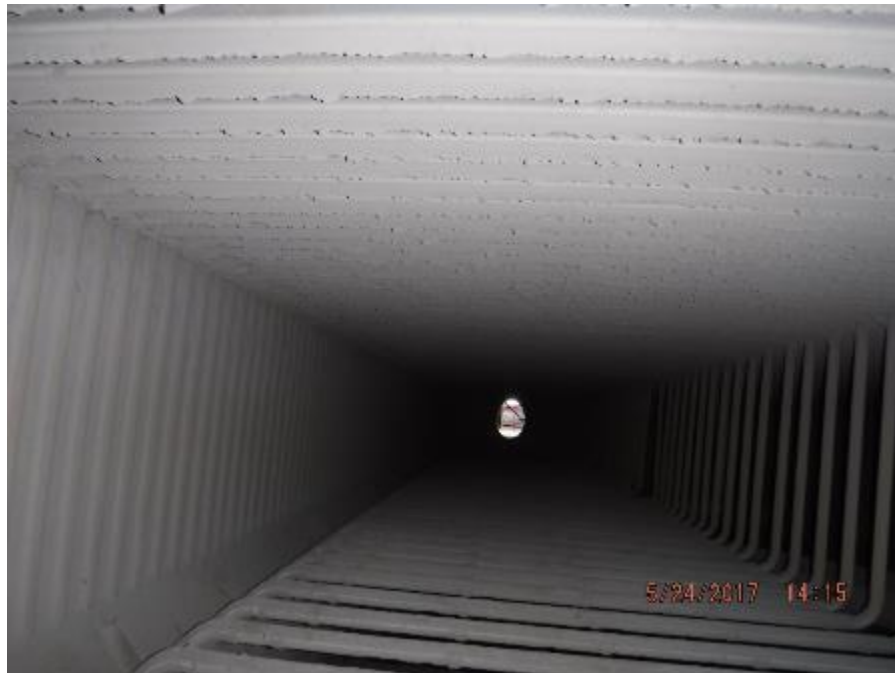
Photo 33 – On horizontal run of SH stringer tubes, tubes are straight and tube shields are in good condition.

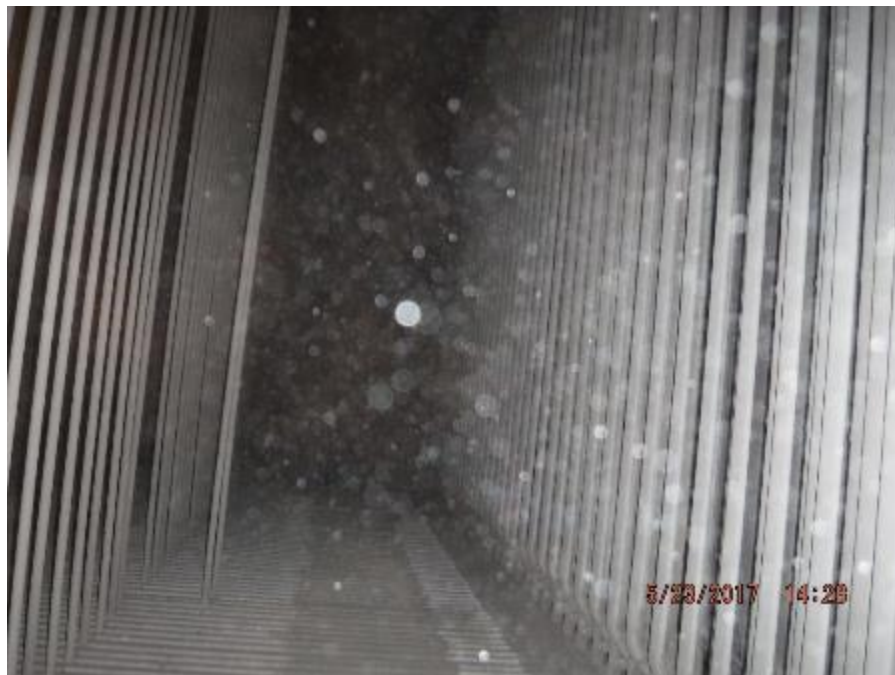
Photo 34 – View across top face of primary 1 SH. No downward sag in elements.

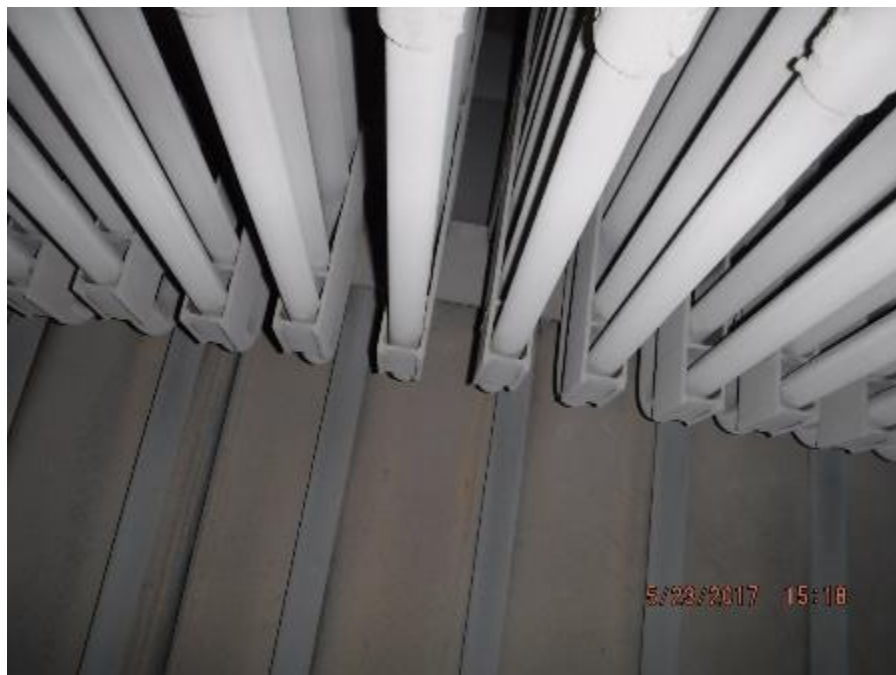
Photo 38 – On front wall of back pass, primary 1 SH element supports are in good condition.

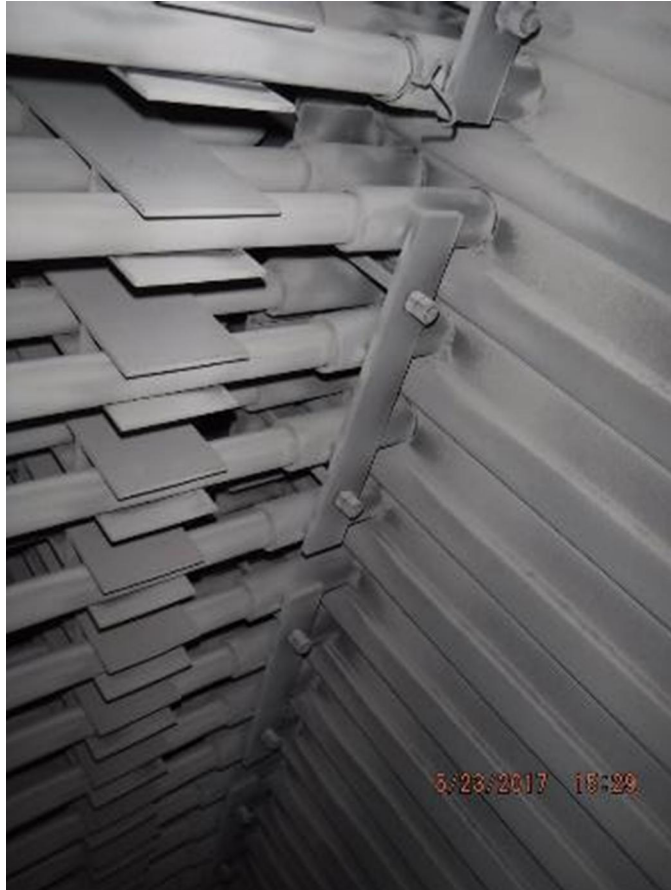
Photo 39 – On rear wall of back pass, primary 1 SH element supports are in good condition.

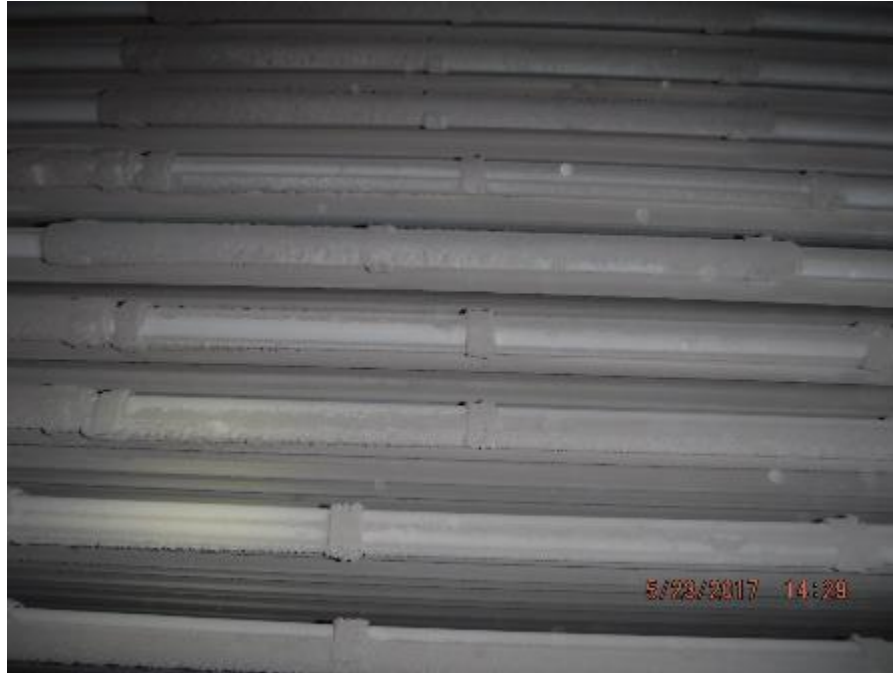
Photo 40 – Primary 1 SH element top tubes, some tube shields rolled out of position.

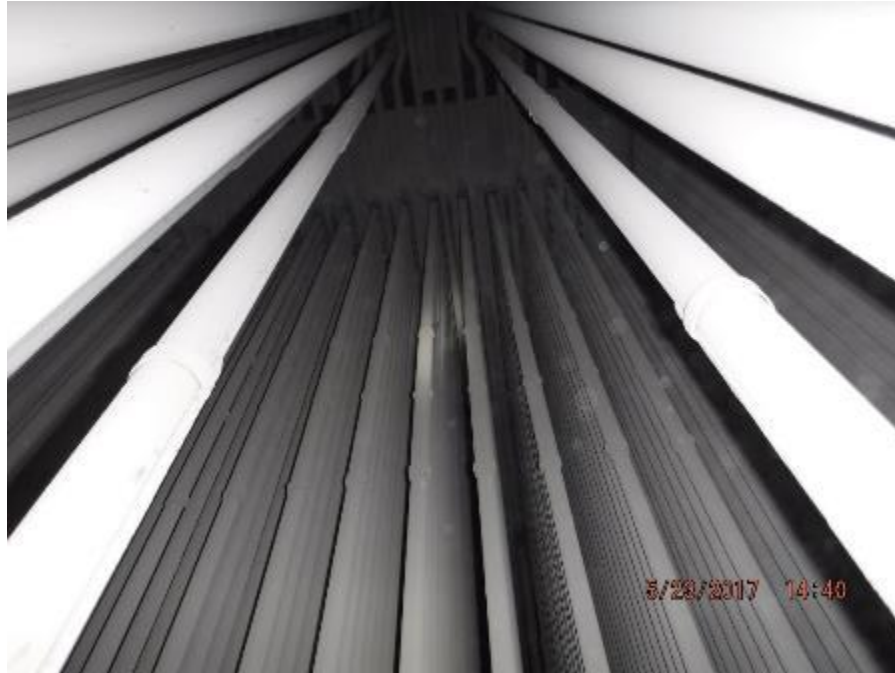
Photo 41 – As viewed looking through the back pass rear wall screen tubes, primary 2 SH element spacing is good. Tube shields are in good condition.

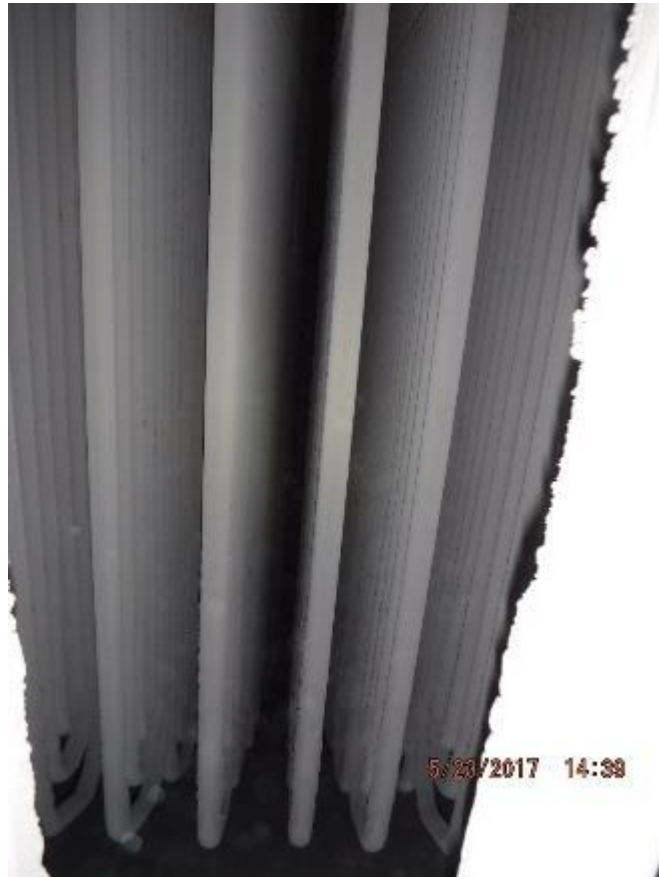
Photo 42 – As viewed looking through the back pass rear wall screen tubes, primary 2 SH element spacing is good. Tube shields are in good condition.

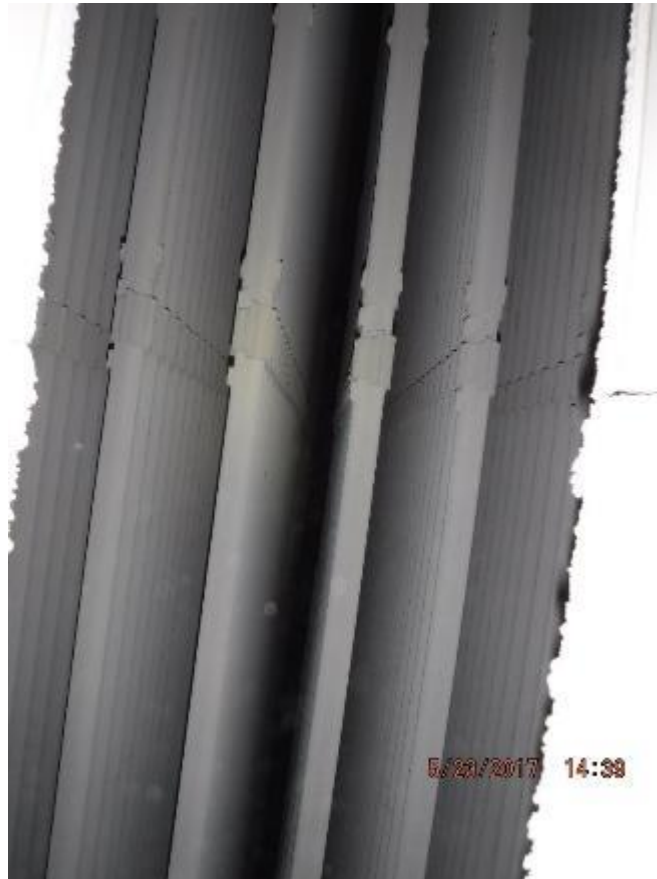
Photo 43 – As viewed looking through the back pass rear wall screen tubes, primary 2 SH element hand cuff clamps are in good condition.

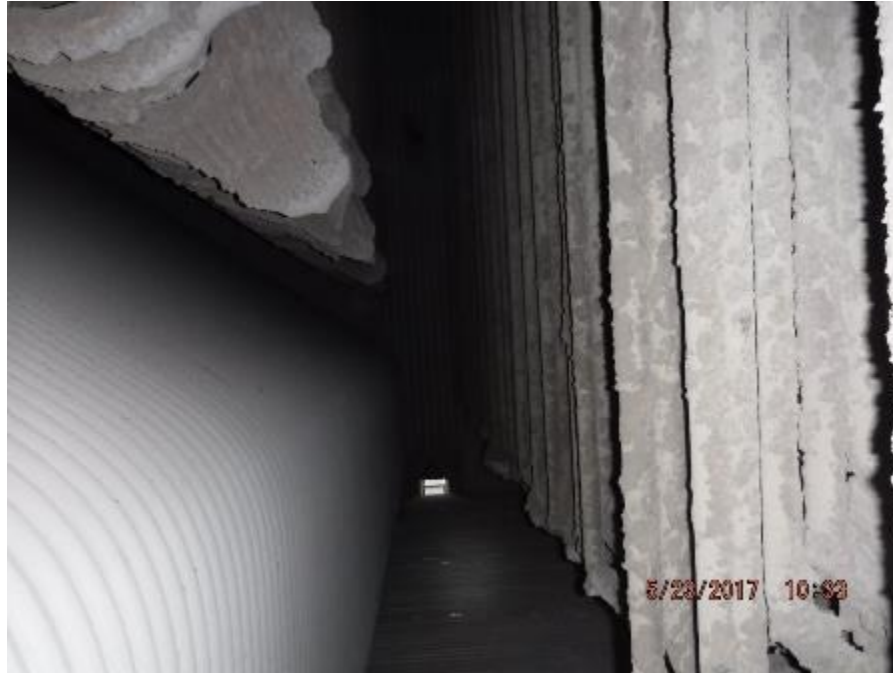
Photo 44 – Looking across rear side of secondary superheater, elements are all in line.

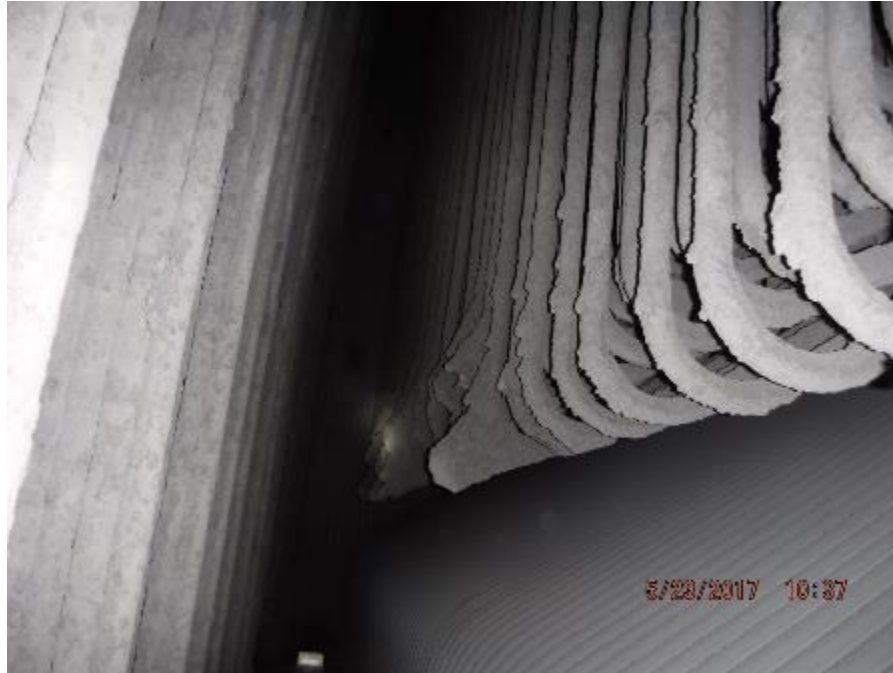
Photo 53 – Front to rear alignment of finishing SH elements is good. View is right to left with finishing superheater on right side of photo.

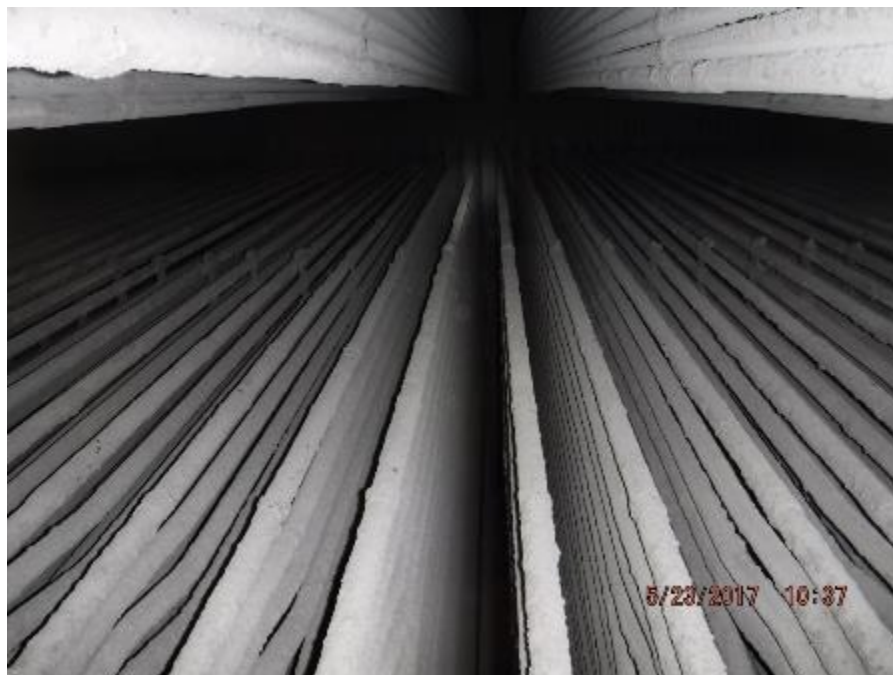
Photo 54 – Side to side alignment between the finishing SH elements is good. Handcuff clamps are in good condition.

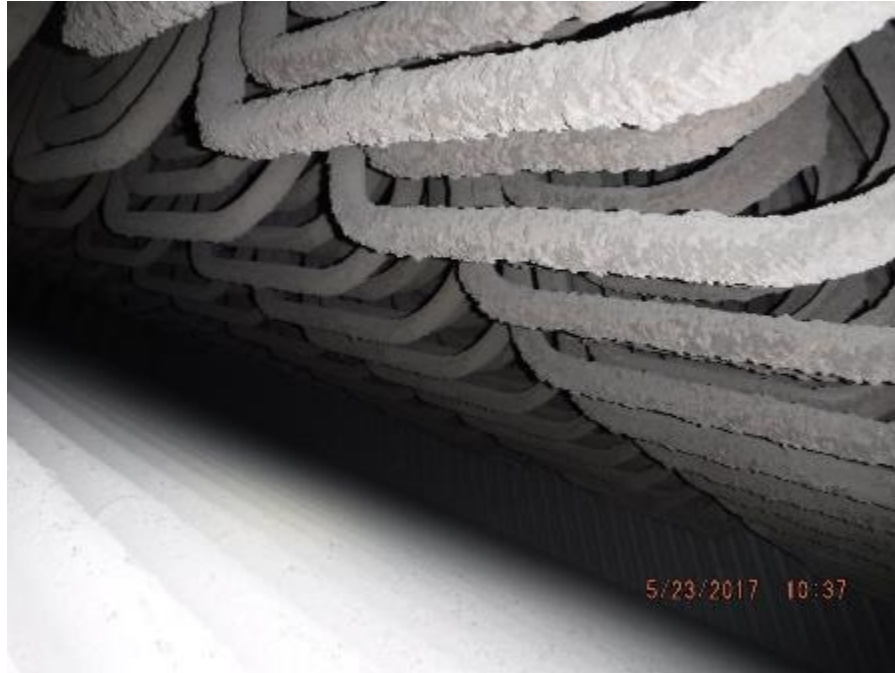
Photo 55 – Finishing SH; view of lower tube loops.

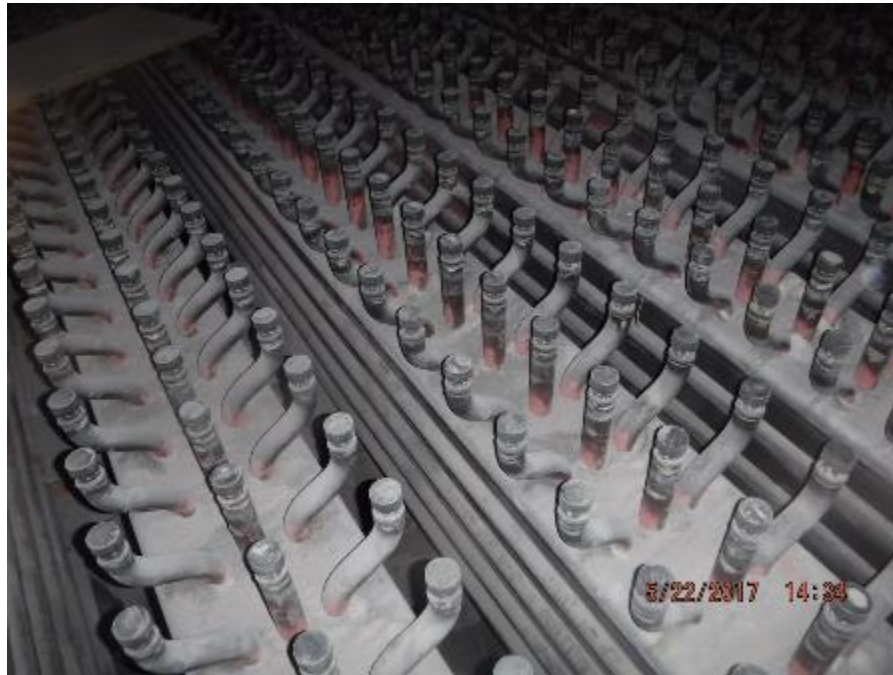
Photo 57 – View of lower furnace tuyeres. The tuyeres are in very good condition.

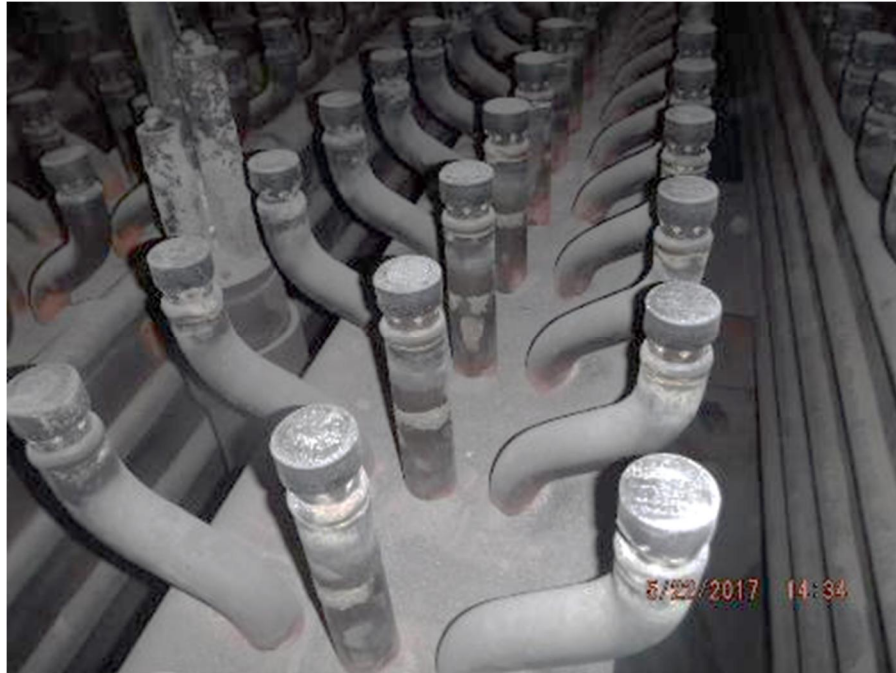
Photo 58 – View of lower furnace tuyeres. The tuyeres are in very good condition.

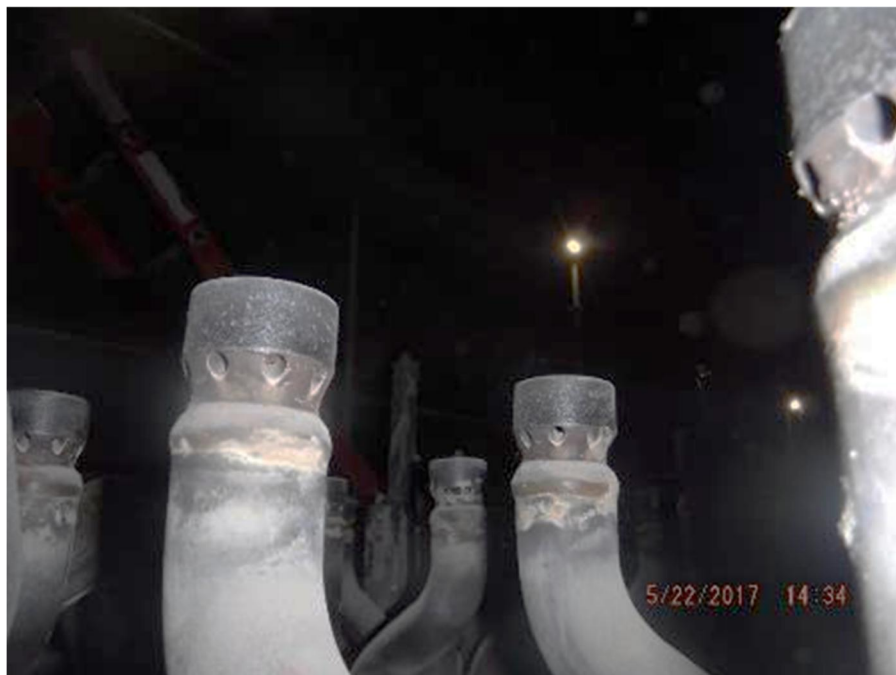
Photo 59 – View of lower furnace tuyeres. The tuyeres are in very good condition.

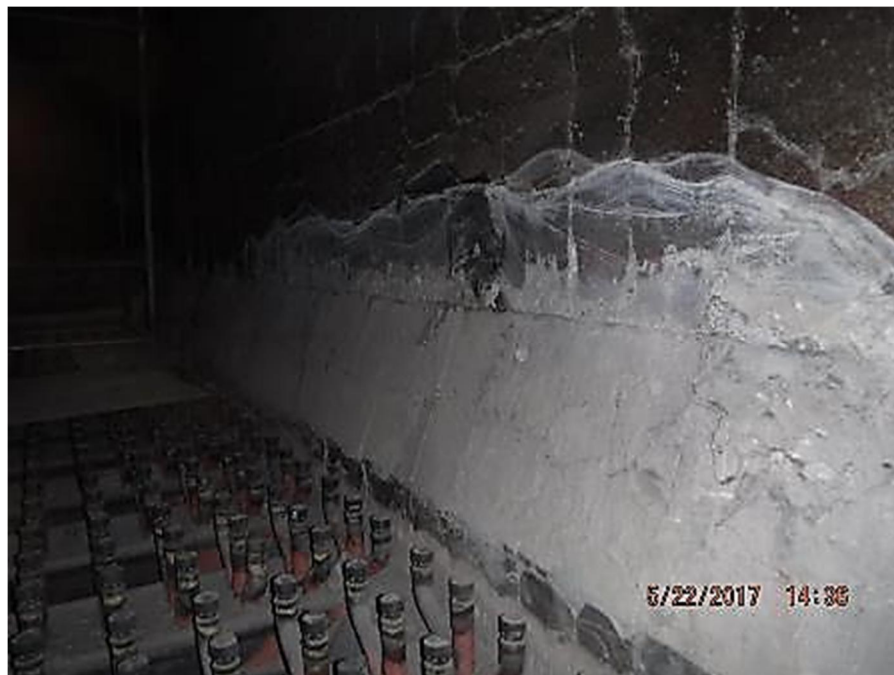
Photos 60 – Lower furnace refractory is in good condition with no repair work required.

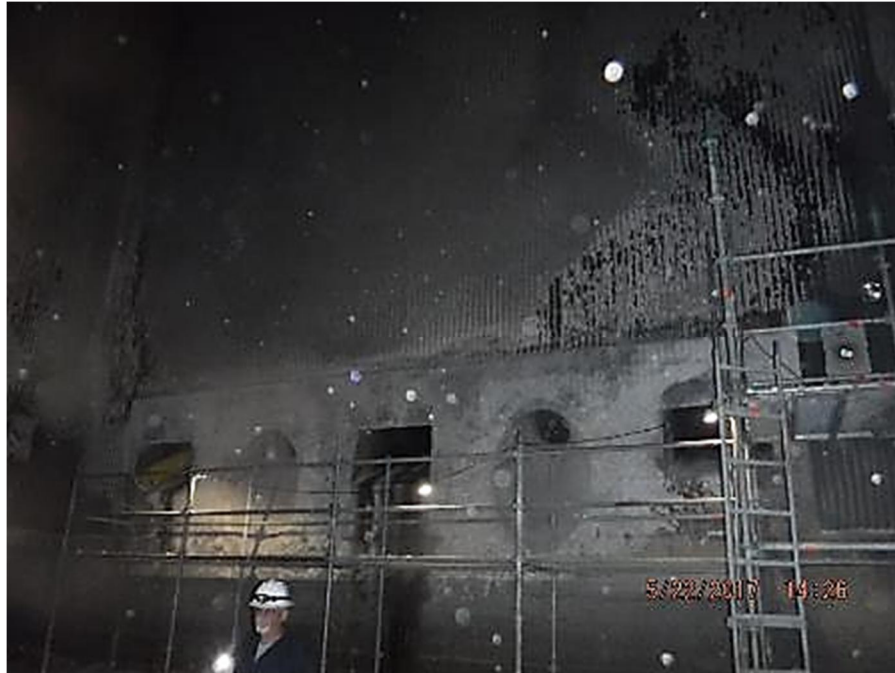
Photo 61 – Lower furnace refractory is in good condition with no repair work required.

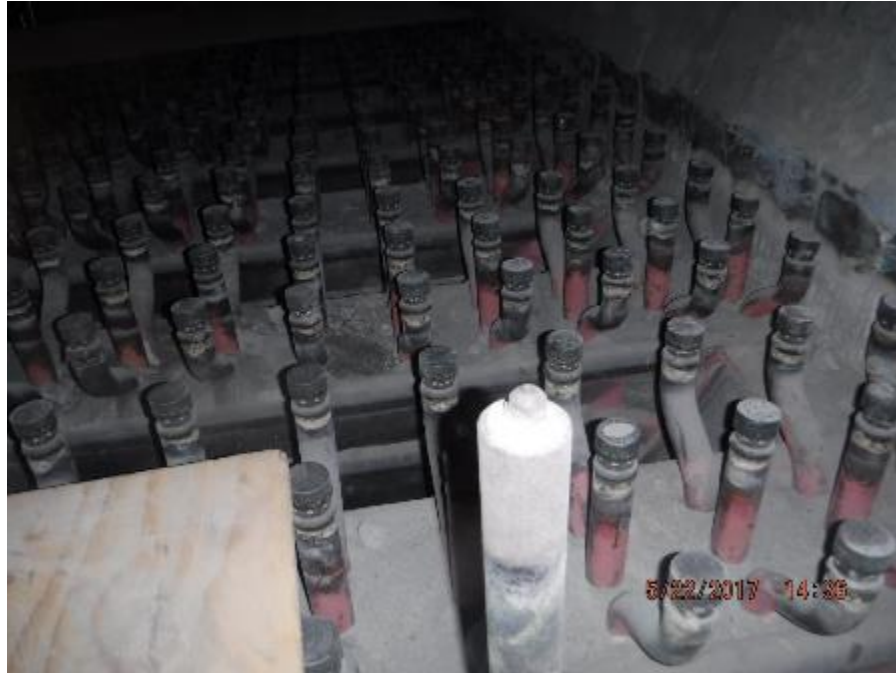
Photo 62 – Lower furnace single TC are in good condition.

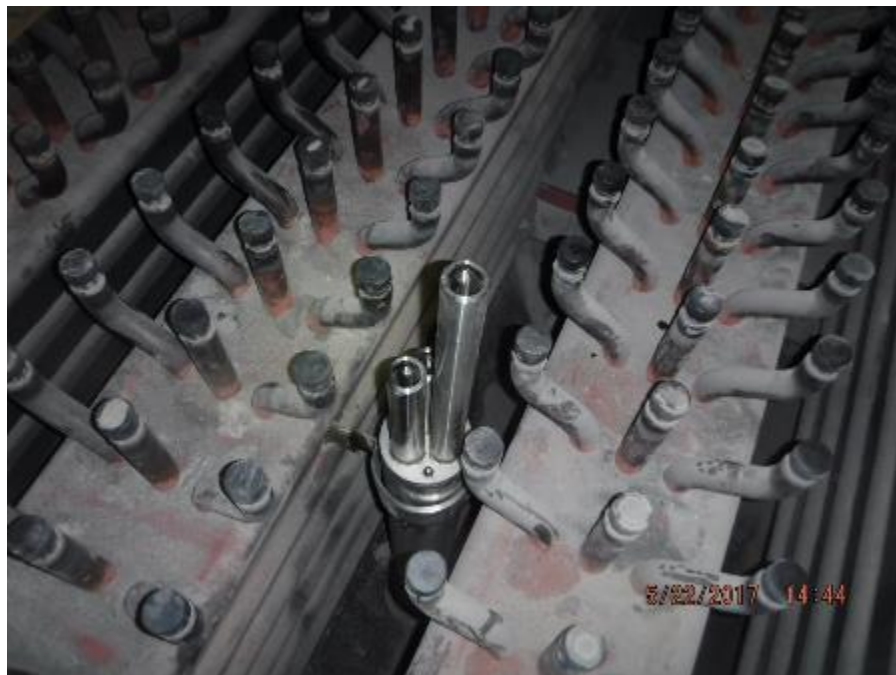
Photo 63 – Lower furnace, three staged TC replaced.

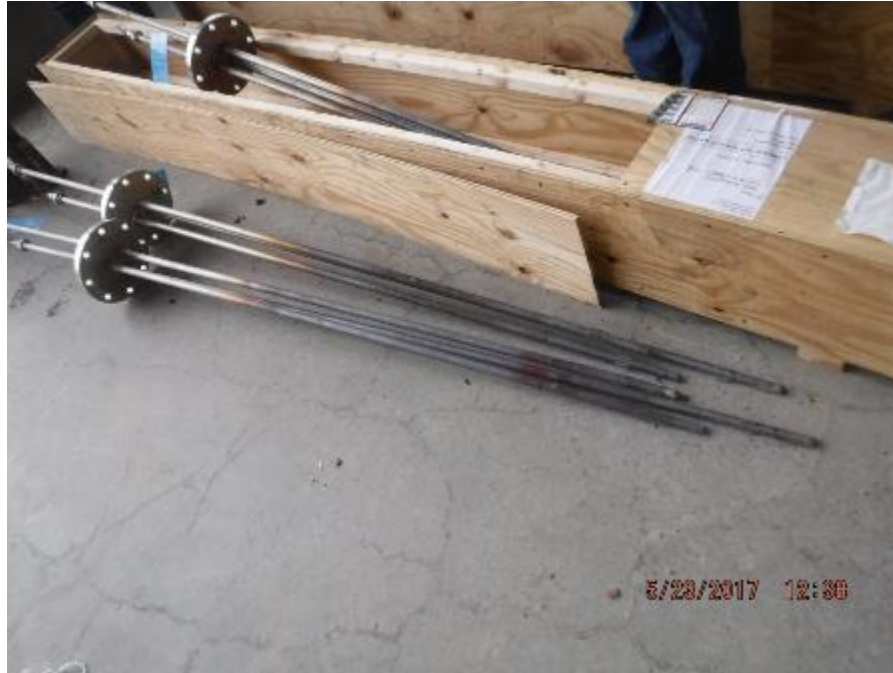
Photo 64 – The cluster of 3 TC removed from furnace. Thermowells do not show heat or mechanical damage.
