BOILER INSPECTION REPORT

VALMET REFERENCE No. M40001

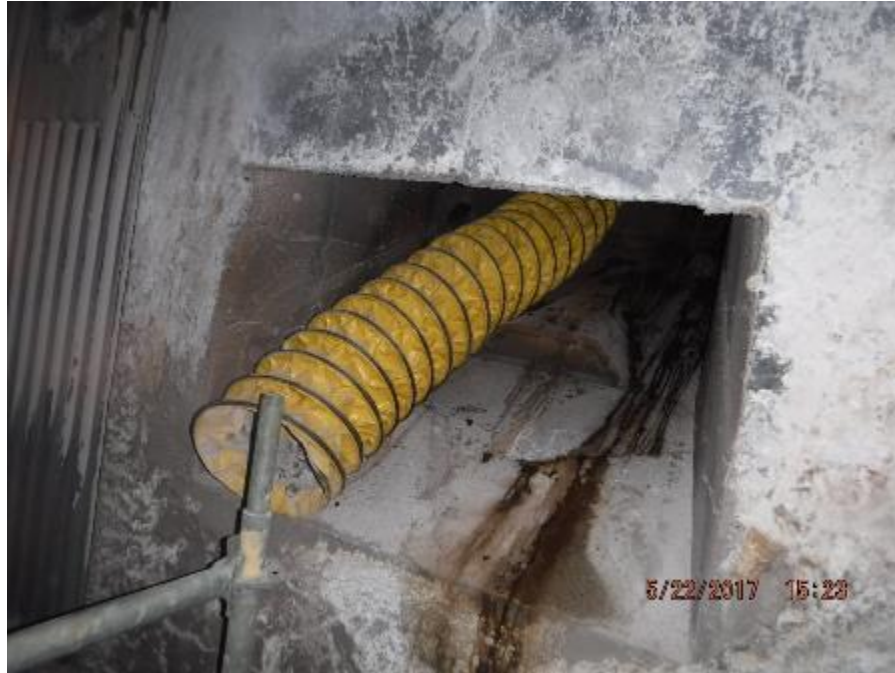
Photo 65 – Depicts general condition of refractory at biomass fuel feed openings. Refractory is in very good condition at all feed openings.

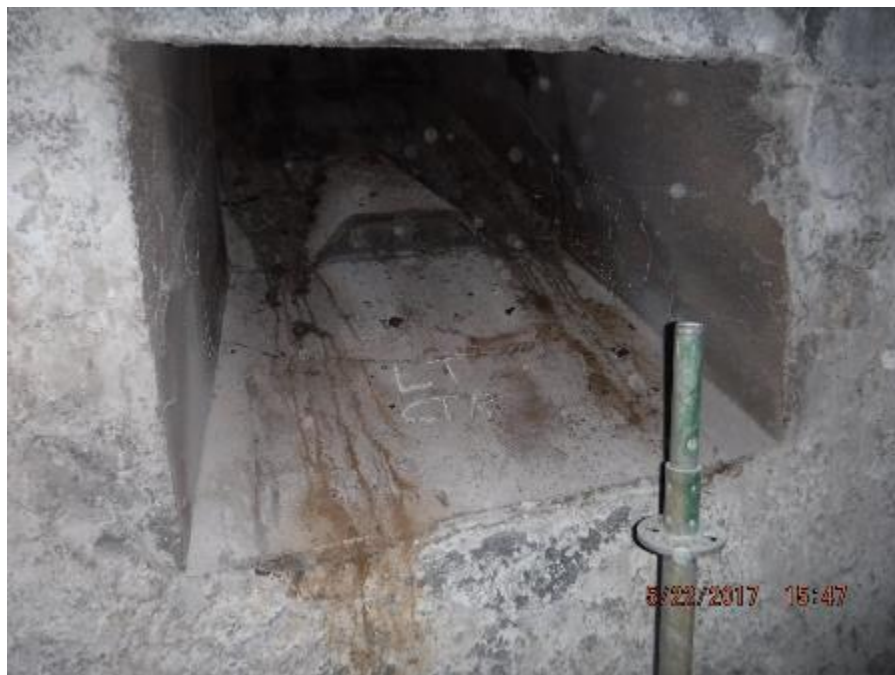
Photo 66 – Depicts very good condition of metal plate work at biomass fuel feed openings.

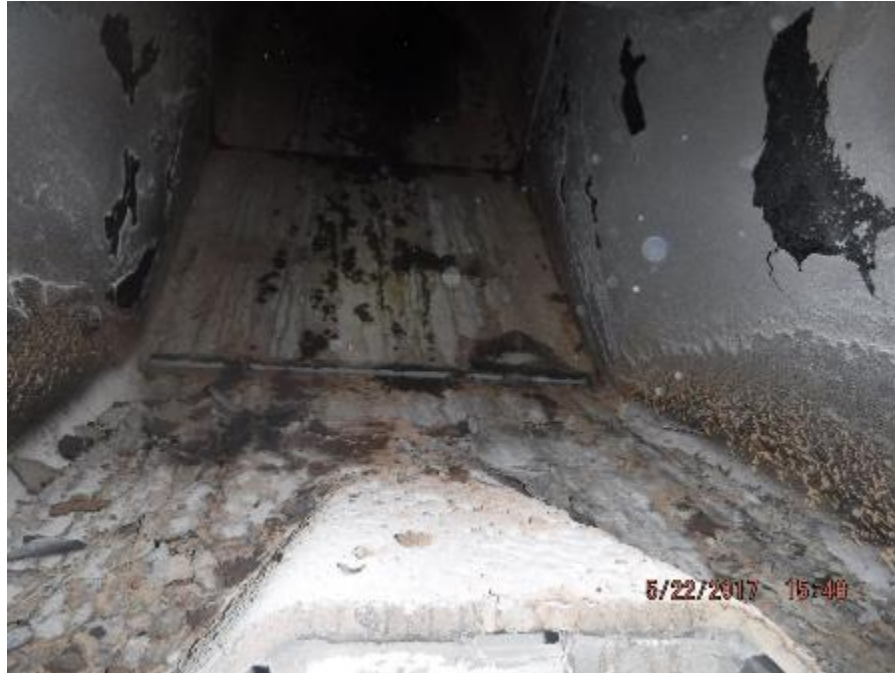
Photo 67 – Depicts very good condition of metal plate work at biomass fuel feed openings.

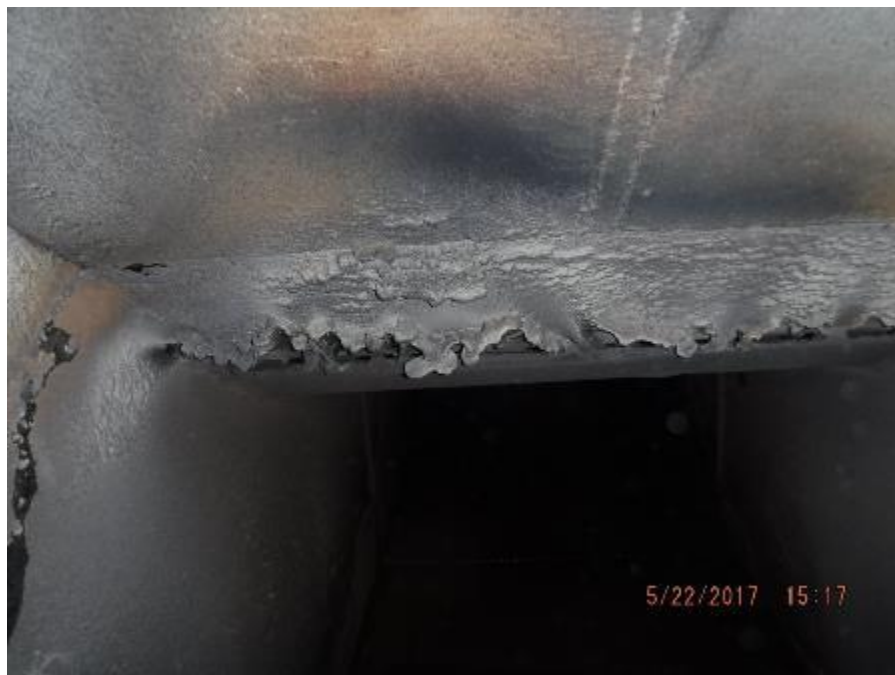
Photo 68 – Biomass fuel feed openings; hardened ash deposits partially blocking off upper sweep air opening slot.

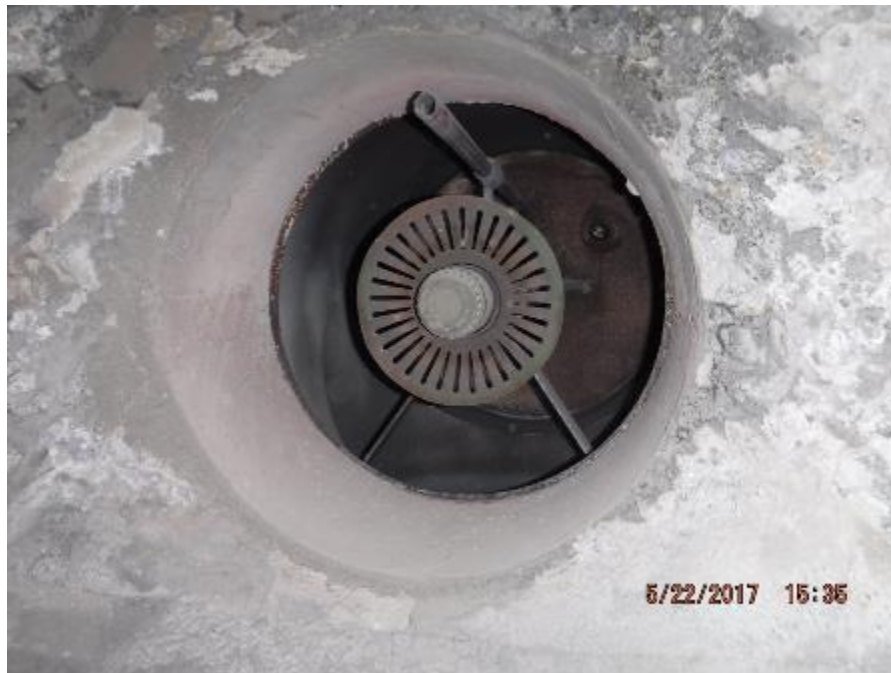
Photo 69 – View of start-up burner opening. Burner throat refractory and diffuser are in good condition.

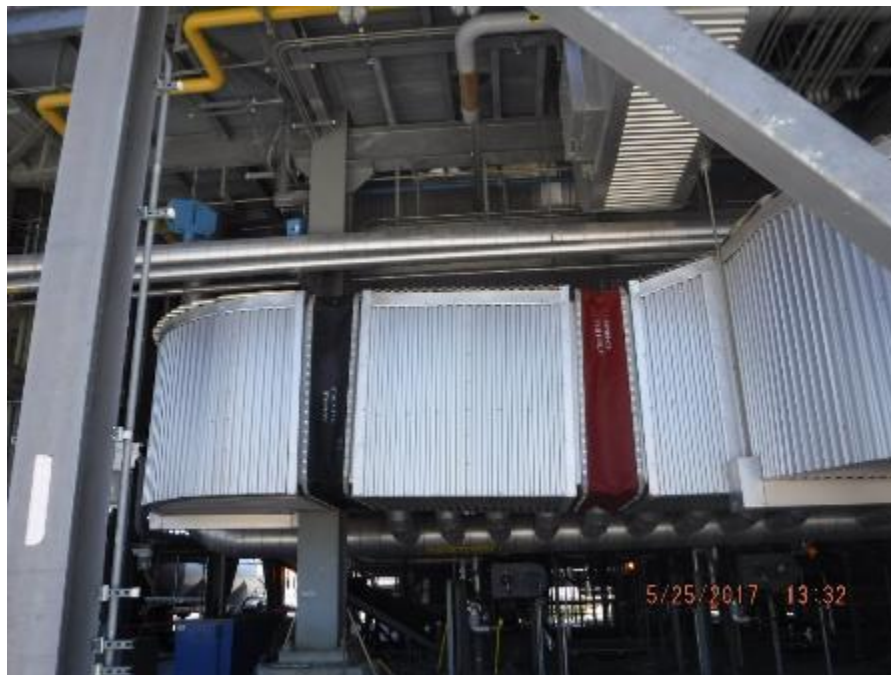
Photo 71 – Expansion joints replaced on PA supply duct.

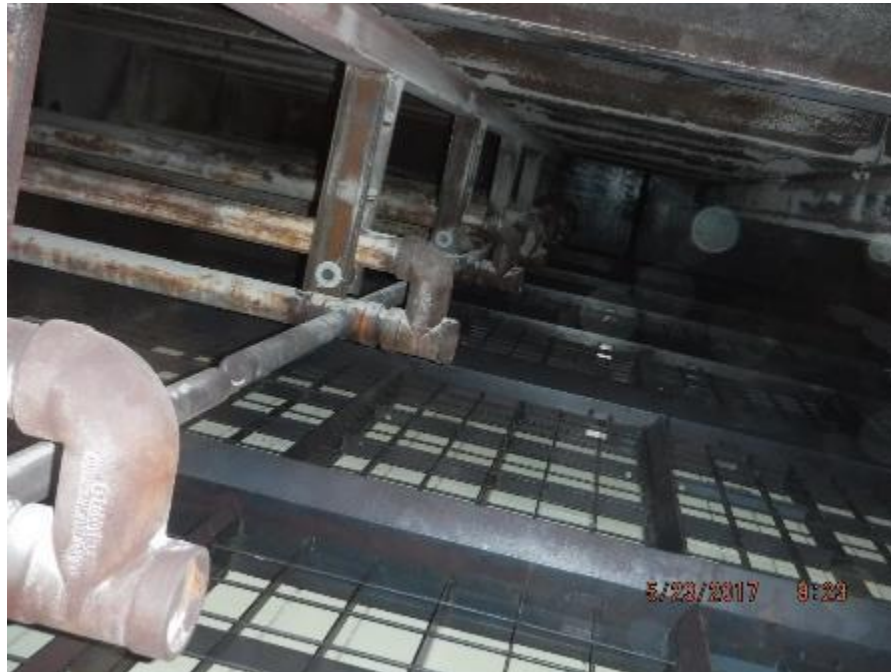
Photo 72 – View across top side of catalyst section.

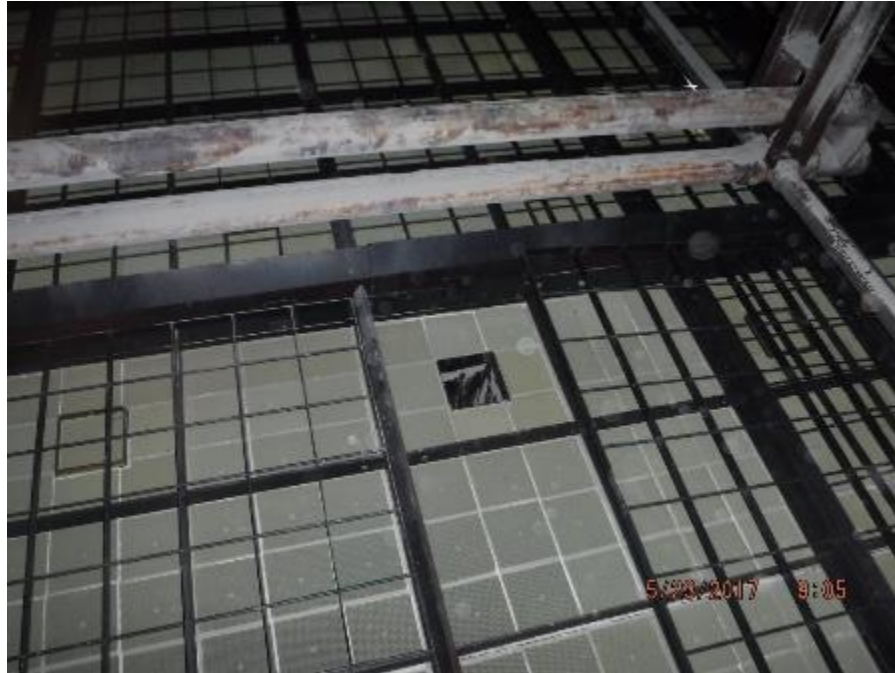
Photo 73 – Top face of catalyst baskets are in good condition. One catalyst basket removed to be sent out for analysis.

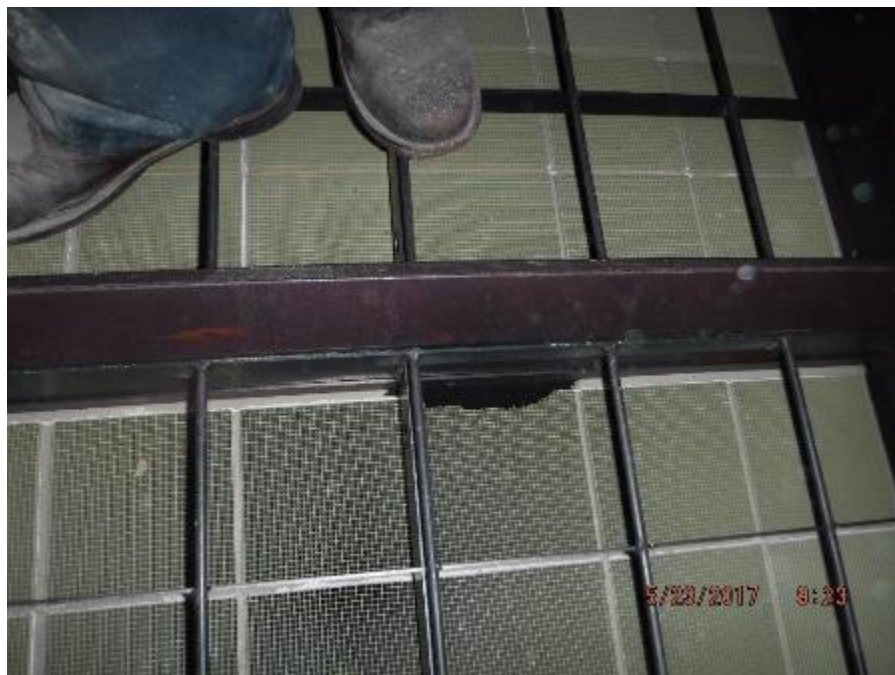
Photo 74 – Small section broke off catalyst basket.

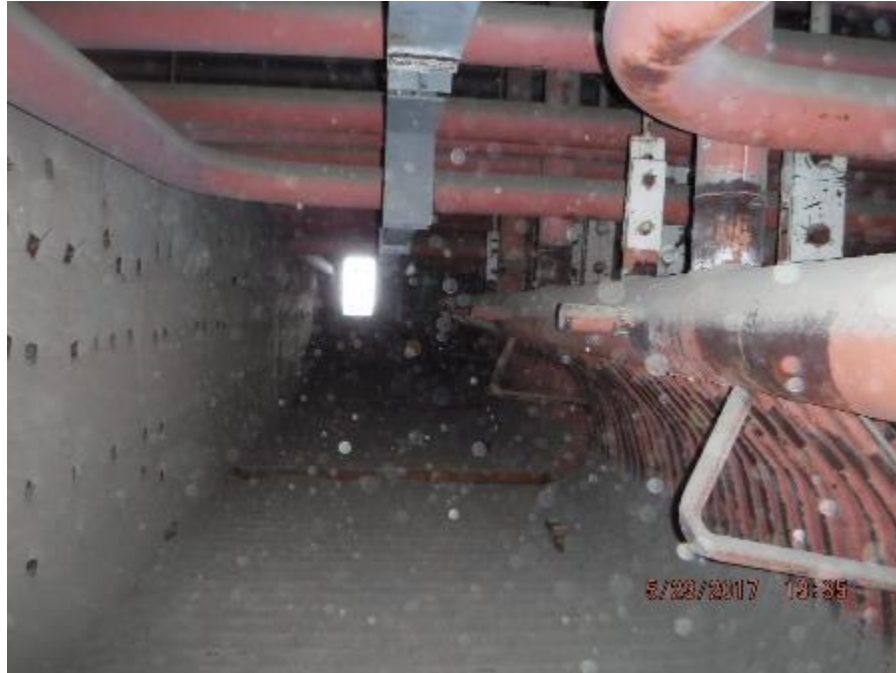
Photo 77 – View across front section of penthouse. Slight dusting of fly ash.

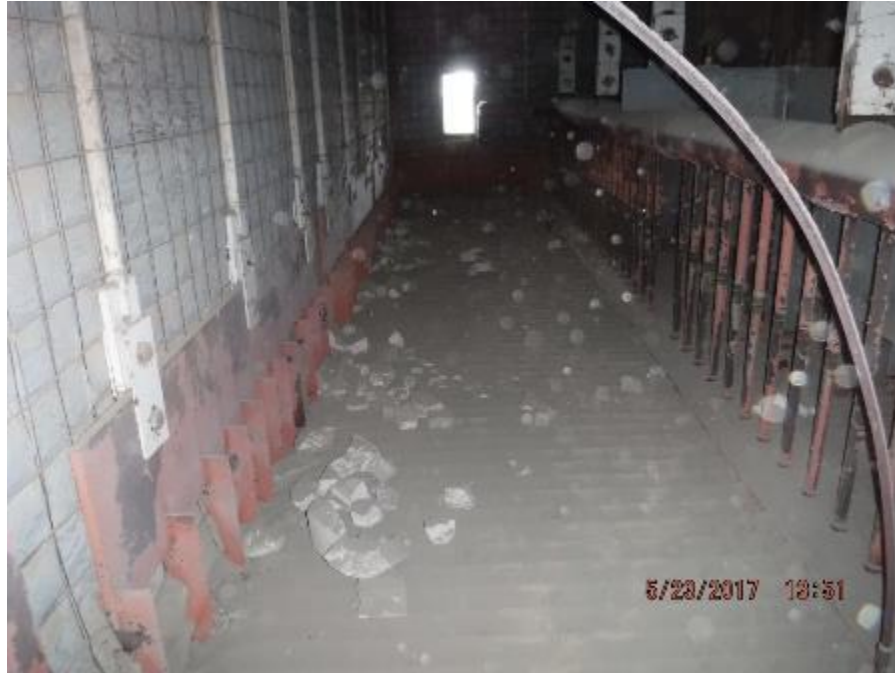
Photo 82 – Slight amount of fly ash accumulation in rear section of penthouse.

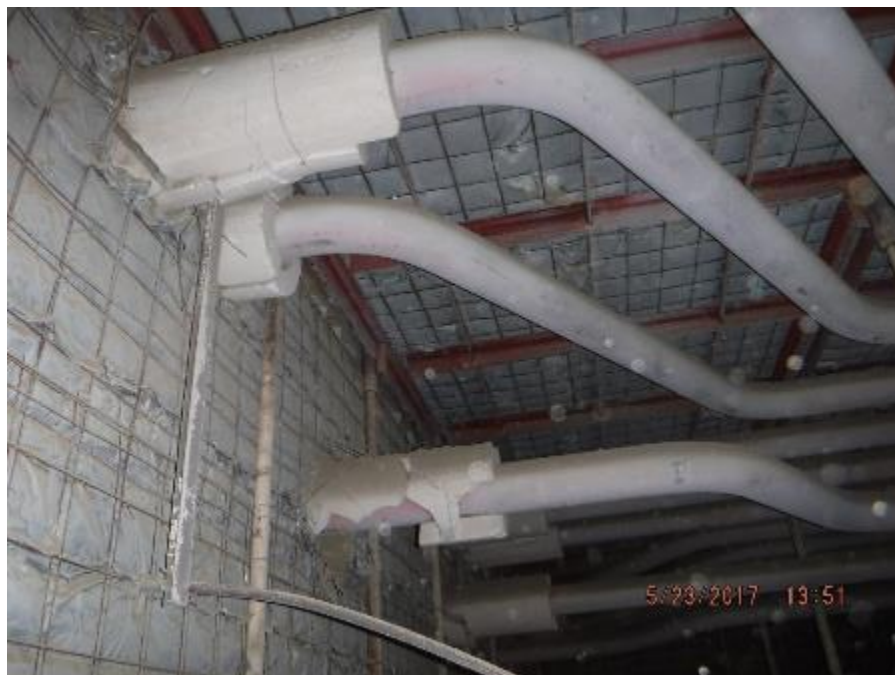
Photo 83 – In rear section of penthouse, sections of calsil insulation block broken off boiler bank riser pipes.

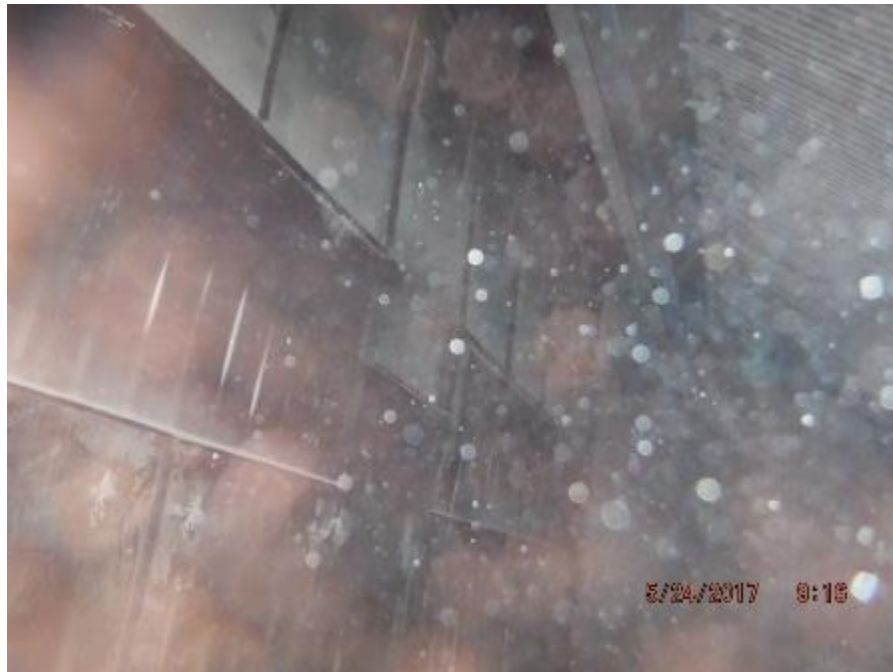
Photo 84 – View of nose arch dead air space. The seal plates are in good condition with no appreciable heat warping.

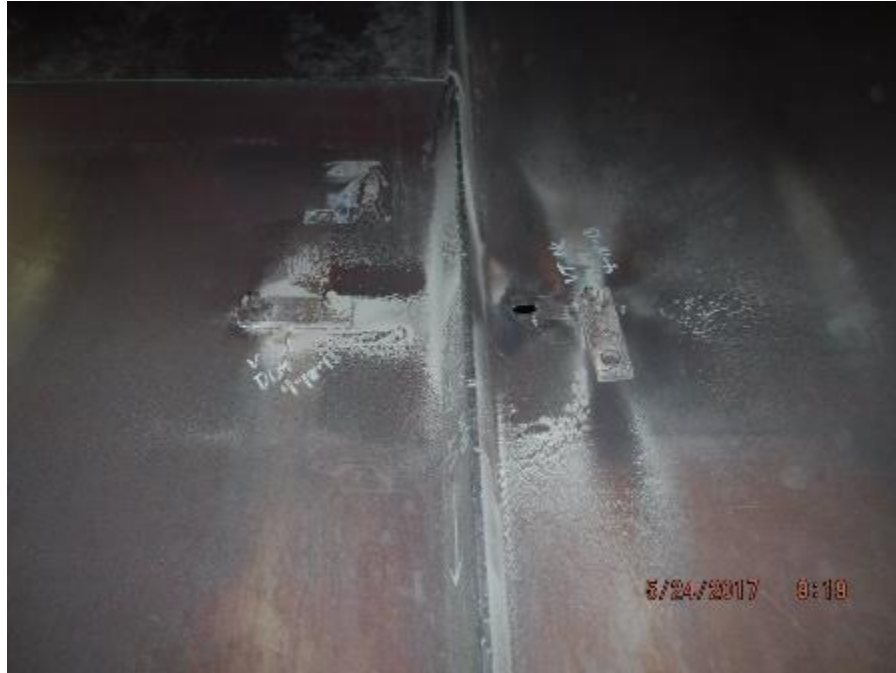
Photo 85 – In nose arch dead air space, broken “U” bolts that is used to secure seal plates to tube in back pass.

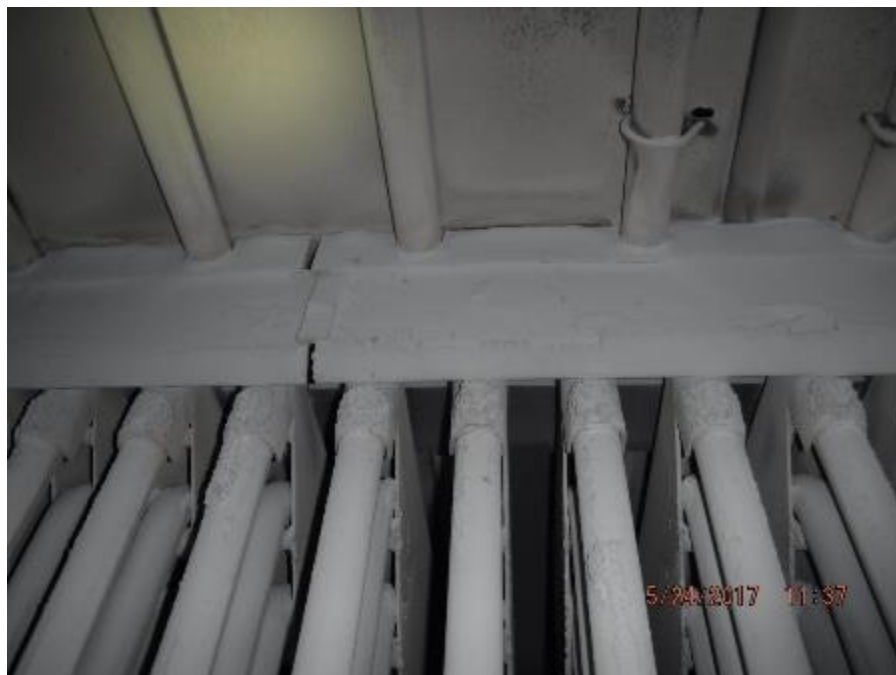
Photo 86 – Front wall of back pass in boiler bank section, broken “U” bolt used to secure nose arch dead air space cavity seal plate to back pass tube.
