Gainesville Regional Utilities Deerhaven Generating Station

Coal Combustion Residual Units Annual Inspection Report (December 16, 2016 – December 12, 2017)

**Innovative Waste Consulting Services, LLC
3720 NW 43rd Street, Ste. 103
Gainesville, Florida 32606**

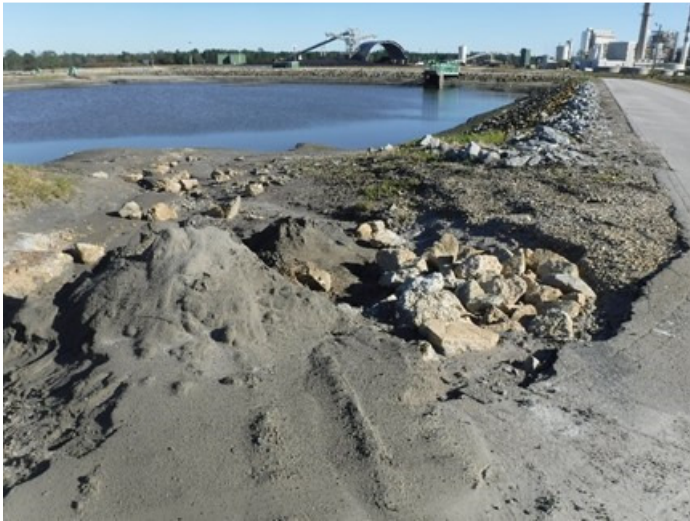
Moderate interior slope erosion was observed in the western and northern corner of Ash Cell #1 and in the northern corner of Ash Cell #2. Based on discussion with operations personnel, these corners are used as discharge points for vacuum trucks used to clean out bottom ash that has accumulated at low points in plant process equipment. Figures 5, 6, and 7 respectively present the erosion observed in the western corner of Ash Cell #1, the northern corner of Ash Cell #1, and the northern corner of Ash Cell #2.

Figure 5. Erosion on the Western Inside Corner of Ash Cell #1

IWCS observed an absence of riprap or other slope armor in these areas – continued erosion in these areas will compromise the structural integrity of the adjacent road and peripheral berm.

1. For the internal ash pond corners where erosion was observed, IWCS recommends that GRU remove the existing unsuitable material from these corners and restore them to their original condition (i.e., compact existing underlying soils, place and/or compact well-graded aggregate or an alternative suitable base course, and then place riprap over the surface to provide internal slope erosion protection against future pond wave action and other erosive forces). In addition, IWCS recommends that future vacuum truck loads be discharged at an alternative (to be determined) location within the CCR landfill to prevent further erosion of internal surface impoundment system slopes.

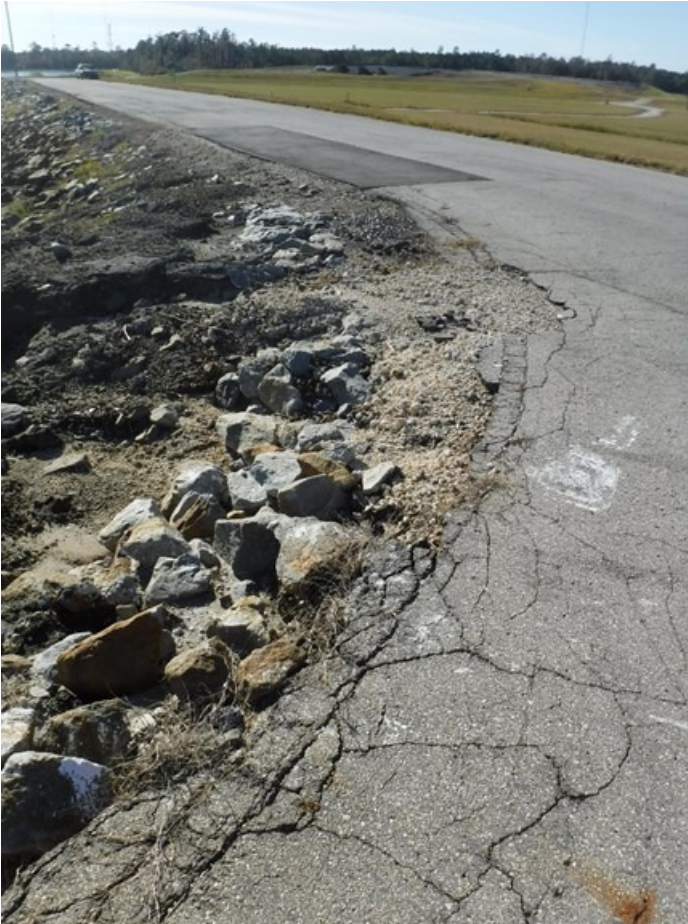
Figure 6. Erosion on the Northern Inside Corner of Ash Cell #1

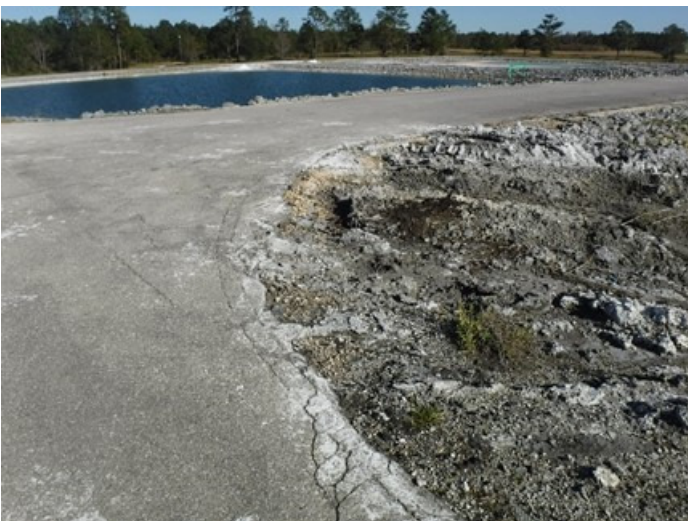
Figure 7. Erosion on the Northern Inside Corner of Ash Cell #2

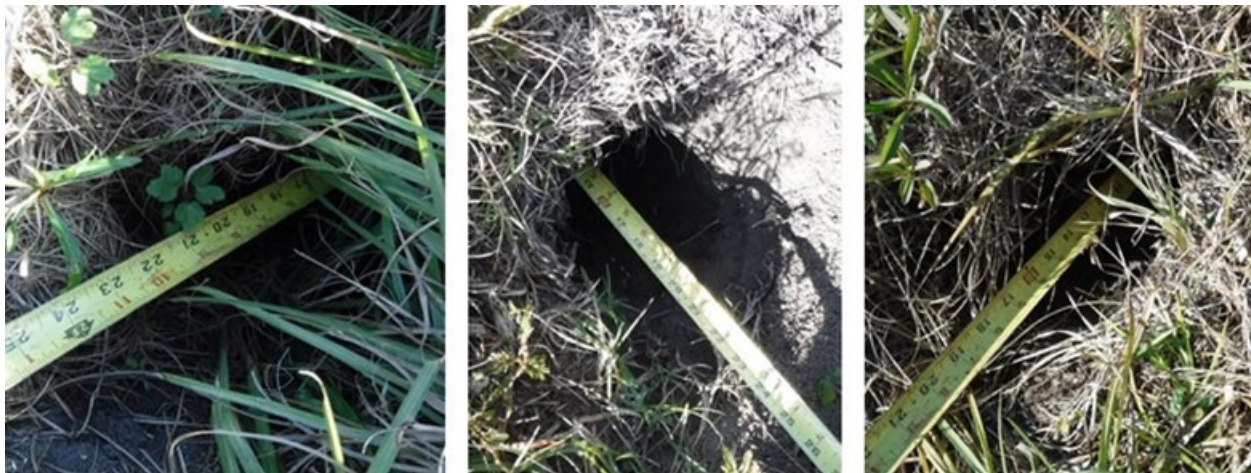
A single animal forage hole was found on the external slopes of the surface impoundment system and two forage holes were found on the outer slopes of the pump back ponds. Images of these forage holes are presented in Figure 8. As shown in the images, these holes were approximately 16-24 inches deep.

Figure 8. Forage Holes and Depths Observed on External Slopes of the Surface Impoundment System and Pump Back Ponds

6. GRU should relocate resident animal(s) and backfill all animal forage holes/burrows in accordance with federal, state, and local law.
7. As part of the minimum list of annual inspection items, §257.83(b)(1)(iii) requires “a visual inspection of any hydraulic structures underlying the base of the CCR unit or passing through the dike of the CCR unit for structural integrity and continued safe and reliable operation”. IWCS was unable to inspect the subsurface culverts which connect each ash cell with its adjacent pump back pond. Considering the age (i.e., approximately 37 years old) and importance of these culverts to the safe and reliable operation of the plant, IWCS strongly recommends that these culverts be inspected as soon as possible.

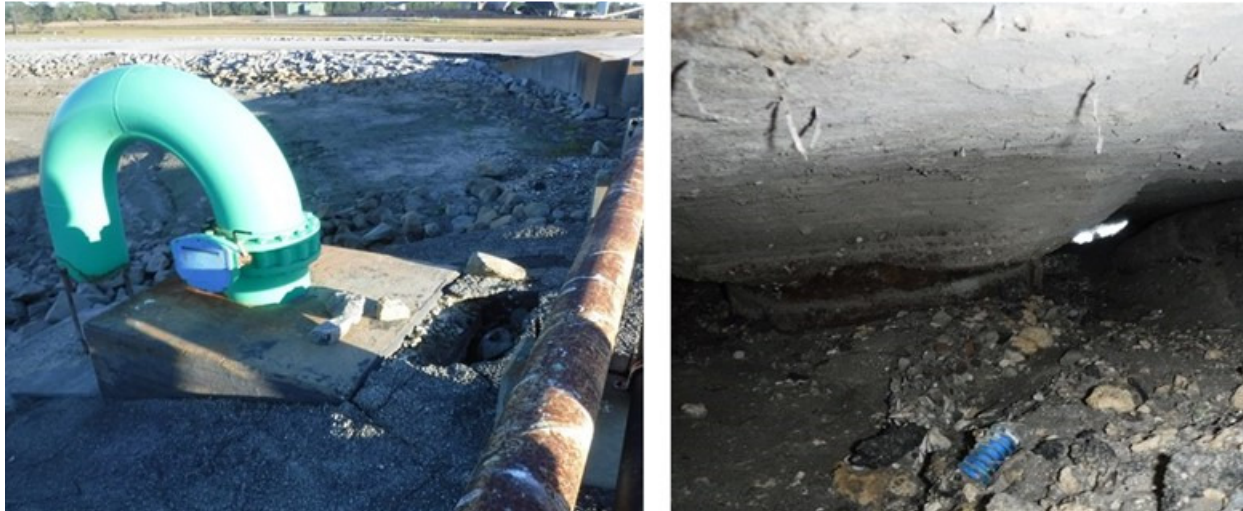
Several splash blocks are located on the internal slopes of the ash ponds. These splash blocks are used for energy dissipation of discharged plant process waters. Excessive erosion was observed along the inside edge of the southern-most splash block in Ash Cell #1 (see Figure 9). Figure 9 also presents an image of the below-grade condition around the pipe. As shown in the picture, it appears that water has washed out a significant portion of the base grade material which supports the splash block – except for the back side, the entire pipe is visible in the picture.

Figure 9. Above- and Below-Grade Conditions of the Southern-Most Splash Block in Ash Cell #2

2. The culvert penetrating the southern-most splash block in Ash Cell #2 should be inspected for leaks and defects and repaired or replaced as necessary. A suitable foundational support material/base layer should be installed below the splash block as soon as possible.

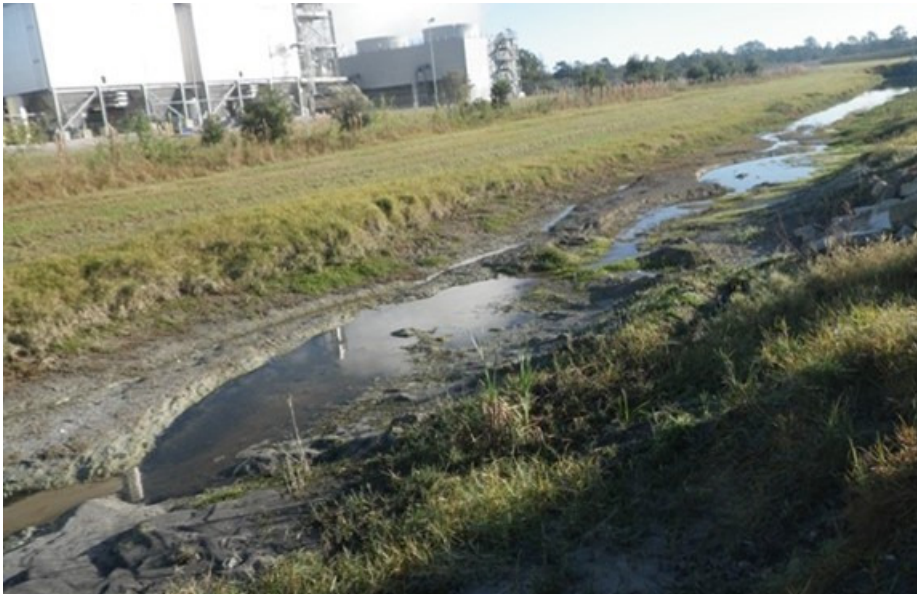
Sediment accumulation was observed near the middle of the Northern Drainage Ditch – this ditch accepts CCR contact water from the landfill which gravity drains to a pump station located at its eastern extent. Accumulated sediment is partially obstructing gravity drainage. Figure 10 depicts the condition in this area.

Figure 10. Sediment Accumulation in the Northern Drainage Ditch

3. Sediments accumulated in the Northern Drainage Ditch should be excavated and relocated to the interior of the landfill.
4. GRU should ensure that the top deck is sloped at approximately 2% to the south in accordance with the design presented in the CCR Landfill Filling Plan – this will mitigate both the Cell 2/Cell 3 access ramp erosion issue and the issue associated with improper grading of the western portion of Cell 1. IWCS recommends that GRU place additional CCR in these areas as necessary to achieve the design grades.

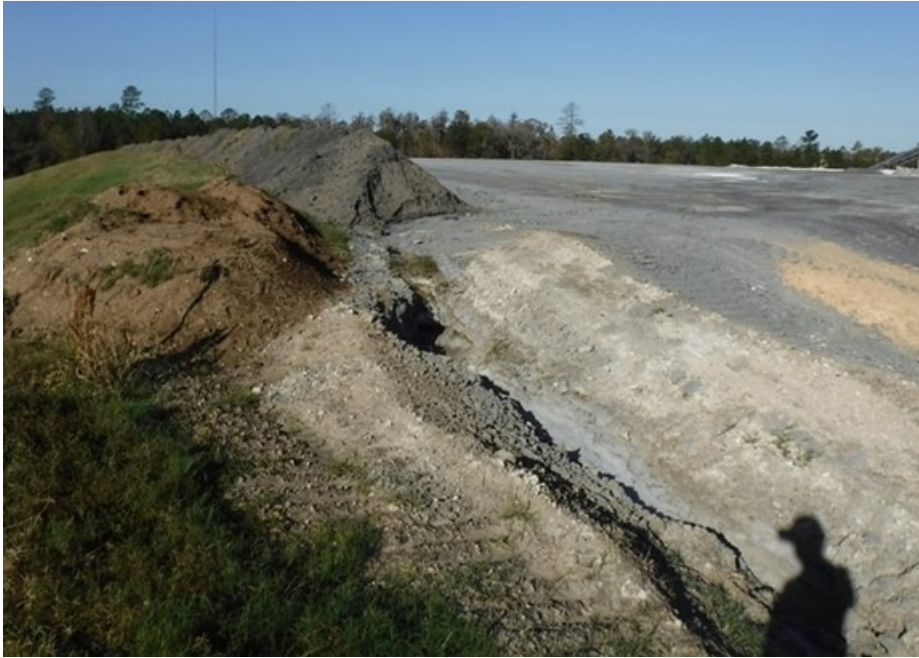
- **Moderate erosion of the southern side of an internal access ramp leading from Cell 3 to Cell 2** – rather than draining from south to north, as detailed in the landfill filling plan, it appears that the southeast corner of Cell 2 is draining to the southeast. As a result, contact water has eroded a portion of the interior slope of the peripheral containment berm located in this area. Figure 11 shows the erosion in this area.

Figure 11. Erosion near Cell 2/Cell 3 Access Ramp

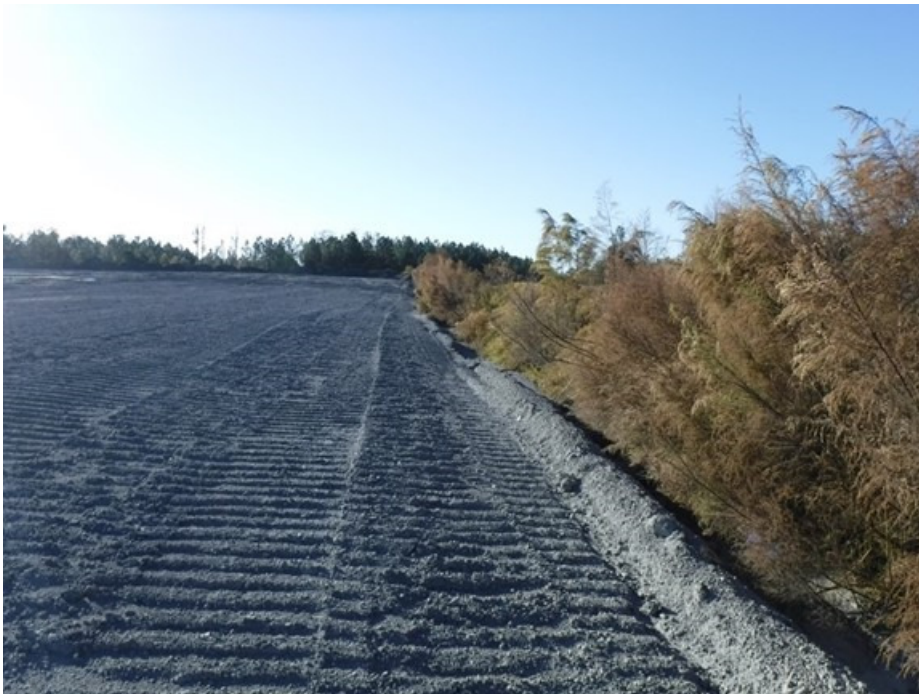
- **Concentration and slight erosion of inside toe of west-most peripheral containment berm** – the western portion of Cell 1 currently appears to be graded so that contact water primarily flows west, concentrates along the inside edge of the western peripheral containment berm, and then continues flowing north. This flow path is starting to cause erosion along the toe of the peripheral berm and is contributing to contact water accumulation and ponding in the northwest corner of the landfill; this

area has historically been challenging to operate equipment in due to soft spots. The grading of this area is presented in Figure 12 – please note that this picture was taken facing south.

Figure 12. Grading Along Western Side of Cell 1

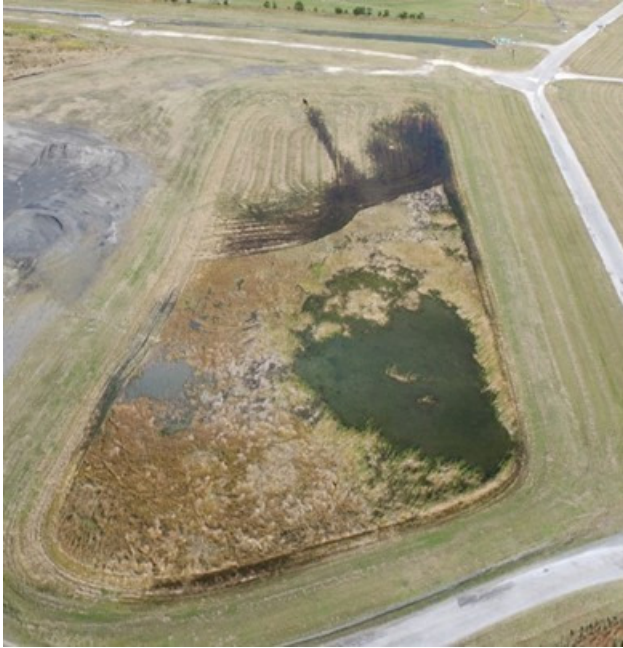
Ponded CCR contact water was observed in the southern end of the Cell 4 basin area. As described in the Run-on and Run-off Control System Plan (IWCS 2016b), this Cell 4 basin area is necessary for contact water

storage in the event of a 24-hour, 25-year storm; ponding in this area represents a decrease in contingency storage capacity. Figure 13 presents an aerial image of the Cell 4 basin area. Please note that the picture is oriented according to the cardinal directions (i.e., up is north).

Figure 13. Aerial Image of Ponding in the Southern End of the Cell 4 Basin Area

5. Additional material should be placed in the southern portion of the Cell 4 basin area to provide gravity drainage of CCR contact water to the 36-inch culvert located at the basin's northern extent. Once this material is placed, the change in capacity of this area should be evaluated to estimate what changes (if any) are necessary to maintain sufficient capacity to manage the total volume of precipitation associated with a 24-hour, 25-year storm. Prior to the placement of CCR in this area, GRU should provide inlet protection (e.g., hay bales) of the 36-inch culvert to prevent sediment intrusion.

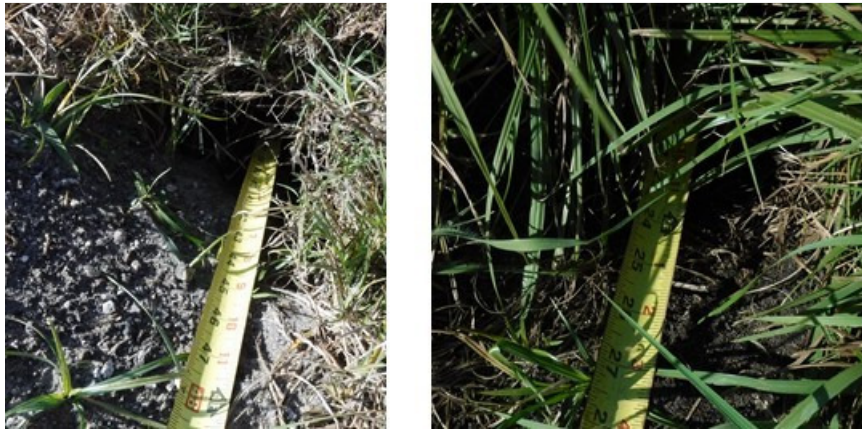
IWCS performed a visual inspection of all exterior slopes of the CCR landfill for any appearance of actual or potential structural weakness including signs of erosion; bulging; depressions; cracks; animal burrows; boils; or excessive, turbid, or sediment-laden seepage. Two relatively deep (i.e., greater than 2 feet deep)

animal burrows/forage holes were identified on the southern slope of the landfill. Pictures of these burrows are presented in Figure 14.

Figure 14. Animal Burrows/Forage Holes and Hole Depths Observed on the Southern Slope of the CCR Landfill
