Gainesville Regional Utilities Deerhaven Generating Station

Coal Combustion Residual Units Annual Inspection Report (13 December 2017 – 12 December 2018)

**Innovative Waste Consulting Services, LLC
3720 NW 43rd Street, Ste. 103
Gainesville, Florida 32606**

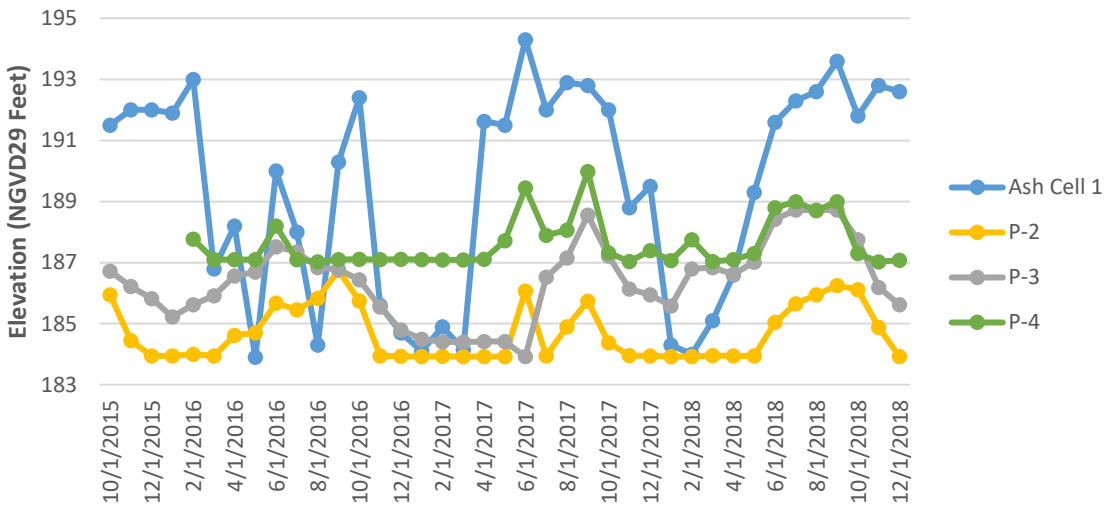
Figure 3. Liquid Elevations for Ash Cell #1 and Piezometers

The first period of elevated water levels occurred in August after an extended rain event; the water level of both ponds was observed to exceed the 193-foot (NGVD29) normal maximum operating level on 29 August 2018. The water levels continued to be above the normal maximum operating level until 5 October 2018 and 17 October 2018 for Ash Cell #1 and Ash Cell #2, respectively.

2. The water level in Ash Cell #1 and #2 were found to be greater than 193 ft NGVD29. IWCS recommends GRU to maintain water level in the ash cells less than 193 ft NGVD29 to ensure a freeboard of at least 2 ft.

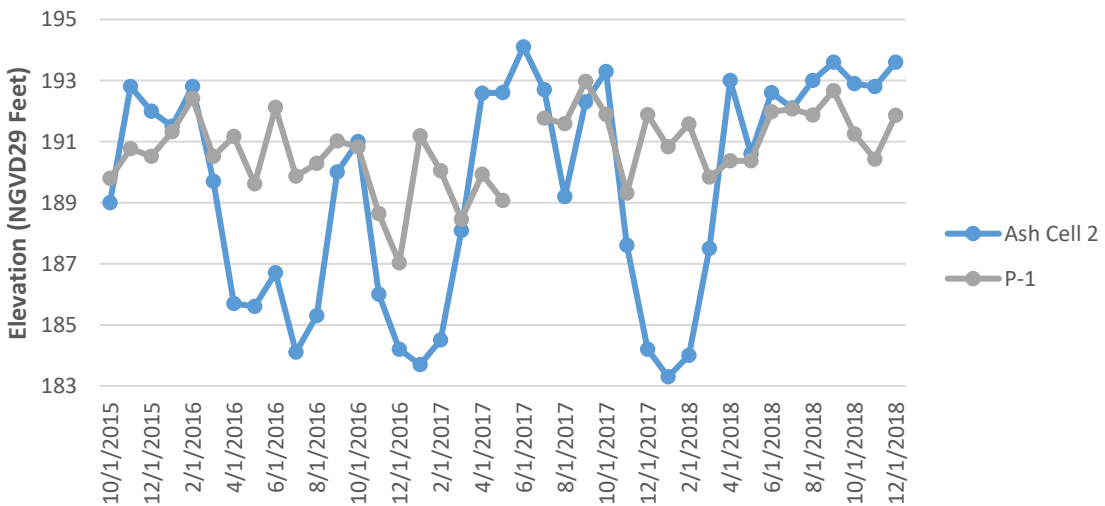
Figure 4. Liquid Elevations for Ash Cell #2 and Piezometer

The second period of elevated water levels was observed in December 2018; the levels in Ash Cell #2 was observed above the normal maximum operating level starting 3 December 2018 due to Unit 2 Air Heater washing.

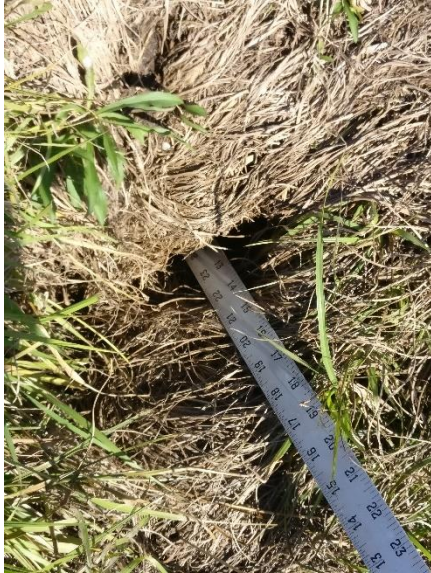
Figure 5. Forage Holes and Depths Observed on External Slopes of the Surface Impoundment System and Pump Back Ponds

signs of erosion; bulging; depressions; cracks; animal forage holes; boils; or excessive, turbid, or sediment-laden seepage. One animal forage hole was found on the external slopes of the surface impoundment system (Figure 5). As shown in Figure 5, the hole was approximately 12-14 inches deep. A large portion of the slopes could not be inspected as the vegetation height was more than 6 inches. The grass height on the western slopes of both Ash Cell #1 and Ash Cell #2 on 12 December 2018 was observed to be greater than the 6-inch requirement.

1. GRU should relocate resident animal(s) and backfill all animal forage holes in accordance with federal, state, and local law.

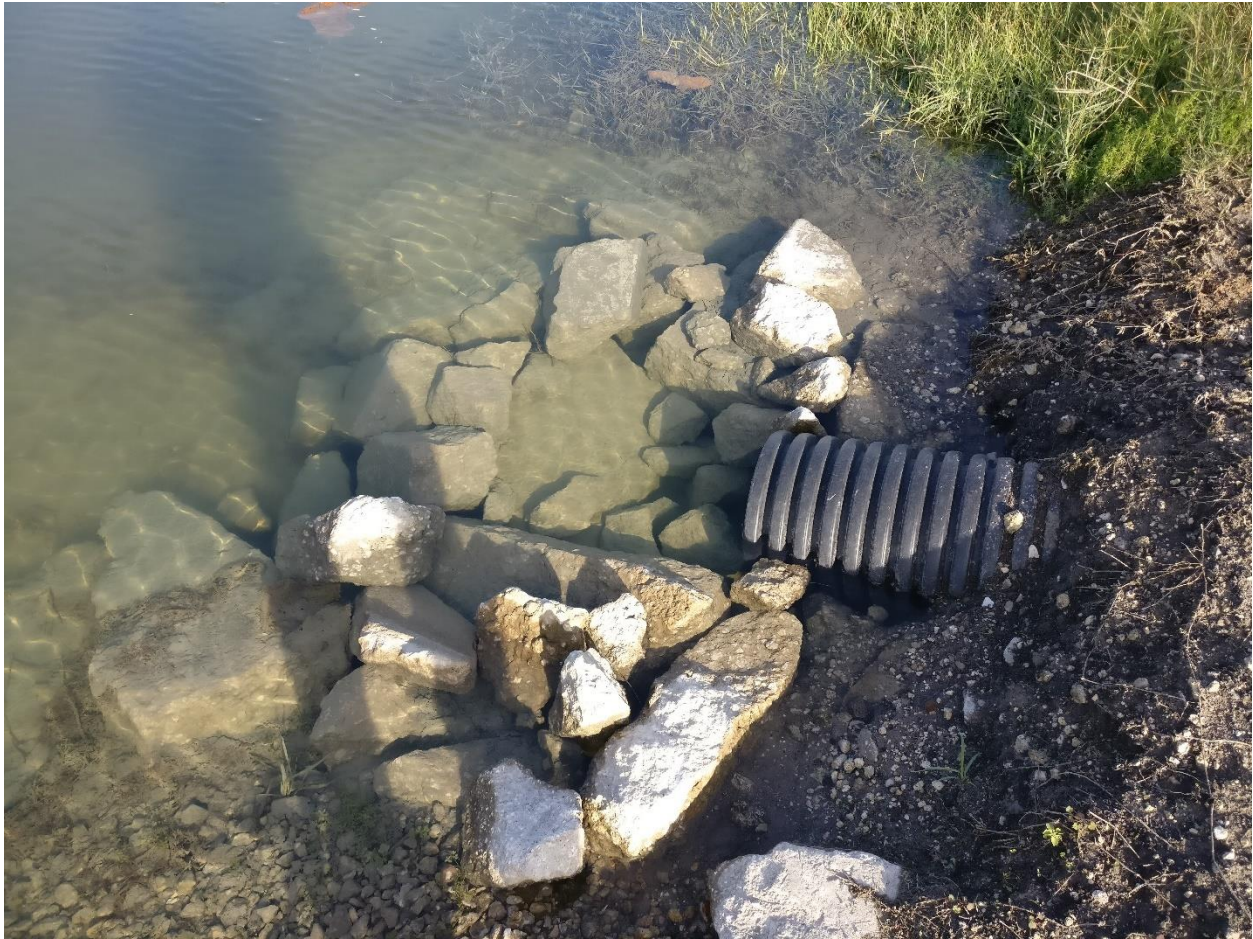
Figure 6. CCR in Northern Drainage Ditch

The Northern Drainage Ditch accepts CCR contact water from the landfill and gravity drains to a pump station located at its eastern extent. As shown in Figure 6, CCRs appeared to be transported into the ditch with the contact water exiting the landfill through the downcomers, which may be due to displaced hay bales and gaps between the hay bales around the downcomers inlets (Figure 7). Two downcomers are installed along the northern slope of the CCR landfill to gravity drain the contact water from the landfill to the Northern Ditch. IWCS observed displaced hay bales and resultant gaps between the hay bales; hay bales are placed around the downcomers inlets to control sediment intrusion into the downcomers and the drainage ditch; one hay bale appeared to completely obstruct the inlet of one of the downcomers (Figure 7). GRU is recommended to adjust/replace the existing hay bales to control sediment intrusion into the downcomers. IWCS observed erosion around one the downcomer pipes (Figure 8).

5. Sediments accumulated in the Northern Drainage Ditch should be excavated and relocated in the landfill.
6. IWCS recommends compacting soil and seeding/sodding the finished grades to address erosion around the downcomer with visible erosion.

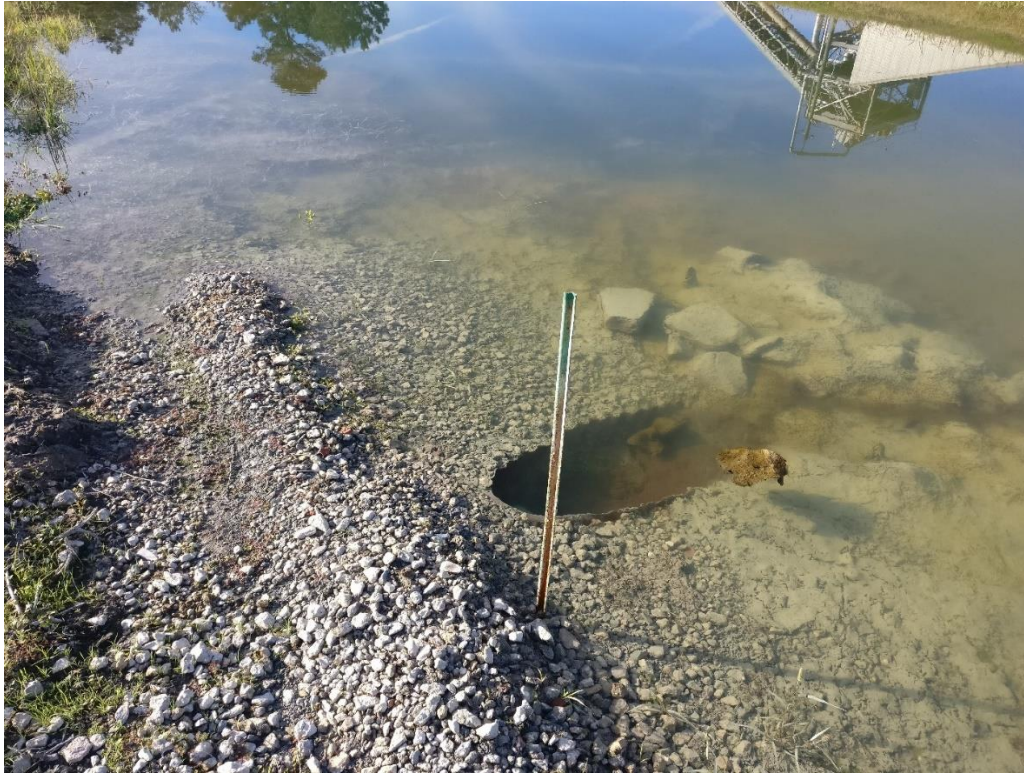
Figure 9. An Inundated Underdrain

The water level in the Northern Drainage Ditch was high and inundated all four underdrains (Figure 9). These underdrains route the contact water accumulated on the landfill bottom to the Northern Drainage Ditch. The water level in the Northern Ditch must be maintained below the outlet of the underdrains for efficient removal of the contact water from the landfill bottom. The Northern Drainage Ditch water level, if above the bottom elevation of the underdrains, impedes the flow of contact water from CCR landfill into the Northern Drainage Ditch and may lead to accumulation of the contact water within the landfill. Due to high water level, the extent of sediment built-up in the Northern Drainage Ditch could not be assessed.

3. The water level in Northern Drainage Ditch was observed to be above the underdrains. The water level must be maintained such that it is below the underdrain outlets.

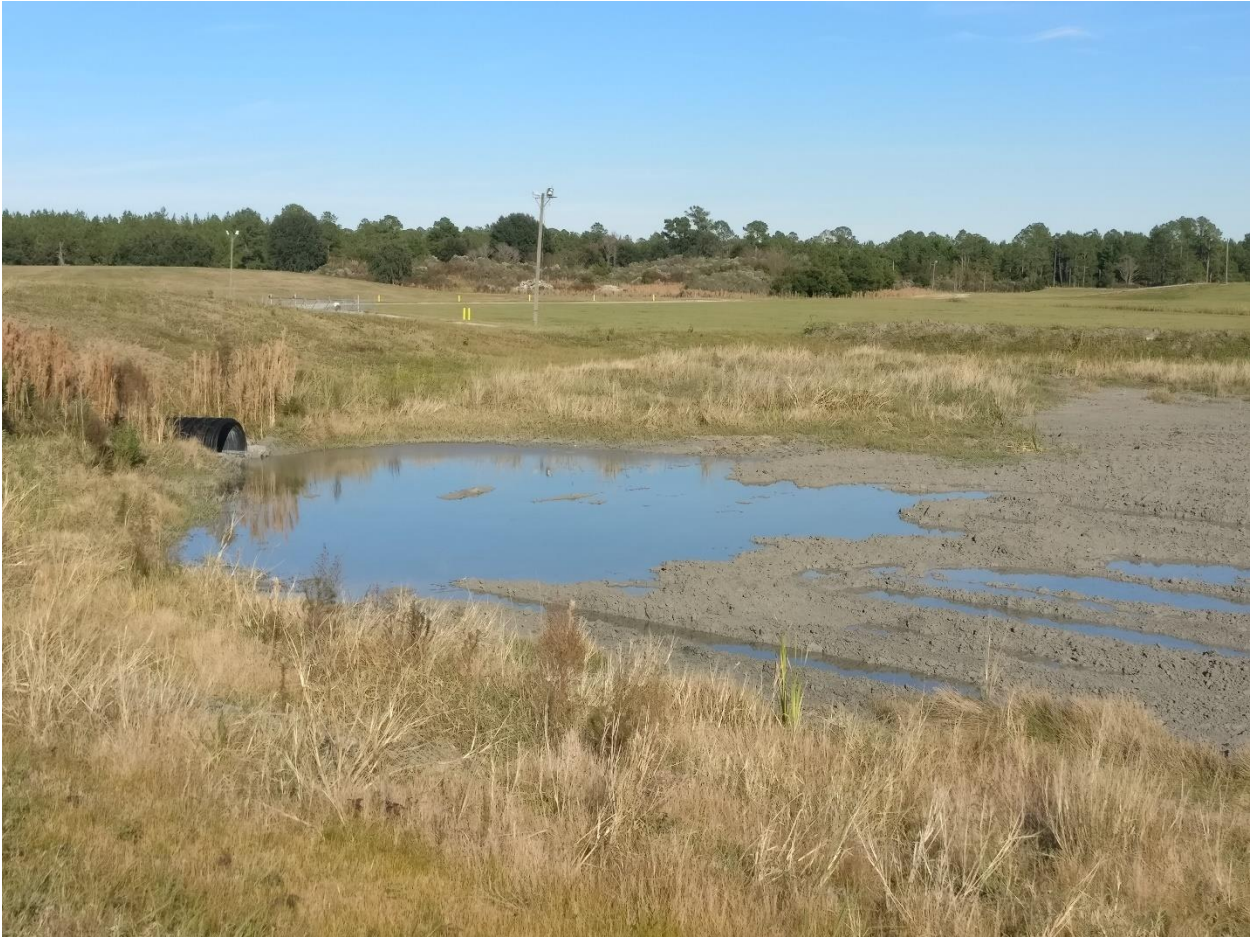
Figure 10. Ponding of Contact Water in the Northern Edge of the Cell 4 Basin Area

A small amount of ponded CCR contact water was observed in the northern end of the Cell 4 basin area. As described in the Run-on and Run-off Control System Plan (IWCS 2016b), this Cell 4 basin area is necessary for contact water storage in the event of a 24-hour, 25-year storm; ponding in this area represents a decrease in contingency storage capacity. Figure 10 shows the Cell 4 basin area with ponding. Although the amount of ponded water was small and does not appear to significantly impact the available storage capacity, GRU is recommended to grade the area for minimizing contact water ponding within the landfill footprint.

7. GRU must take measures to ensure there is no ponding of water in Cell 4 area. The Cell 4 area would be needed to accommodate the stormwater run-off from 25-year 24-hour storm event. Ponding of water in Cell 4 area reduces the capacity of the cell to manage the stormwater run-off.
