# Gainesville Regional Utilities Deerhaven Generating Station

## Coal Combustion Residual Units Annual Inspection Report (11 December 2020 – 8 December 2021)

Innovative Technical Solutions  
3720 NW 43<sup>rd</sup> Street, Ste. 103  
Gainesville, Florida 32606

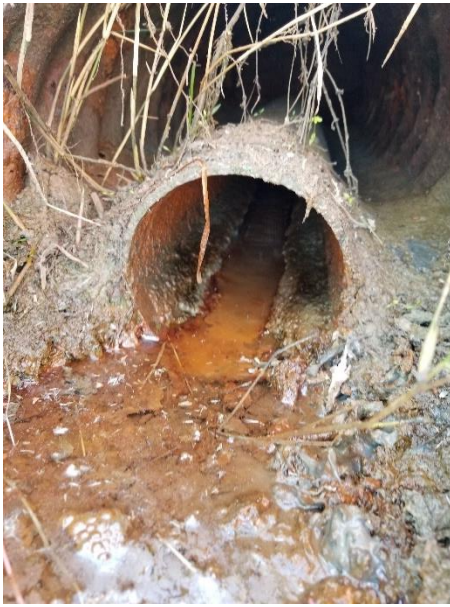
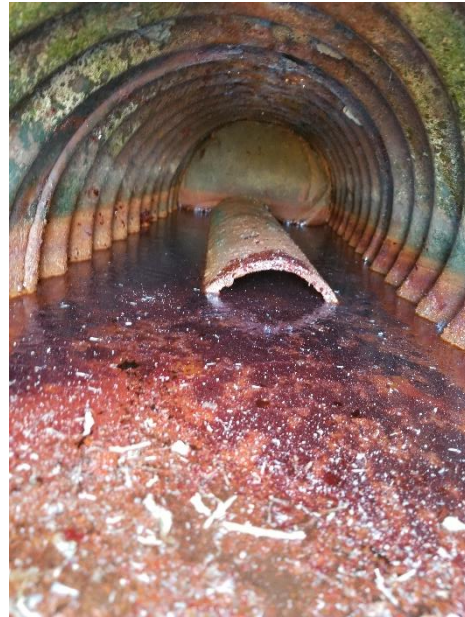
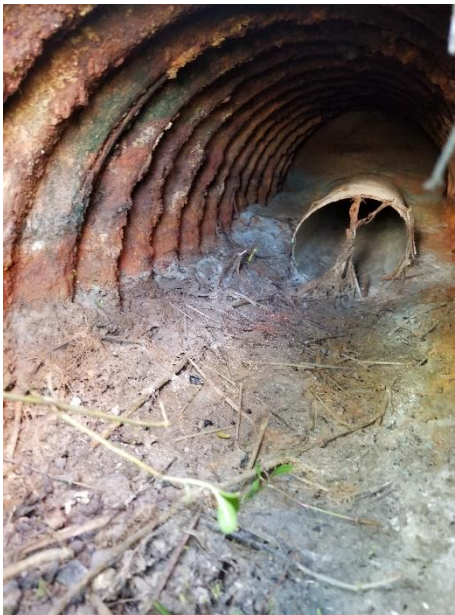
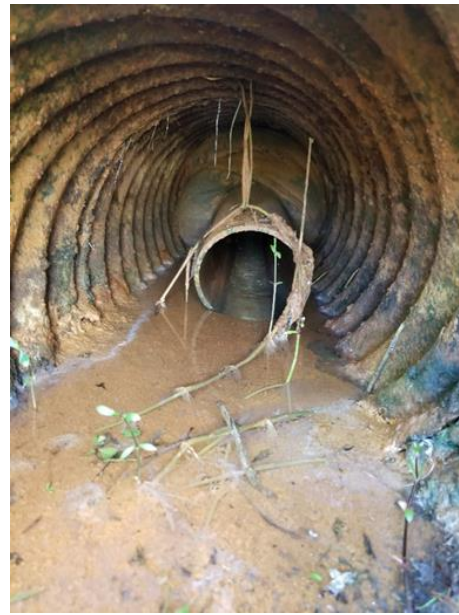
Sedimentation around the underdrain outlets in the Northern Drainage Ditch was observed. The sediments appear to impede drainage from the underdrains causing water to back up into the underdrains (Figure 5).

**Figure 5. Sediment Build-up Around Underdrain Outlets of (a) Cell 1, (b) Cell 2, (c) Cell 3, and (d) Cell 4**  
**3.2.2 Geometrical Changes of CCR Landfill**

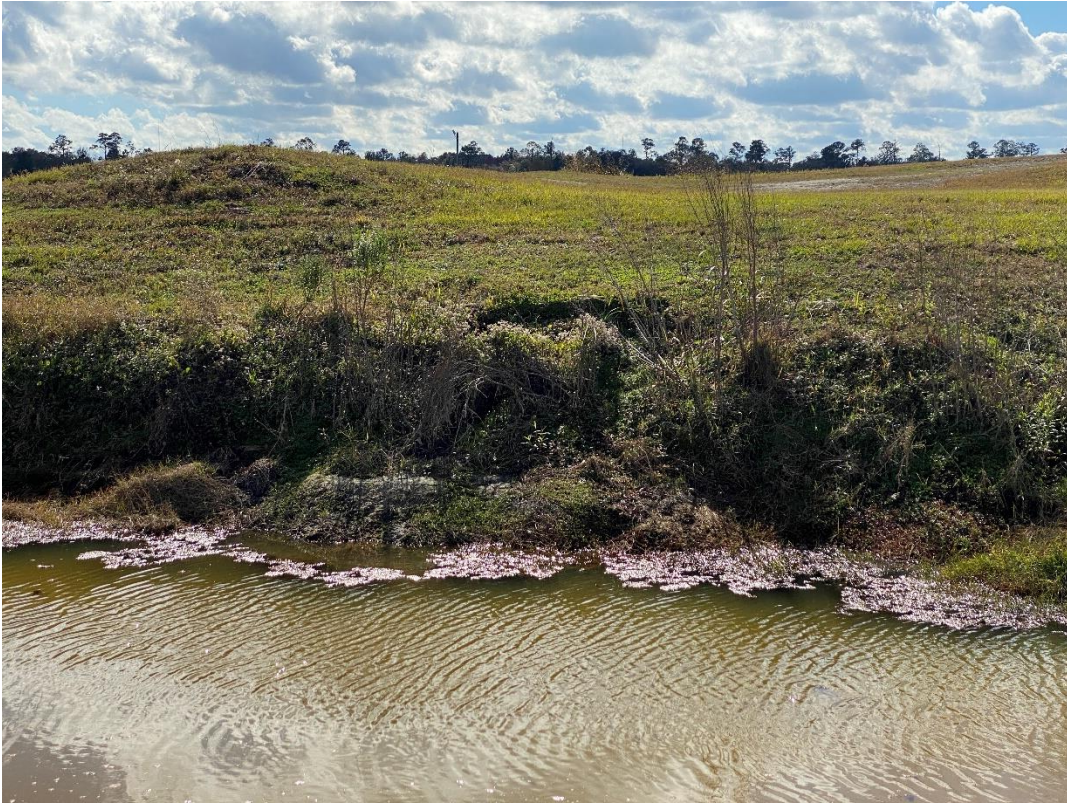
- a) Localized erosion of the southeast corner of Northern Drainage Ditch was observed (Figure 6)
- b) Mower ruts were observed on the southeast corner and southwest toe of the landfill (Figure 7). These ruts can potentially accumulate stormwater run-off.
- c) Thick vegetation around the culverts on the north side of Cell 3 was observed (Figure 8). These culverts route contact water run-off from Cells 3 and 4 to the Northern Drainage Ditch.
- d) Sediment build-up in the Northern Drainage Ditch around the downcomers outlets was observed (Figure 9).
- e) Loose piles were present on top of the landfill (Figure 10).
- f) Unvegetated spots on the stormwater channel on the west and south sides of the landfill were observed (Figure 11).
- g) An identification label is missing for two groundwater monitoring wells and one piezometer located on the west side of the landfill.

**Figure 6. Erosion near the Southeast Corner of North Drainage Ditch**

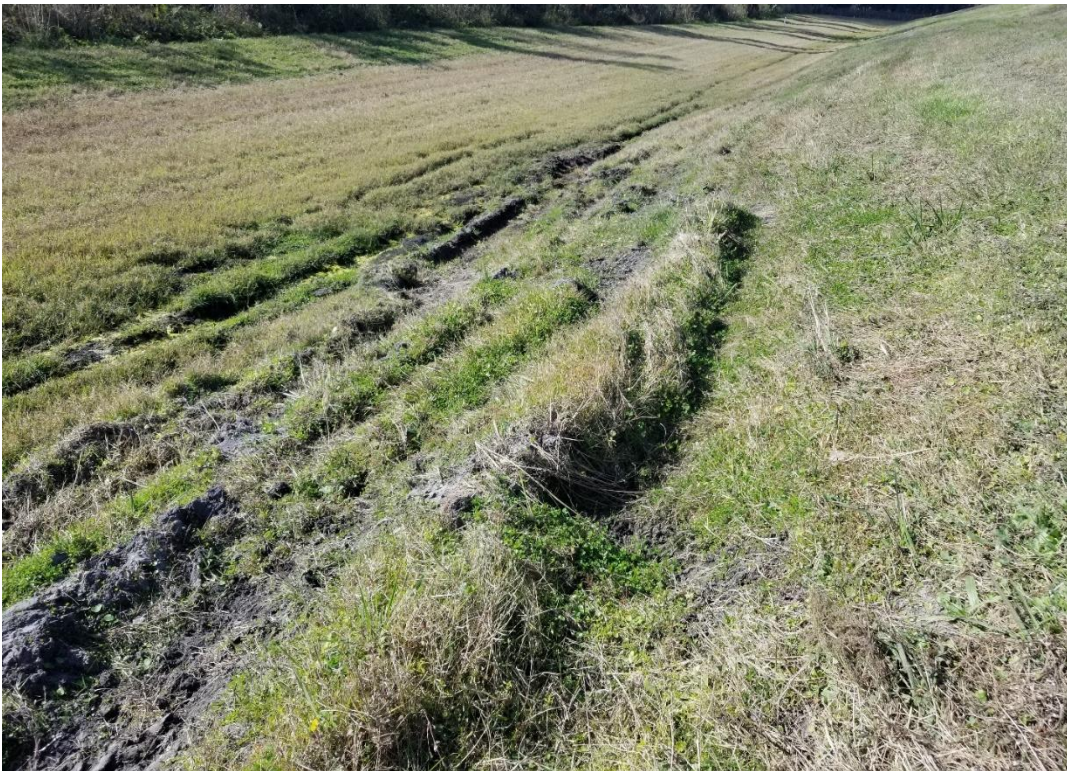
**Figure 7. Erosion on Southeast Corner on Landfill**

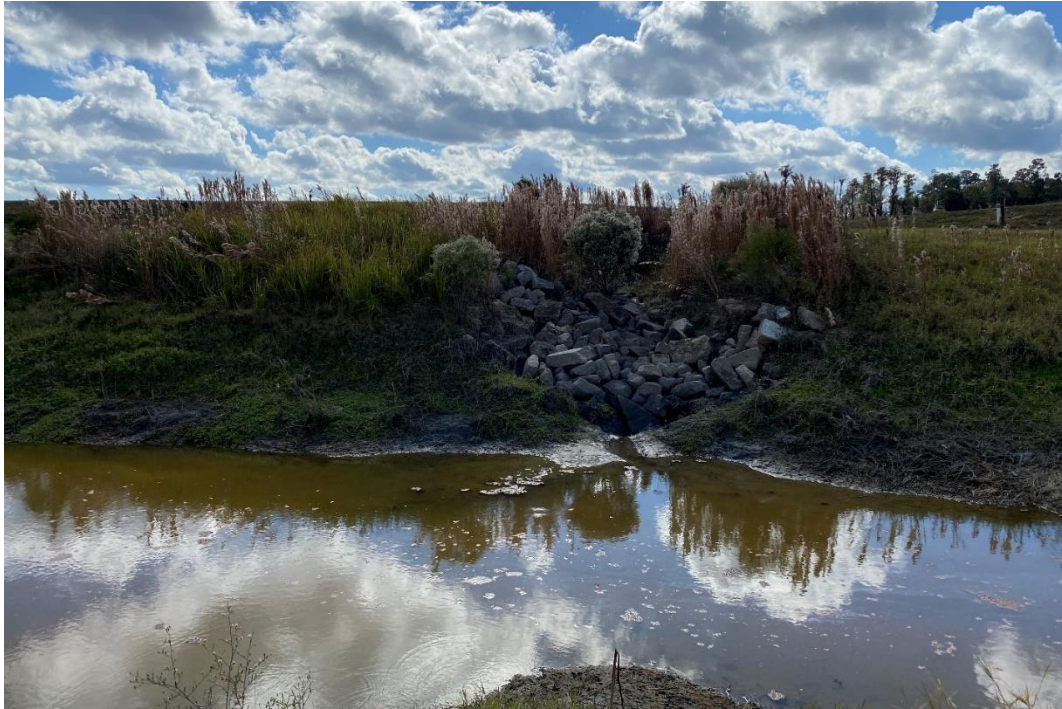
**Figure 8. Thick Vegetation Around the Culverts Located on the North Side of Cell 3**

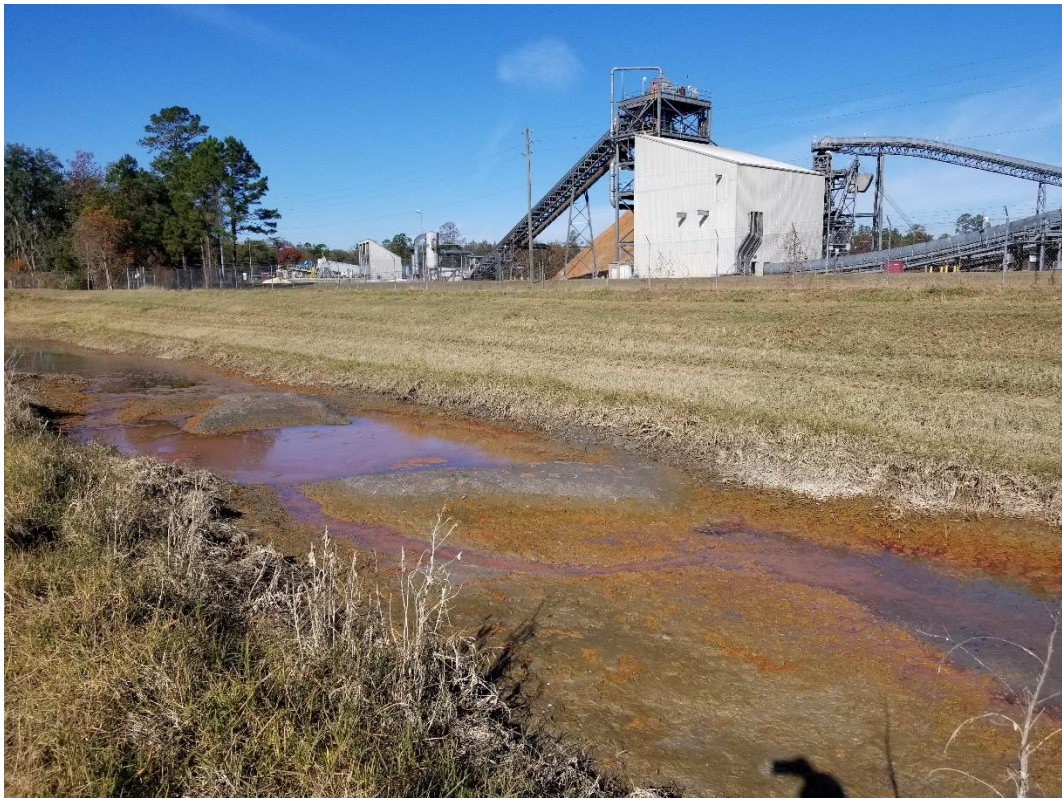
**Figure 9. Sediment Accumulation in the Northern Drainage Ditch**

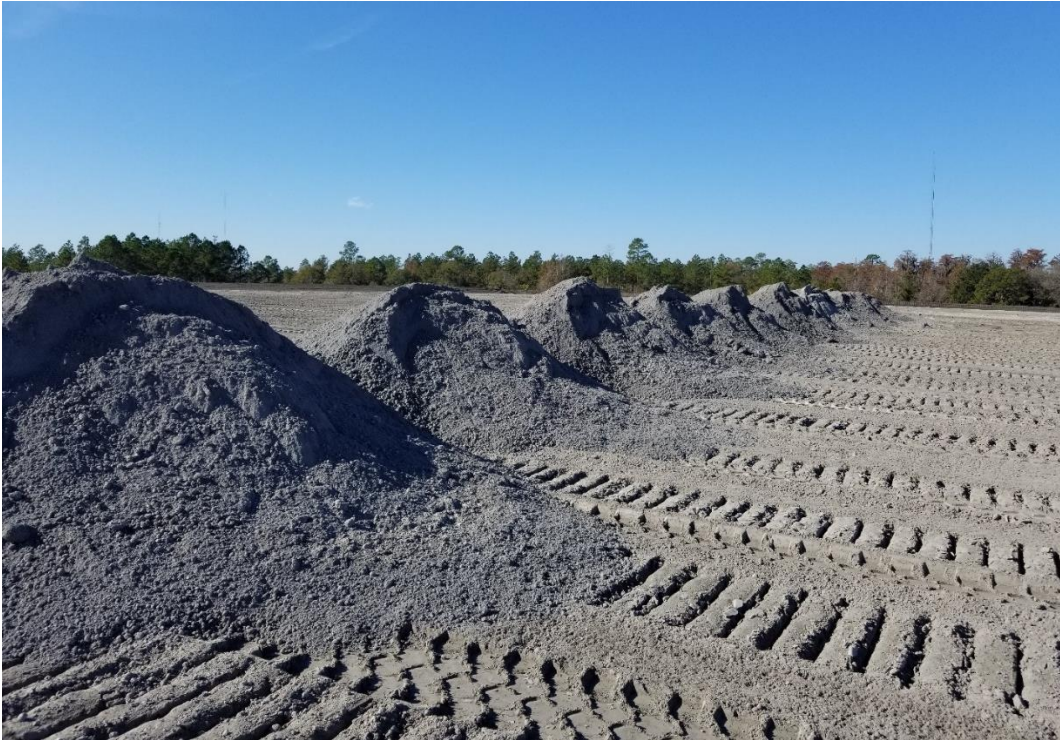
**Figure 10. Several Loose Piles on Top of Landfill**

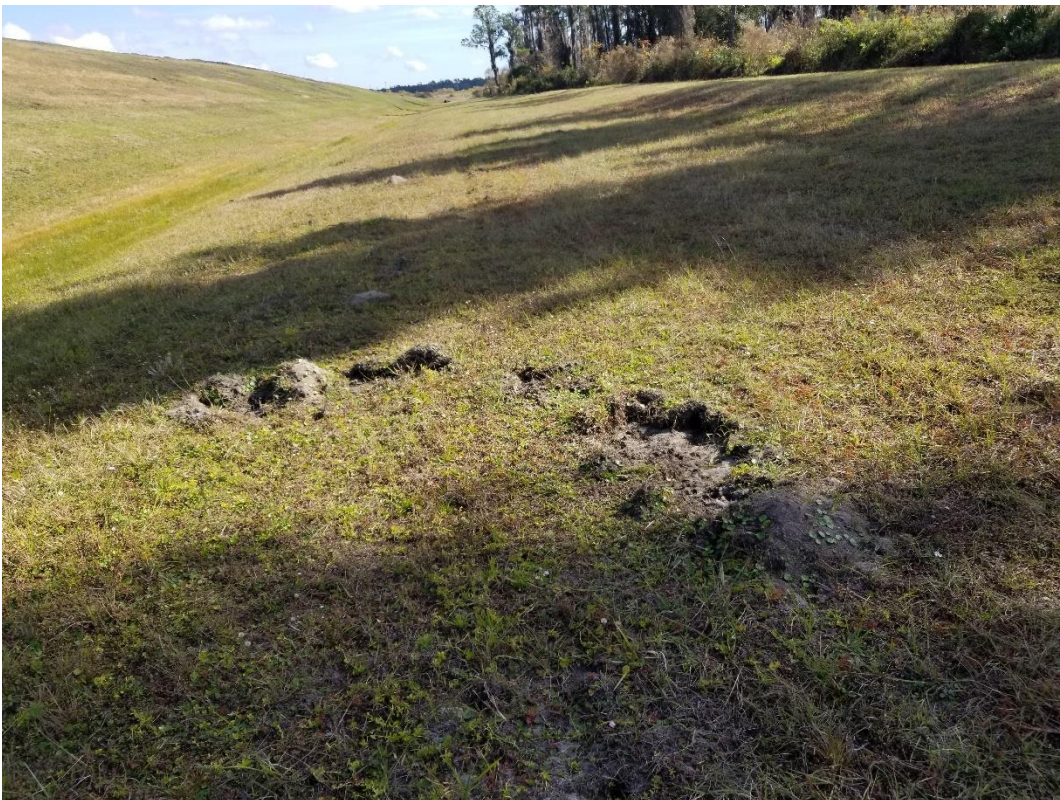
**Figure 11. Unvegetated Areas in Stormwater Channel on the South and West Side of the Landfill**
