## **Corrective Measures to Address Deficiencies Noted in the Coal Combustion Residuals Units Annual Inspection Report**

**(Annual inspection covering the period from December 11, 2020 – December 10,  
2021)**

**Table 1. Remedies Taken to Address Deficiencies Noted in the 2021 CCR Units Annual Inspection Report**

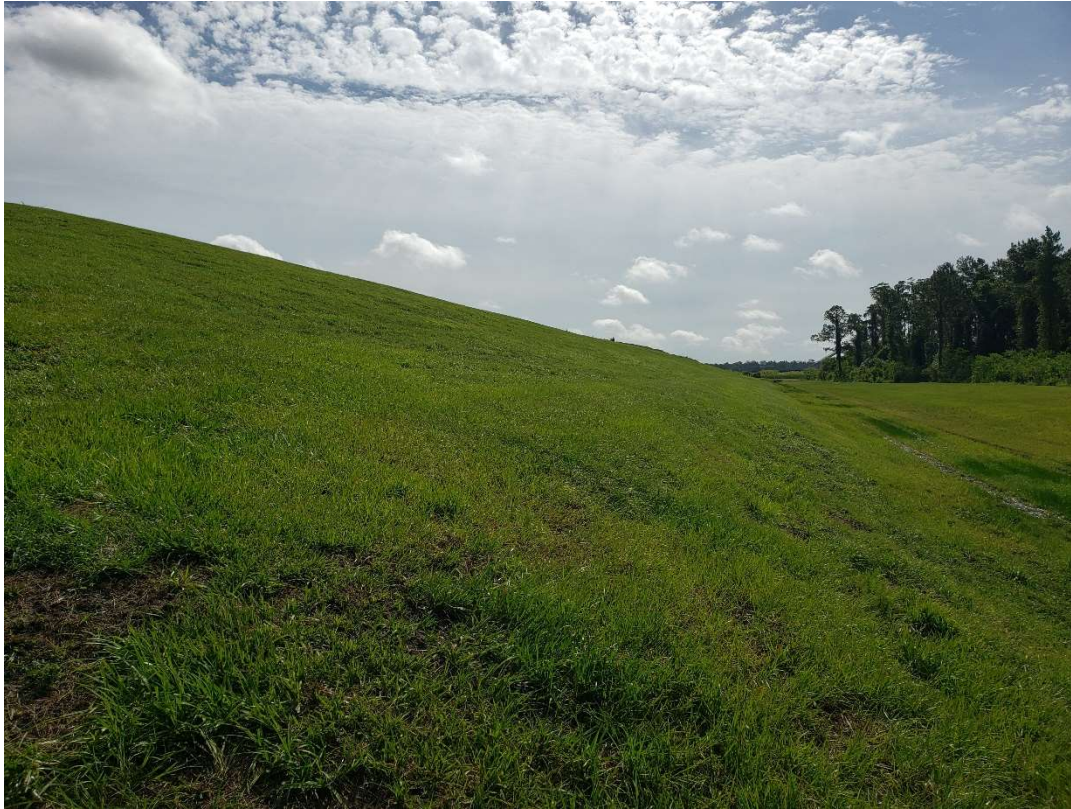
**Figure A1. South Side of Landfill (No Ruts); 5/24/2022**

| CCR Unit | Location | Previous Condition | Remedy Action | Attach. | Date of Remedy Completion |
|---|--|--|---|---|---|
| | Southeast corner on Landfill and Northern Drainage Ditch | Erosion | GRU notified ITS that erosion area was graded and sodded on 4/21/2022. ITS inspected the CCR unit on 05/24/2022 and confirmed that the area is regraded and vegetated. Pictures taken during the inspection on 05/24/2022 are provided in Attachment A. | Figure A1 | 4/21/2022 |
| | Southeast and southwest slope (near slope toe) | Mower ruts | ITS inspected the CCR unit on 05/24/2022 and did not observe the ruts. Pictures taken during the inspection on 05/24/2022 are provided in Attachment A. | Figure A1 | Before 05/24/2022 |

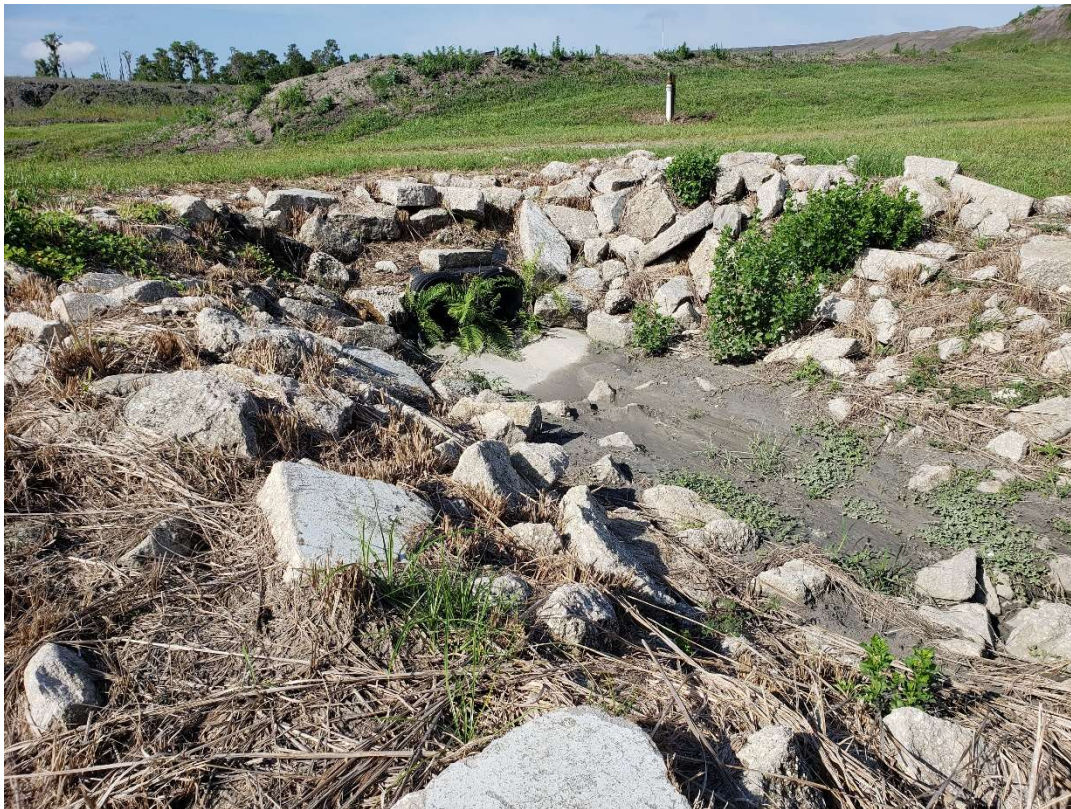
**Figure A2. Cell 3 Culverts; 5/24/2022**

| CCR Unit | Location | Previous Condition | Remedy Action | Attach. | Date of Remedy Completion |
|---|--|--|---|---|---|
| | Cell 3 culverts | Thick vegetation around the culvert inlets and outlets | GRU notified ITS that that the vegetation around the culverts inlets and outlets trimmed. ITS inspected the CCR unit on 05/24/2022 and observed that the | Figure A2 | Before 05/24/2022 |

| | | | vegetation has been trimmed. | | |

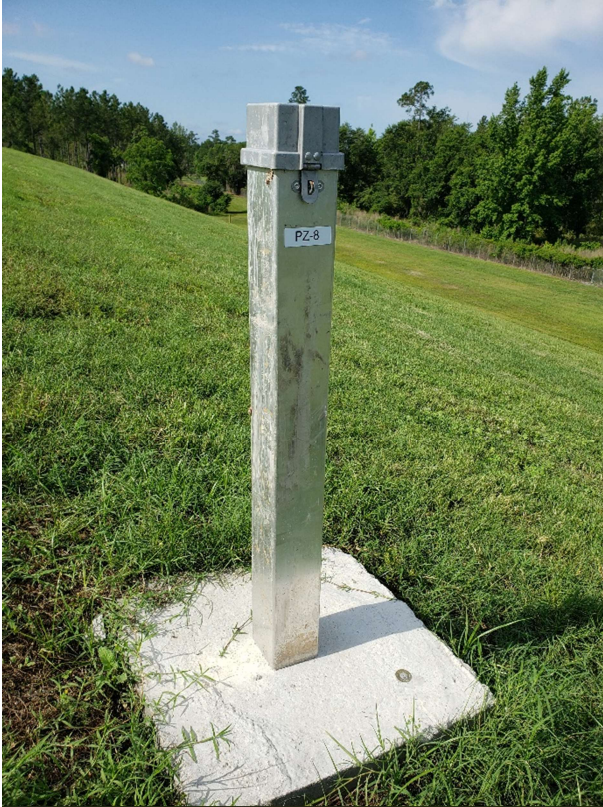
**Figure A3. PZ-8 (Label Present); 5/24/2022**

| | Two groundwater monitoring wells and one piezometer on the west side of the landfill | Identification labels missing | Labels haven been placed on all wells. ITS inspected the CCR unit on 05/24/2022 and observed that all piezometers had been labeled. GRU notified that LF-5 and LF-6 were labeled in the week of the July 11, 2022. | Figures A3-A5 | 07/11/2022-7/15/2022 |

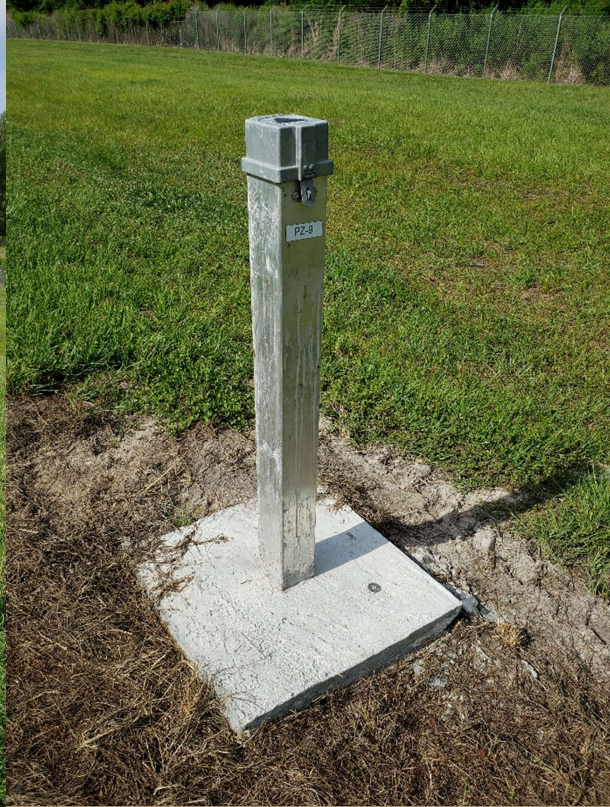
**Figure A4. PZ-9 (Label Present); 5/24/2022**

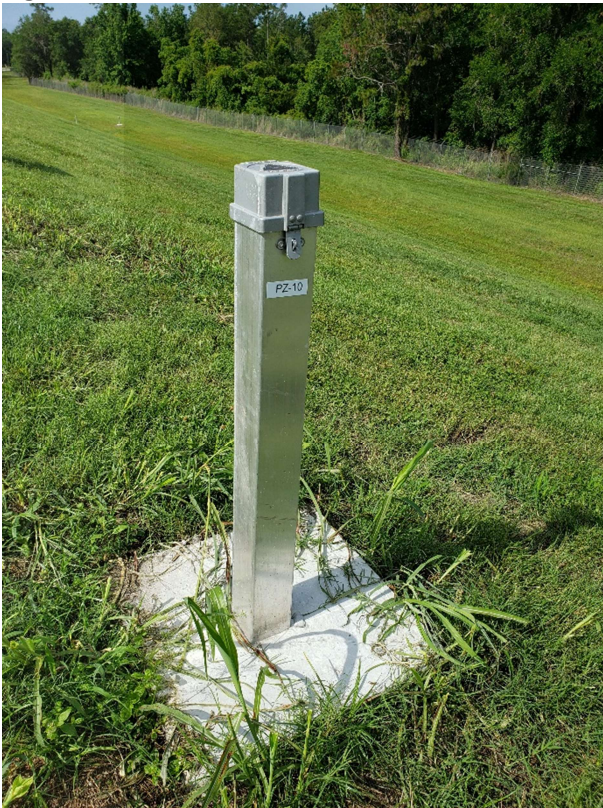
**Figure A5. PZ-10 (Label Present); 5/24/2022**
