Gainesville Regional Utilities Deerhaven Generating Station

Coal Combustion Residual Units Annual Inspection Report (December 9, 2021 – December 6, 2022)

Innovative Technical Solutions
3720 NW 43rd Street, Ste. 103
Gainesville, Florida 32606

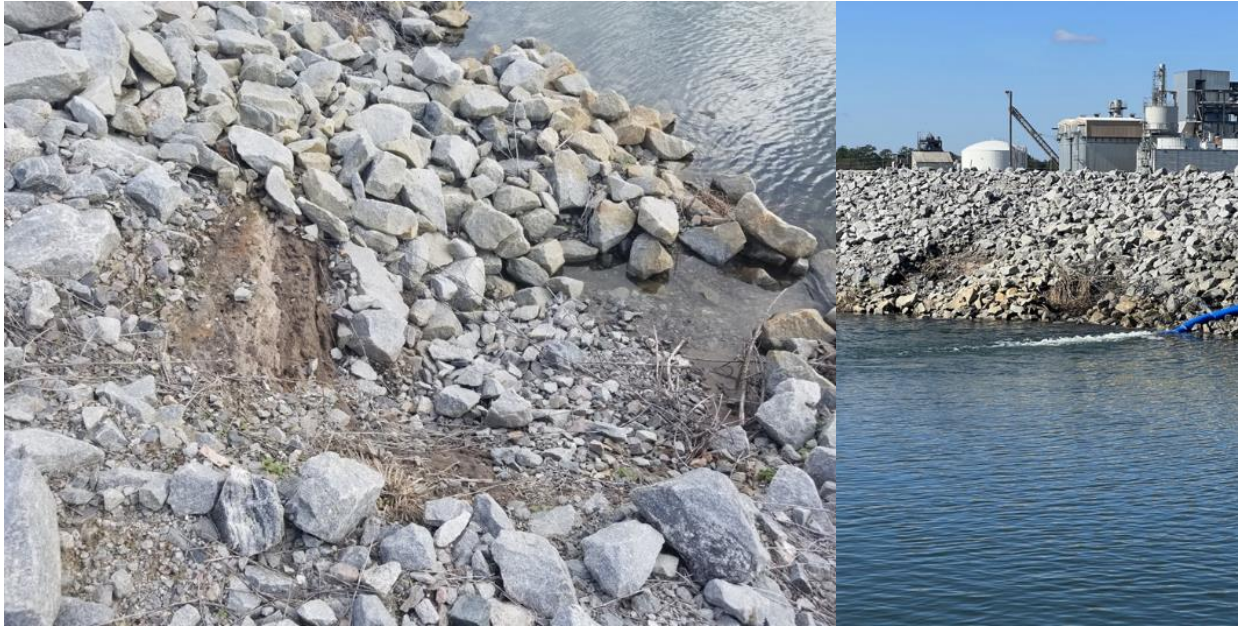
Figure 5. Ash Cell # 2 and Pump Back Cell #2 Embankment Erosion and Riprap Displacement

ITS visually inspected the external side slopes of the surface impoundment system to identify any potential indicators of structural weakness or any other adverse condition, including signs of erosion; bulging; depressions; cracks; animal forage holes; boils; or excessive, turbid, or sediment-laden seepage. No signs of structural weakness or adverse conditions were observed during the annual inspection of the surface impoundment system. Erosion on the embankment between Ash Cell #2 and Pump Back Cell #2 was observed. The erosion and riprap displacement in this area appears to be the result of the pumping of water from Ash Cell #2 to the Pump Back Cell #2 using a diesel pump due to the malfunctioning of the butterfly valve that is used to control the flow of decant water from Ash Cell #2 to Pump Back Cell #2.

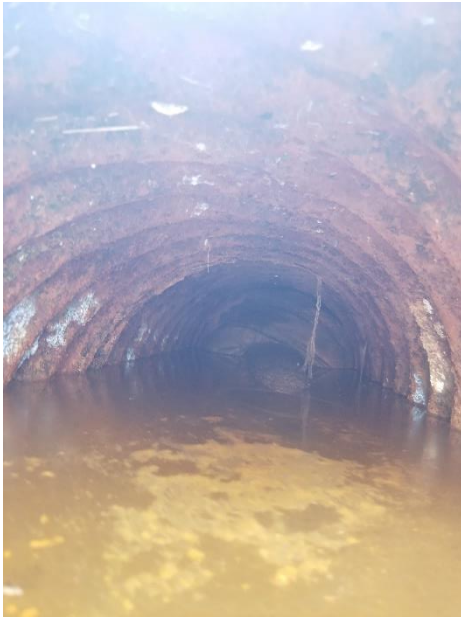
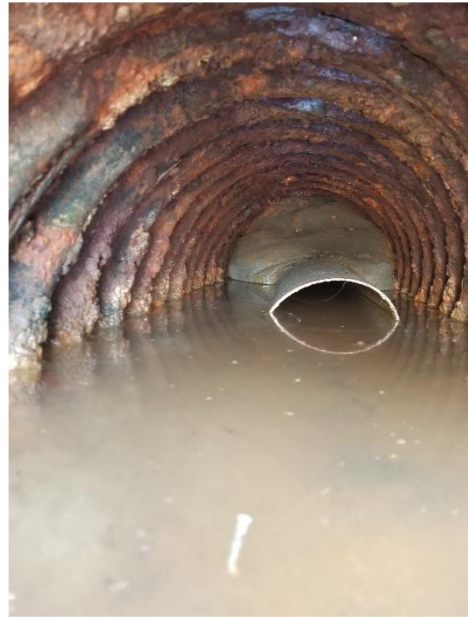
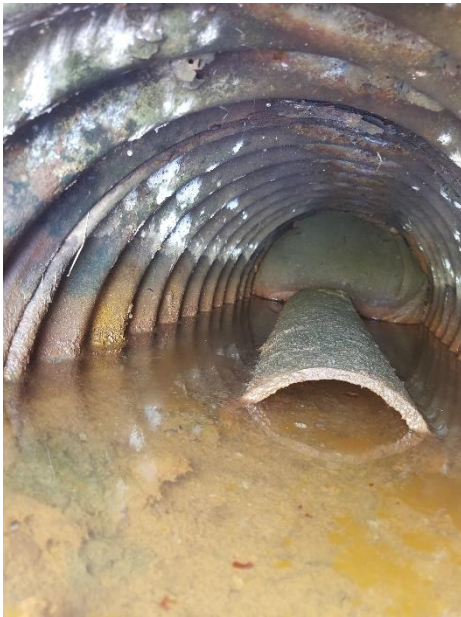
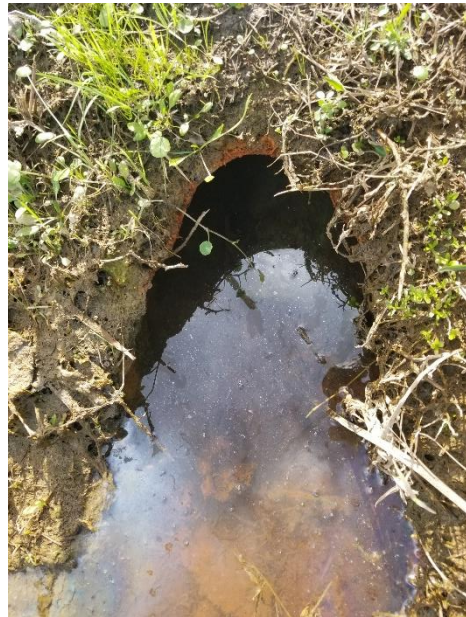
Figure 6. Sediment and Water Build-up Around Underdrain Outlets of (a) Cell 4, (b) Cell 3, (c) Cell 2, and (d) Cell 1 on December 6, 2022.

Cells 2-4 underdrains were partially under water, and Cell 1 underdrain was completely submerged due to a high liquid level in the Northern Drainage Ditch (Figure 6).

| CCR Unit | Location | Condition |
|---|---|---|
| CCR Landfill | All four underdrains | Underwater. Sediment built-up in and around Cells 1 and 2 underdrains was observed. |

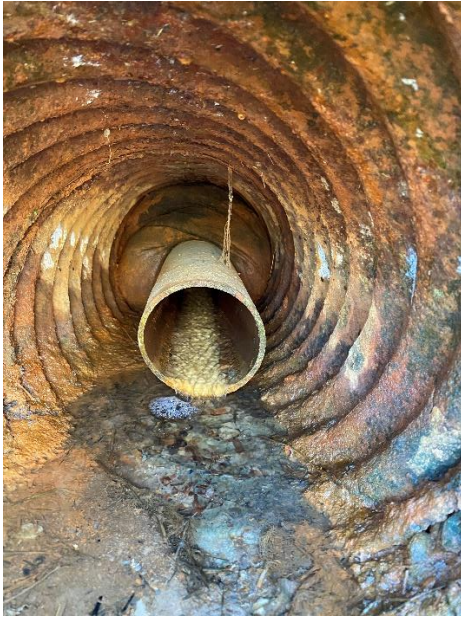
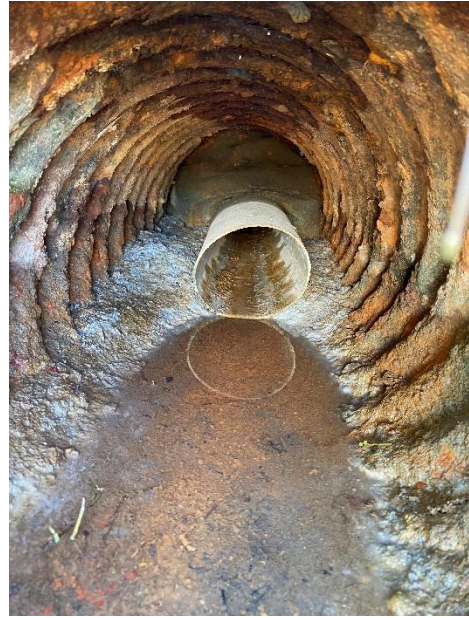
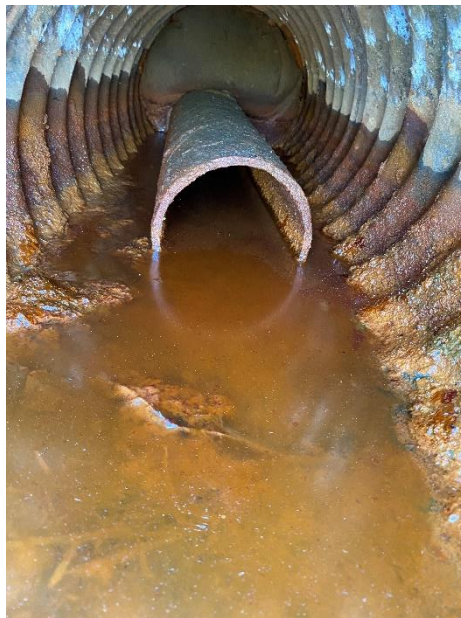
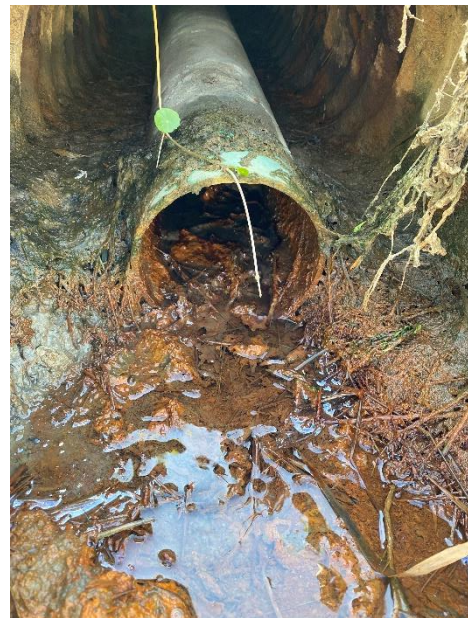
Figure 7. Condition of Underdrain Outlets of (a) Cell 4, (b) Cell 3, (c) Cell 2, and (d) Cell 1 on December 16, 2022.

ITS conducted a follow-up walkthrough of the site with GRU personnel on December 16, 2022 and found only the Cell 2 underdrain to be partially underwater (Figure 7). The Cell 2 underdrain had some sediment

buildup at the outlet that was impeding water from draining into the Northern Drainage Ditch. Dead vegetation and sediment built-up in and around the Cell 1 underdrain outlet were observed.

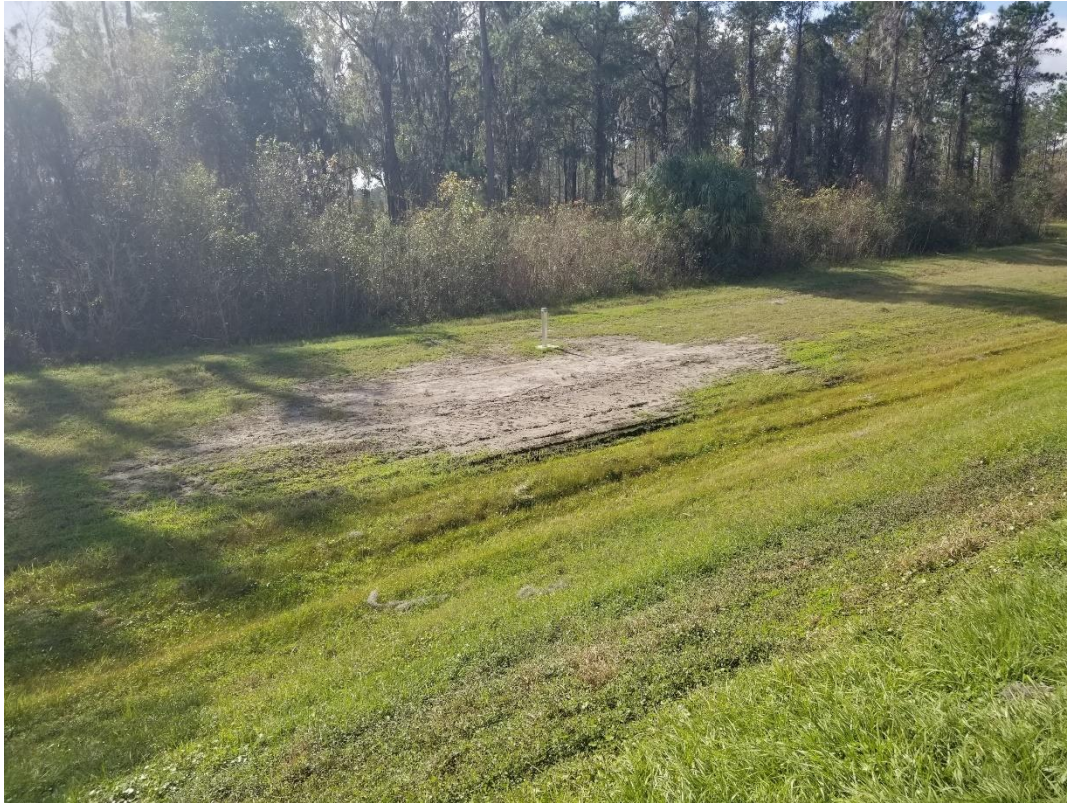
Figure 8. Unvegetated Area Around LF-3

- a) Unvegetated area around LF-3 (Figure 8)
