**COAL COMBUSTION RESIDUALS (CCR)  
ABUTMENT AND BASE SURFACE IMPOUNDMENT SYSTEM EVALUATION**

**DEERHAVEN GENERATING STATION (DGS)  
10001 NW 13<sup>th</sup> STREET  
GAINESVILLE, ALACHUA COUNTY, FLORIDA**

**PROJECT NO. 0230.1500077  
REPORT NO. 1352022**

Reference: **Report of Geotechnical Consulting Services – Desktop Assessment**  
Deerhaven Generating Station  
CCR Abutment and Base Impoundment Evaluation  
10001 NW 13<sup>th</sup> Street  
Gainesville, Alachua County, Florida  
UES Project No. 0230.1500077  
UES Report No. 1352022

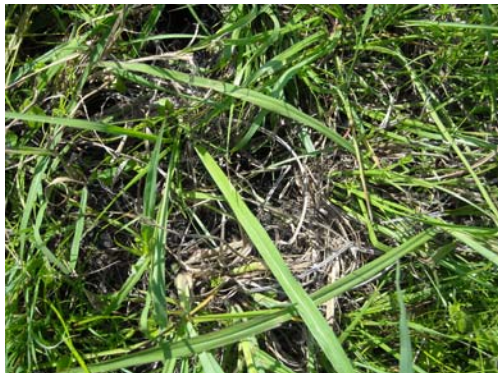
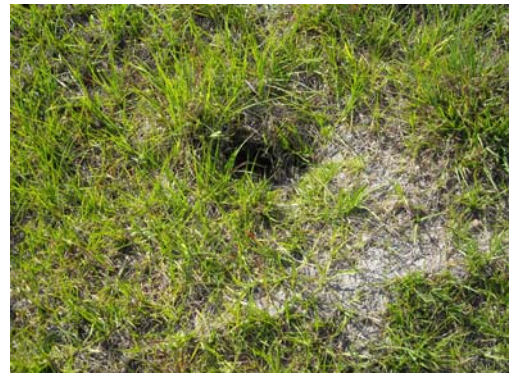
**Exterior Slope:** No scarps, sloughs, major depressions, bulging, sags, tension cracks, or other signs of significant settlement or mass soil movement or slope instability were observed inside or outside the embankment slope. The grass on the exterior slope was generally observed to be well maintained, as shown in **Photos 1 and 2**. Minor erosion was observed from mowing equipment, as shown in **Photos 3 and 4**. Some animal burrows were encountered on the northwestern exterior slope, as shown in **Photos 5 and 6**.

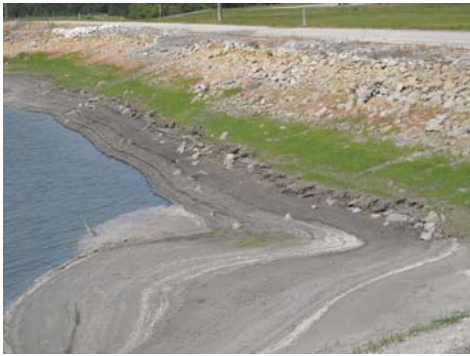
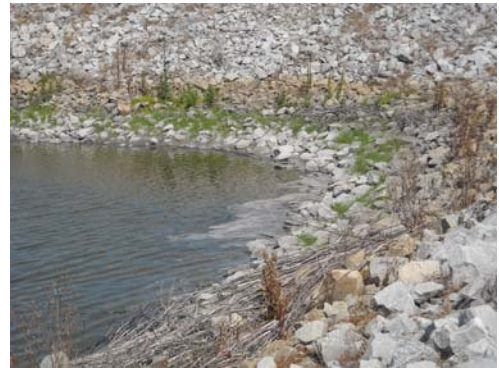
**Interior slope:** The interior slopes of the ash ponds were observed to be lined with riprap with minor amounts of dormant vegetation, including algae and grass, as shown in **Photos 7 and 8**. The bottom slope of the embankment was observed to have a dormant cover of grass and weed with algae resting on some areas. See **Photos 9 and 10**.

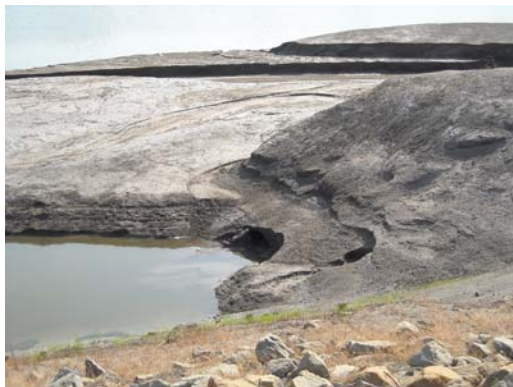
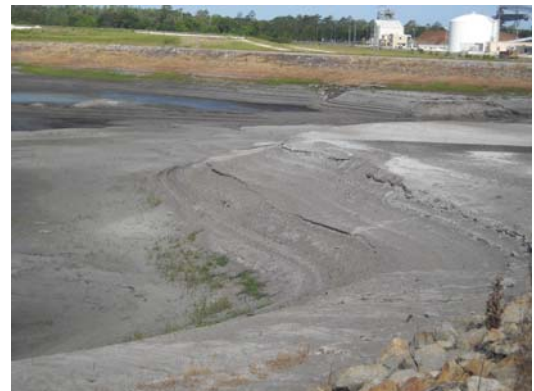
The inside slope toe and much of the slope is covered with ash, particularly along the center of the northeastern slope of Ash Cell #1, and the center of the southwestern slope of Ash Cell #2. See **Photos 11 and 12** where ash is accumulated over the slope of the ash ponds. No slumps, slides or other signs of shear failure were observed in the visible part of the slope above the ash and water levels. No significant erosion was noted.

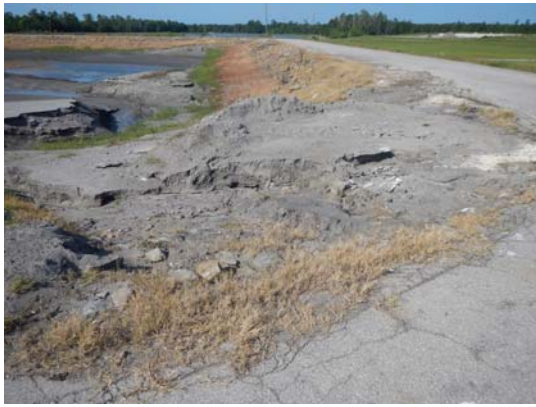
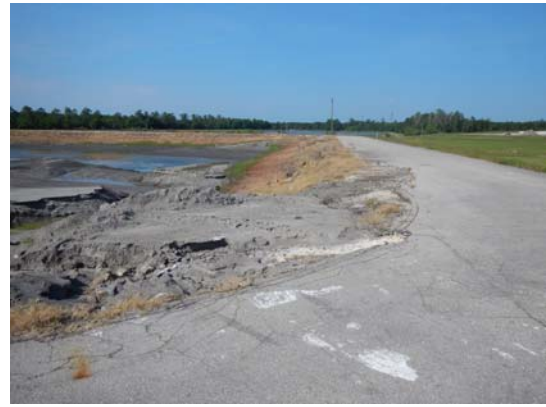
Minor ash sediment erosion was noted along the edge of crest on the north side of the embankment that wraps around the corners, as shown in **Photographs 13 and 14**. Former erosion at the discharge locations in Ash Cell #2 had been repaired with riprap, or stone, as shown in **Photos 15 and 16**.

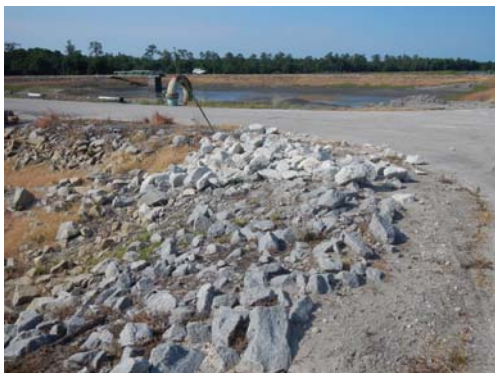
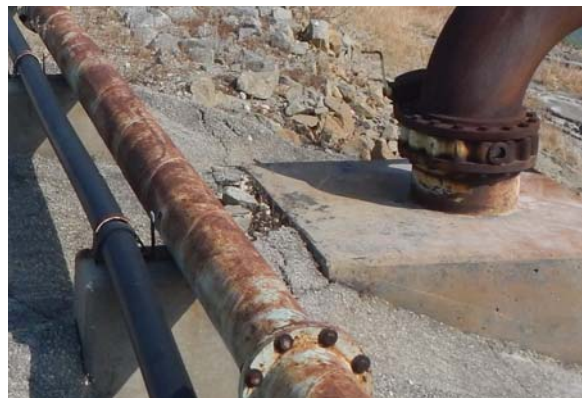
The overall structural integrity of the slopes appears to be stable. However, minor signs of erosion were observed in the interior slope of the embankment at the time of our initial site visit. GRU repaired the erosion and stabilized the area with riprap. No signs of erosion were observed in subsequent site inspections. If further erosion deepening occurs, additional rock (riprap) placement would be necessary for preventative maintenance.

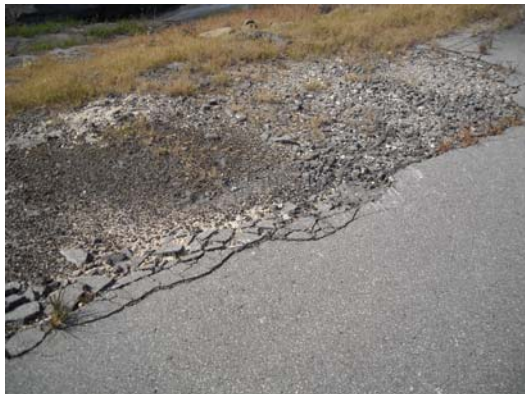
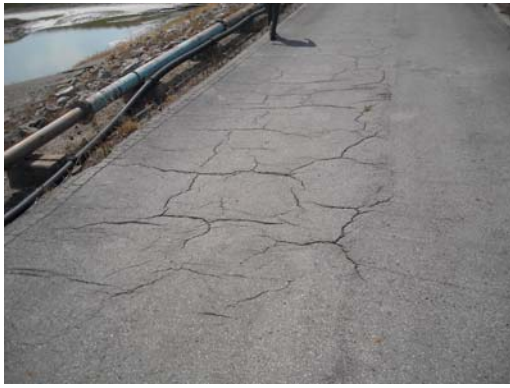
Pavement cracking along the interior edge of the dikes was noted at the northwestern edges of each ash pond, as well as alligator cracking in the pavement atop the interior dike between both ash ponds. See **Photos 17 through 19** for the aforementioned pavement cracking. Previous pavement repair (patching) was apparent along the northwest edge of Ash Cell #2, as shown in **Photo 20**. The water level in the ash ponds was relatively low at the time of inspection. See **Photos 21 and 22** for the approximate ash pond water elevations.

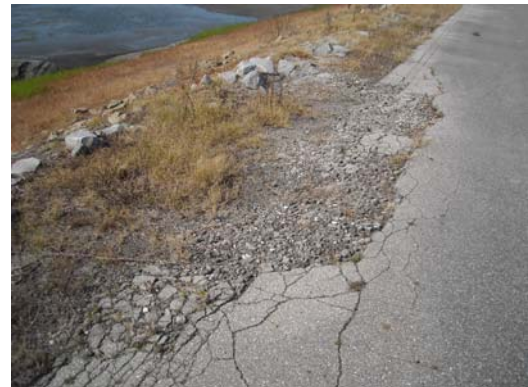
The pavement surface was generally observed to be in fair condition. Some localized areas of distress were noted along the pavement surface. Asphalt surface cracks typically associated with shrinkage of the asphalt (longitudinal/transverse cracks) and weakened subgrade near the edge of pavement (edge cracking), were encountered along the service road at the top of the embankments in some areas. See **Photograph 18** for a typical view of the crest/pavement edge cracking.

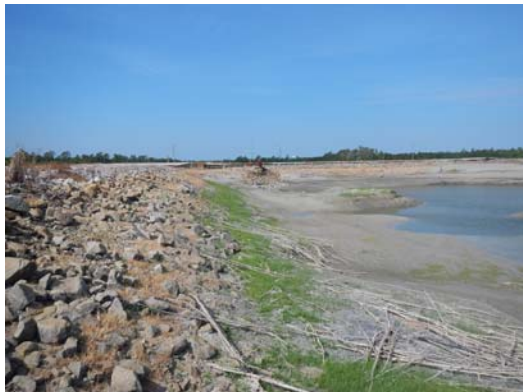
**Photograph 23**

The interior slope of the ash ponds was observed to be lined with riprap, which serves as slope protection, with minor amounts of dormant vegetation (see **Photo 23**). The exterior slope has a grass cover and does not have signs of significant dips, sags or other visual evidence of distress (see **Photo 24**). See **Appendix C** for the aforementioned photos.
