**COAL COMBUSTION RESIDUALS (CCR)  
ABUTMENT AND BASE SURFACE IMPOUNDMENT SYSTEM  
PERIODIC STRUCTURAL STABILITY ASSESSMENT**

**DEERHAVEN GENERATING STATION (DGS)  
10001 NW 13<sup>th</sup> STREET  
GAINESVILLE, ALACHUA COUNTY, FLORIDA**

**PROJECT NO. 0230.1500077  
REPORT NO. 1892167**

September 29, 2021

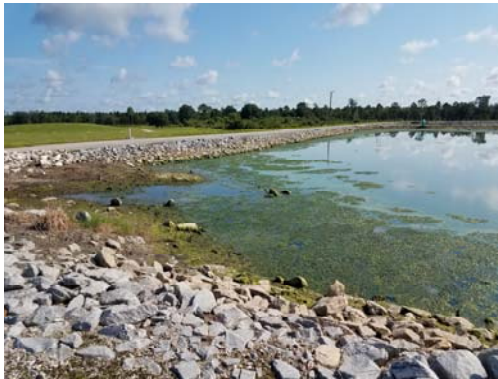
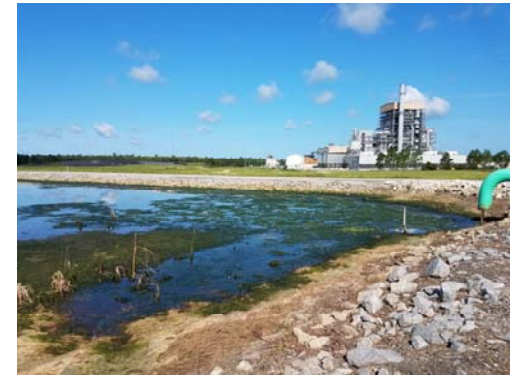
**Interior slope:** The interior slopes of the surface impoundment system were observed to be lined with riprap with moderate amounts of dormant vegetation, including algae and grass, as shown in **Photos 9 and 10**. Due to the high water levels observed in the Ash Cell and Pump Back Cell ponds, the bottom slope of the embankments were not visible.

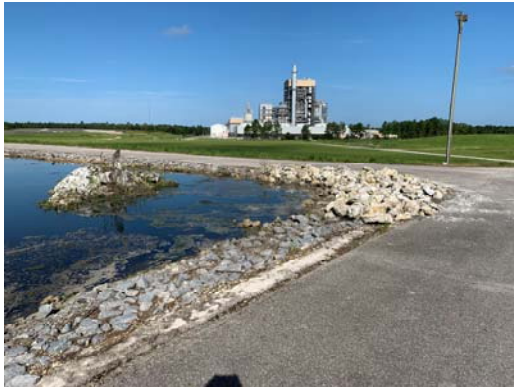
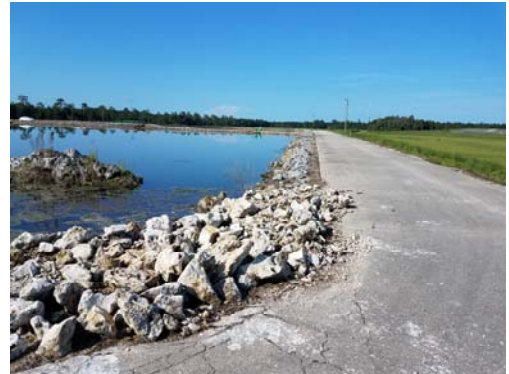
A pile of Ash sediment was observed in cell #2, as shown in **Photographs 13 and 14**. We understand that the pile contain mostly deposited material previously vacuumed out of the L.P. Sump, and that this practice is no longer allowed. Discharge structures in Ash Cells #1 and #2 were observed to be buttressed with riprap, or stone, as shown in **Photos 15 and 16**.

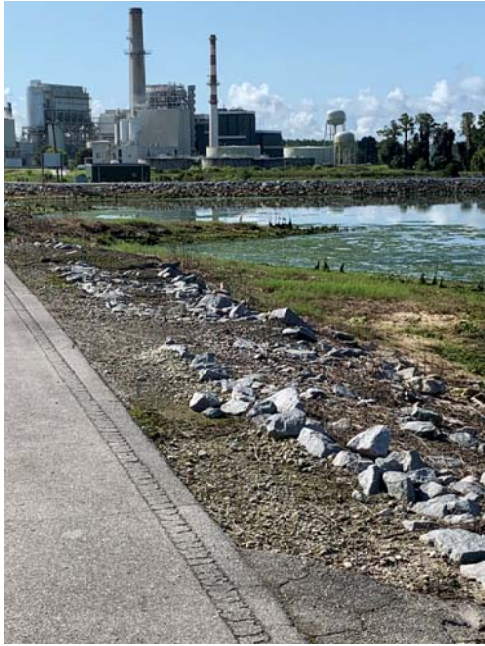
**Photograph 23**

The interior slope of the surface impoundment system was observed to be lined with riprap, which serves as slope protection, with moderate amounts of dormant vegetation (see **Photo 23**). The exterior slope has a grass cover and does not have signs of significant dips, sags or
