**Gainesville Regional Utilities  
Deerhaven Generating Station**

**Coal Combustion Residual Units  
Annual Inspection Report  
(October 17, 2015-January 8, 2016)**

**Innovative Waste Consulting Services, LLC**

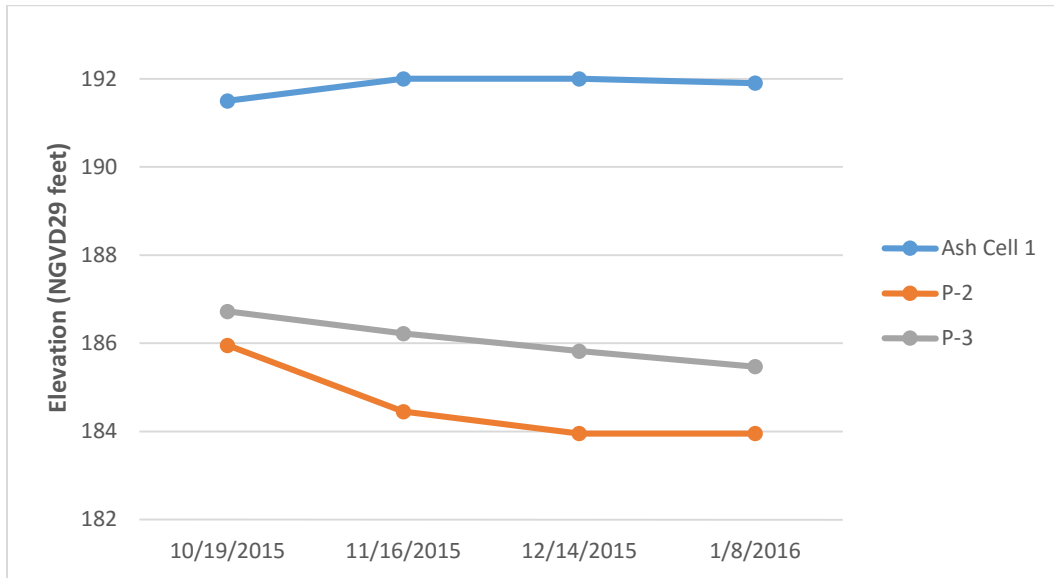
During each monthly inspection, an inspector documents the depth to the phreatic surface in piezometers located in the embankments of Ash Cell #1 and Ash Cell 2. These piezometers are used as a point of comparison to assist in identifying potential embankment seepage areas; Piezometer P-2 and P-3 are each used to monitor each outside embankment for Ash Cell #1 and P-1 is used to monitor the outside embankment of Ash Cell #2. The phreatic surface of the liquid level in the piezometers was compared to the liquid elevation in each adjacent ash pond. Figure 3 and 4 present a comparison of the measured liquid levels for Ash Cell #1 and corresponding piezometers and Ash Cell #2 and corresponding piezometer, respectively. In general, IWCS measurements on the day of the inspection were consistent with those measured by GRU staff during monthly inspections.

**Figure 3. Liquid Elevations for Ash Cell #1 and Piezometers**

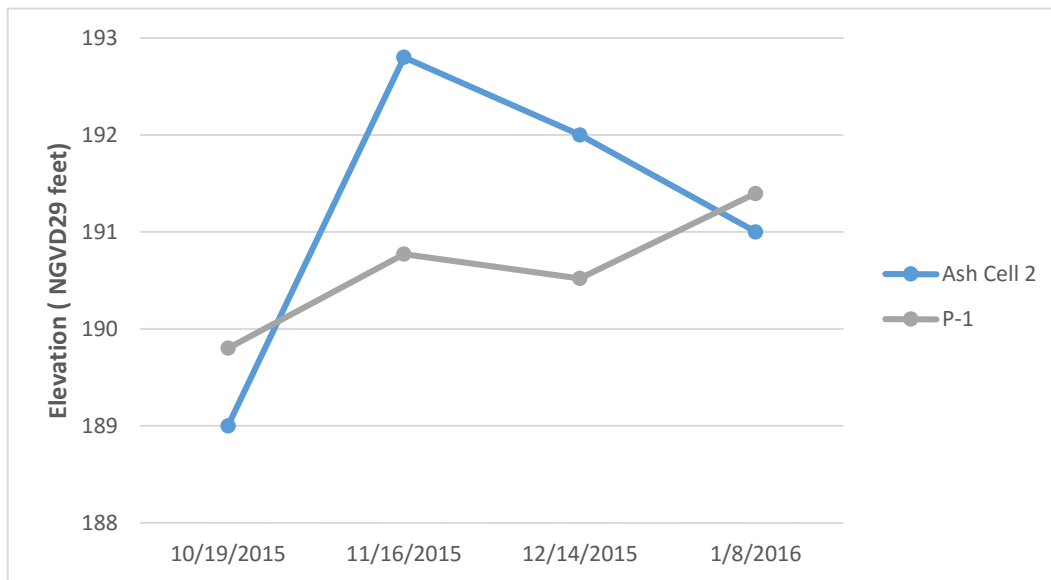
**Figure 4. Liquid Elevations for Ash Cell #2 and Piezometers**

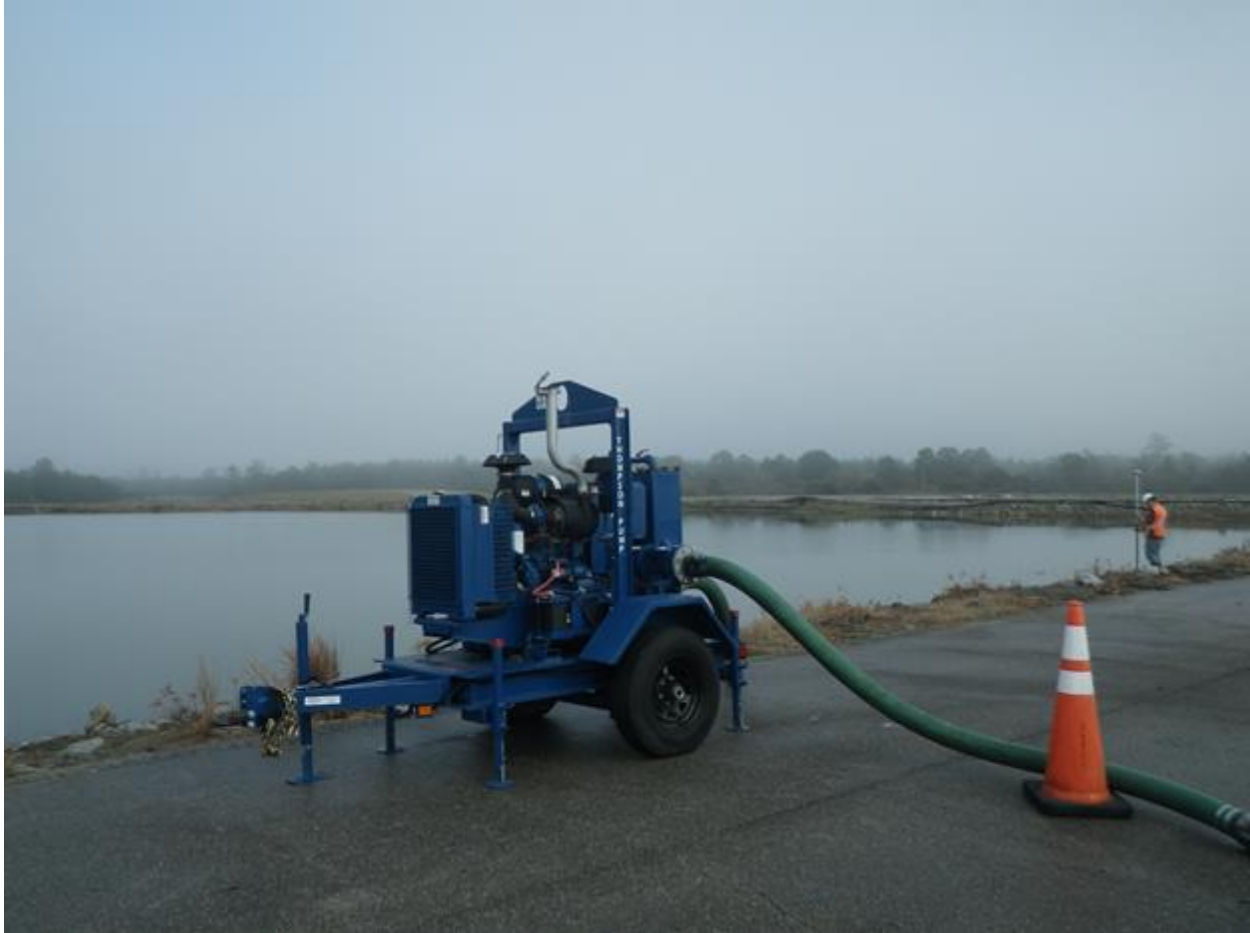
Other than the operation of an external pump to move decant water from Ash Cell #1 to Pump Back Cell #1 (as a result of the inoperative butterfly valve located in the culvert that connects these ponds) as shown in Figure 5, no visible signs of distress or malfunction of the CCR unit or appurtenant structures were

observed at the time of the inspection. An additional discussion concerning this inoperative valve is provided in the Summary of Deficient Conditions section.

**Figure 5. Mobile Pump Transporting Decant Water from Ash Cell #1 to Pump Back Cell #1**

As noted previously, the inoperative butterfly valve which controls the gravity discharge of decant water from Ash Cell #1 to Pump Back Cell #1 has had an active work order in effect since the day the condition was first observed (i.e., 26 October 2015). This valve is critical to the operation of the CCR surface impoundment system and GRU personnel are currently working to repair/replace this valve. GRU has installed a diesel-powered pump to move water from this ash pond to the corresponding pumpback pond. IWCS recommends that GRU complete this repair as soon as possible.

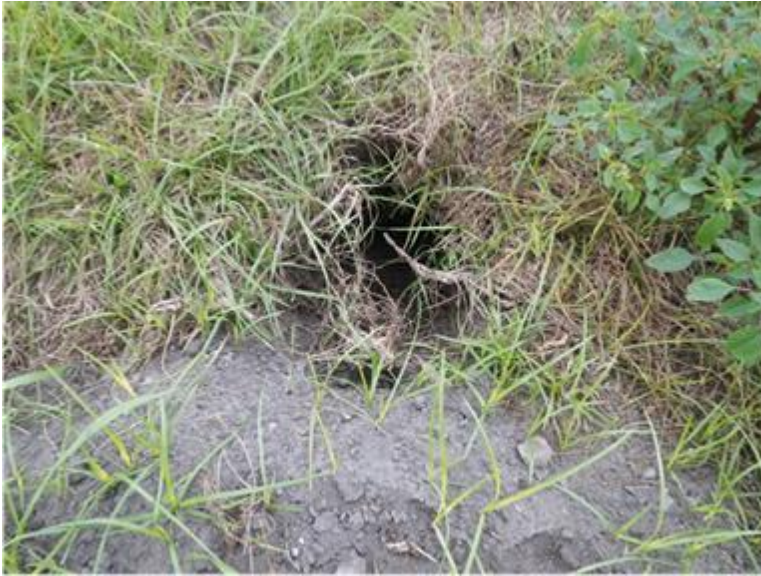
IWCS performed a visual inspection of all exterior slopes of the CCR landfill for any appearance of actual or potential structural weakness including signs of erosion; bulging; depressions; cracks; animal burrows; boils; or excessive, turbid, or sediment-laden seepage. A number of animal burrows were observed on the external southern slope and the southern portion of the external western slope. An example of one of these burrows is depicted in Figure 6.

**Figure 6. Animal Burrow Located on Landfill Southern Exterior Side Slope**

IWCS flagged all animal burrows and brought them to the attention of GRU personnel on 14 January 2016. We recommend that GRU both relocate resident animal(s) and backfill these burrows in accordance with federal, state, and local law.

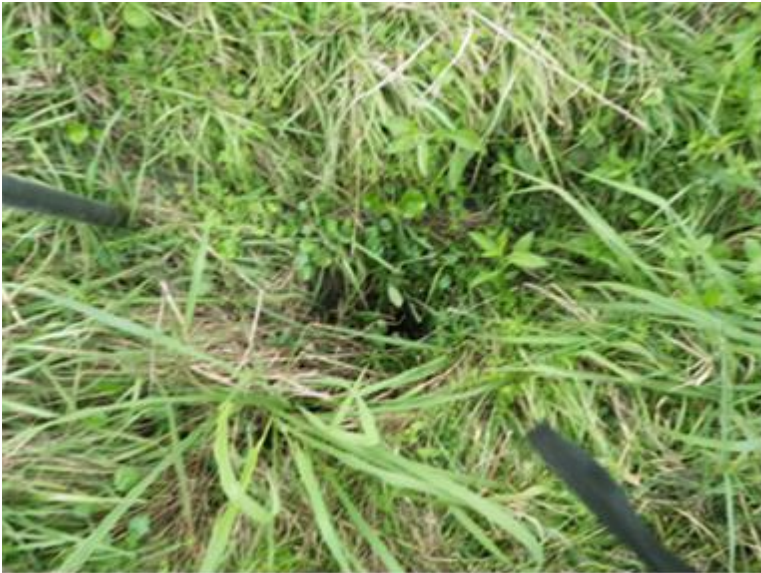
A heavily occluded culvert was observed which routes stormwater from a ditch (located on the eastern side of Cell 4) to the stormwater pond located southeast of the landfill. Figures 7 and 8 show images of what appear to be the inlet and outlet locations, respectively, of this culvert.

**Figure 7. Inlet Location of Occluded Stormwater Culvert**

IWCS notified GRU of an occluded stormwater culvert located near the southeast corner of Cell 4 on 14 January 2016. While the vegetation covering the stormwater culvert inlet and outlet is not currently resulting in ponded conditions at the culvert inlet, IWCS recommends that GRU clear the vegetation around the culvert inlet and outlet to improve its capacity.

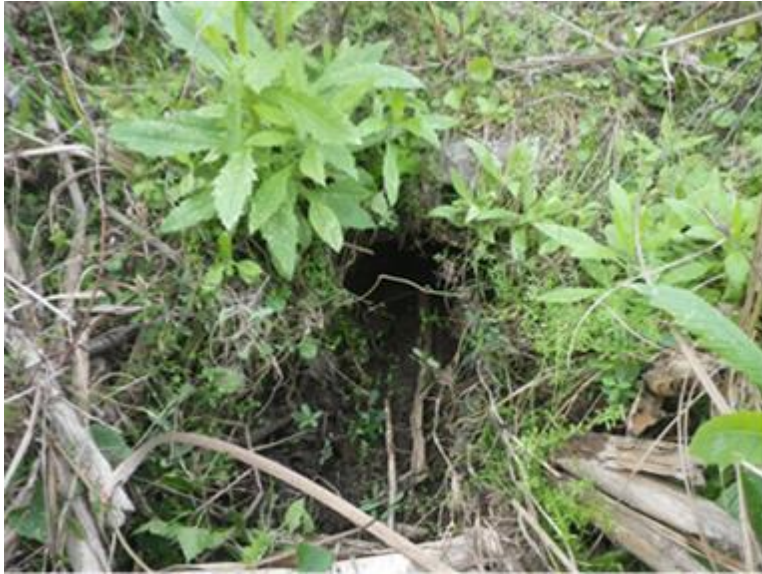
**Figure 8. Outlet Location of Occluded Stormwater Culvert**
