# **Gainesville Regional Utilities Deerhaven Generating Station**

## **Coal Combustion Residual Units Annual Inspection Report (January 9, 2016 – December 15, 2016)**

**Innovative Waste Consulting Services, LLC  
6628 NW 9<sup>th</sup> Blvd, Ste. 3  
Gainesville, Florida 32605**

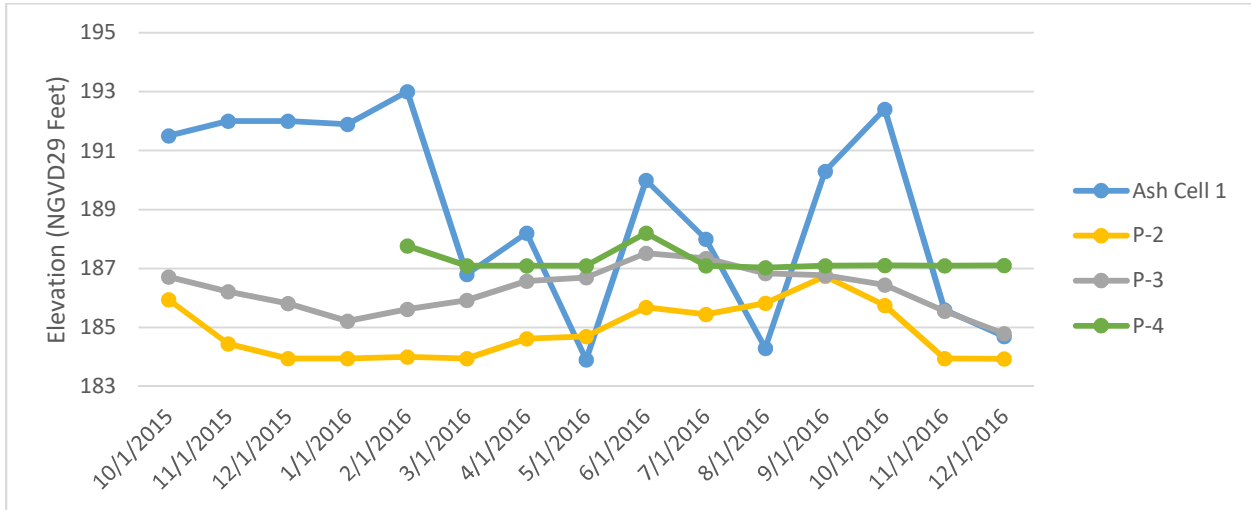
**Figure 3. Liquid Elevations for Ash Cell #1 and Piezometers**

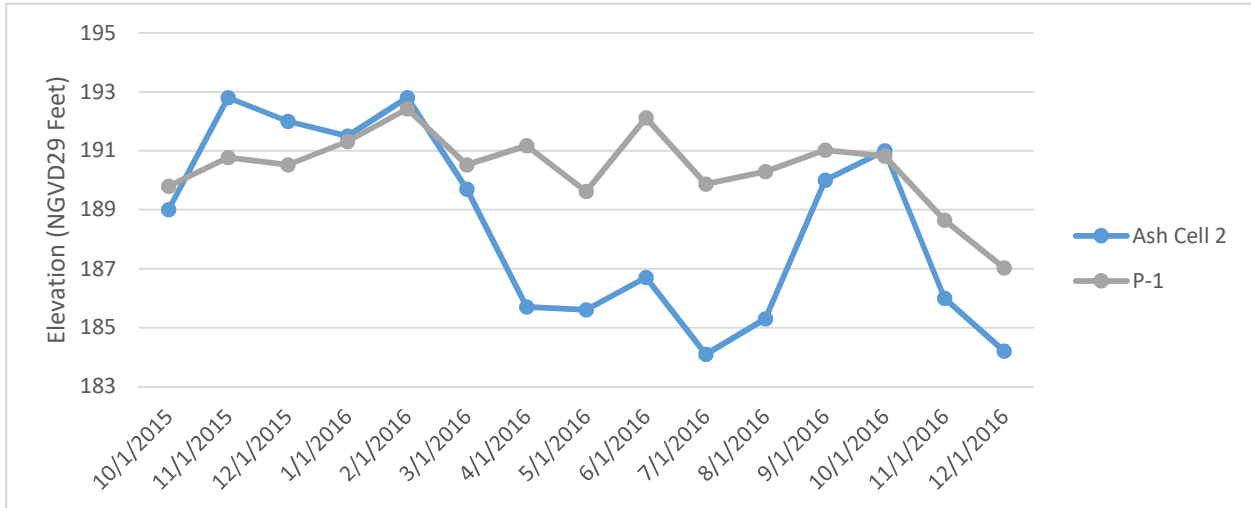
**Figure 4. Liquid Elevations for Ash Cell #2 and Piezometer**

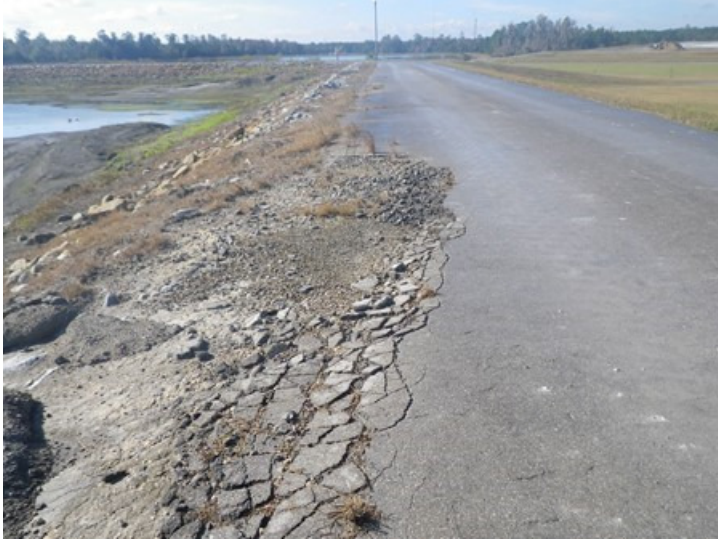
Light pavement damage was apparent on the inside of the road that runs over the outer embankment near the northern corner Ash Cell #1, as shown in Figure 5. No additional visible signs of distress or malfunction of the CCR unit or appurtenant structures were observed at the time of the inspection.

**Figure 5. Pavement Damage on the Inside Edge of the Road on the Northern Corner of Ash Cell #1**

The damaged pavement located on the outer embankment of Ash Cell #1 was discussed with GRU personnel on 15 December 2016.

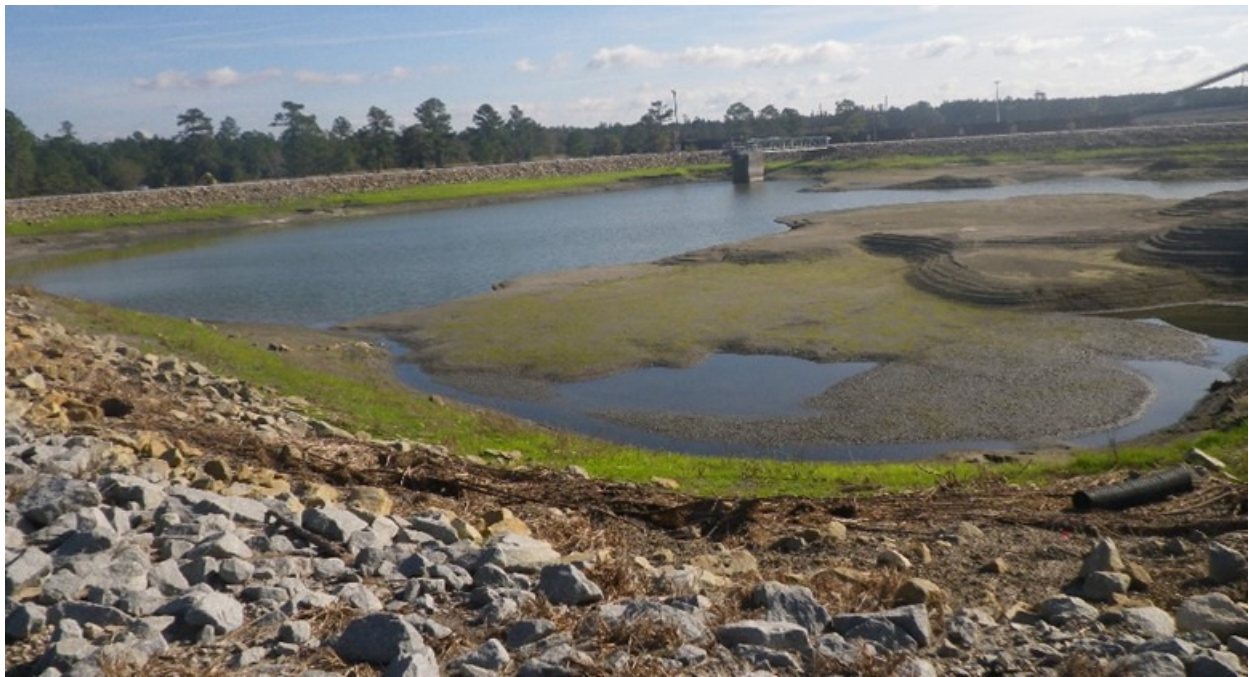
A large fraction of the CCR surface in the ash ponds was inundated at the time of this inspection (as depicted for Ash Cell #2 in Figure 6); the current storage capacity of the CCR unit was not estimated. However, based on construction records, it is estimated that the CCR surface impoundment system has a total volumetric capacity of 17.3 million gallons (or approximately 85,400 cubic yards) with 2 feet of freeboard.

**Figure 6. Variable CCR Surface in Ash Cell #2**

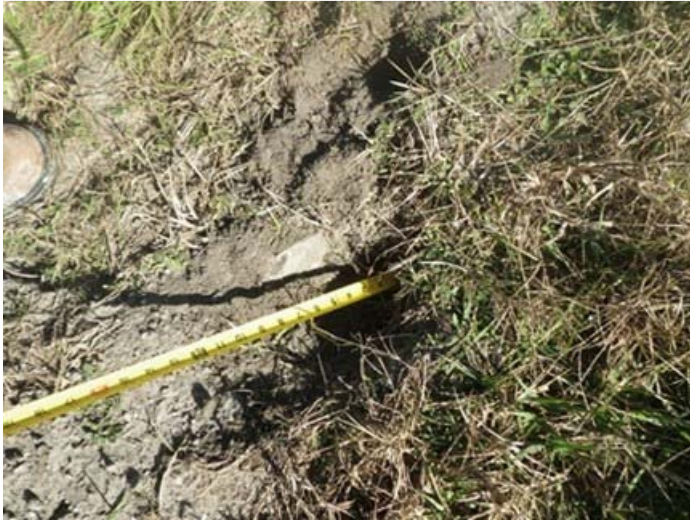
worms/grubs – see Figure 7 for an example of these diggings. These surficial diggings do not appear to be indicative of structural weakness.

**Figure 7. Surficial (<8 Inches Deep) Animal Digging Found on External Western Side Slope**

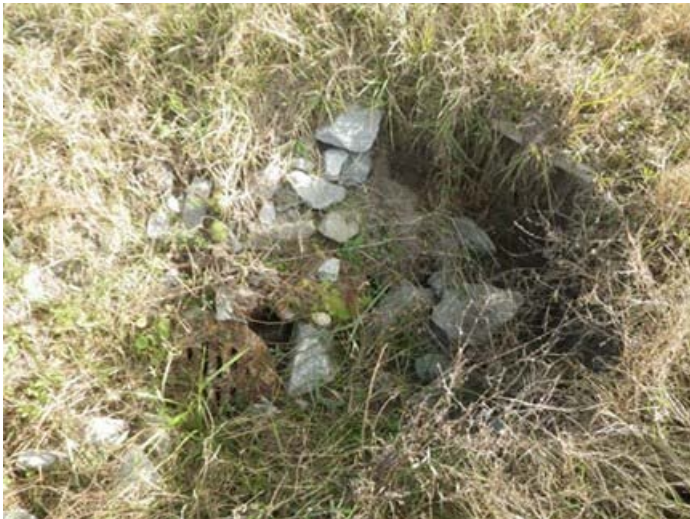
- 6) **Damaged Stormwater Culvert (1 instance)** – a corrugated metal stormwater culvert located in the southeast corner of the landfill was observed to be severely corroded. This culvert

transports stormwater collected in a shallow north-south oriented ditch located along the eastern side of the landfill to a stormwater pond located to the southeast of the landfill. Currently, the catchment basin for this ditch is relatively small. Plans to repair this culvert pipe were made prior to the annual inspection and are scheduled for January 2017.

**Figure 8. Inlet Location of Damaged Stormwater Culvert**

GRU currently has the materials to conduct the repair of the damaged stormwater culvert; this task is scheduled for January 2017.

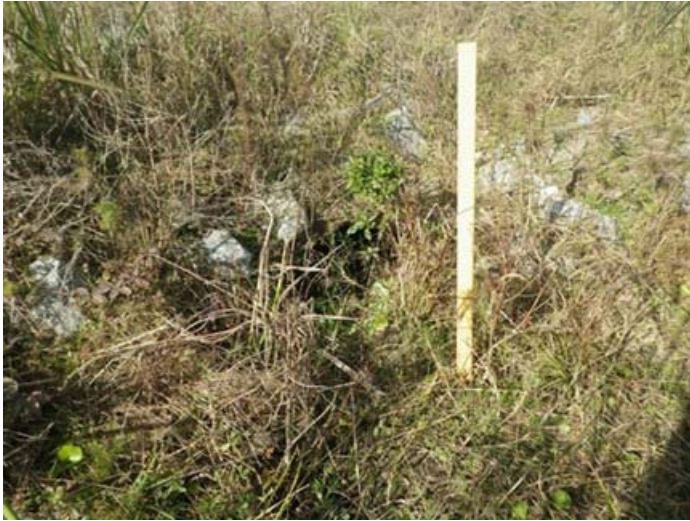
**Figure 9. Outlet Location of Damaged Stormwater Culvert**
