Gainesville Regional Utilities Deerhaven Generating Station

2019 Coal Combustion Residual Units Annual Inspection Report (Reporting Period: 13 December 2018 – 10 December 2019)

Innovative Technical Solutions
3720 NW 43rd Street, Ste. 103
Gainesville, Florida 32606

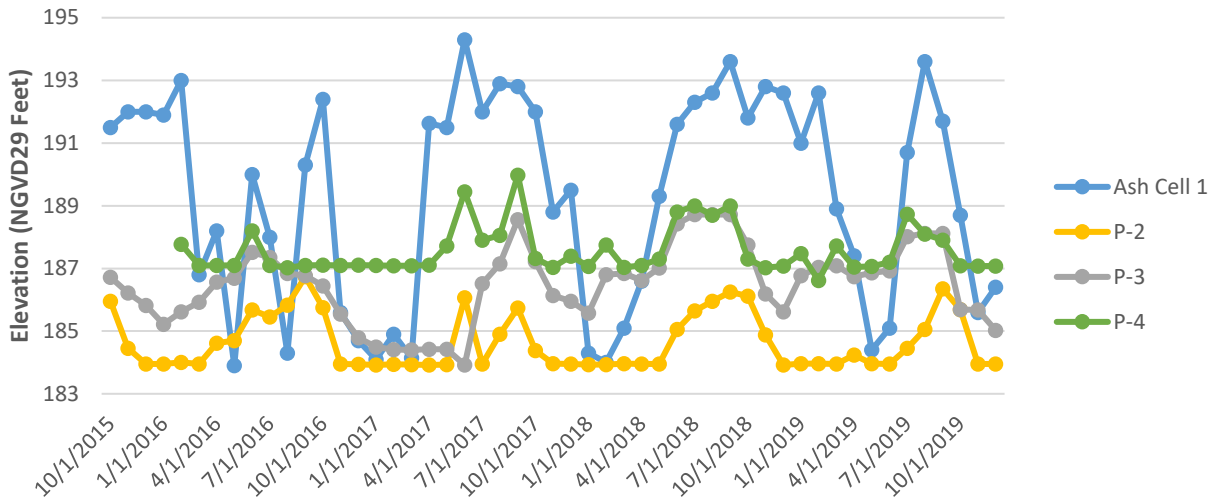
For Ash Cell#1, the first occurrence of elevated water levels was reported on 7/16/2019 due to pump issues. Although the pumps were fixed in the same week, water levels in ash pond #1 continued to remain above the normal maximum operating level until 8/5/2019 due to the loss of the brine concentrator and heavy rains. The second incidence of elevated water levels occurred from 8/12/2019 to 8/26/2019 due to rain and elevated blowdown of the cooling tower to control the chemical balance of water in the systems.

Figure 3. Liquid Elevations for Ash Cell #1 and Piezometers

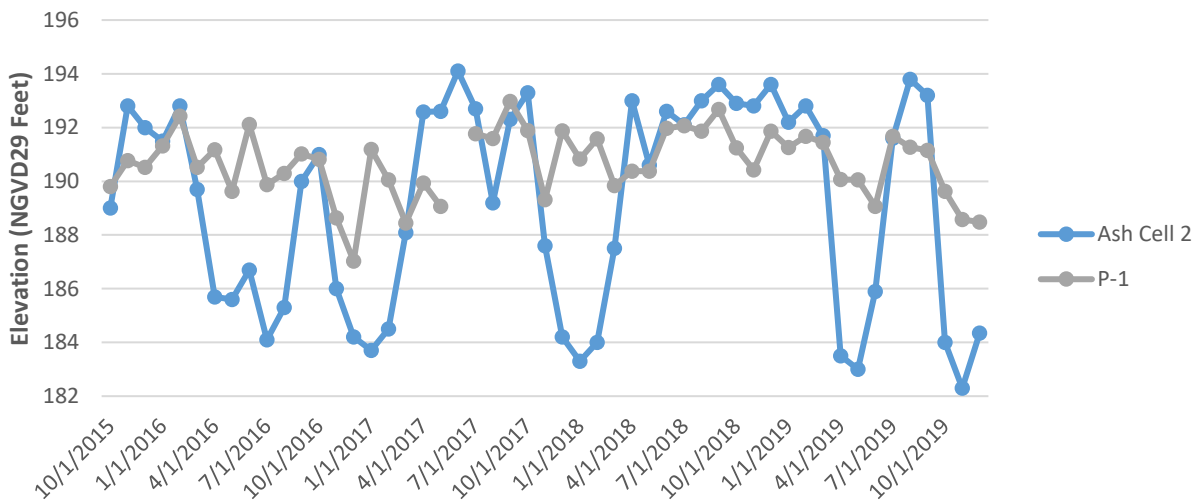
For Ash Cell#2, the first incidence of elevated water levels was reported on 12/17/2018 due to Unit 2 air heater washing. The second incidence of elevated water levels was reported 7/16/2019 due to pump issues. The pump was fixed in the same week and water levels were brought down to normal operating conditions. The water elevation was below 193 ft in the subsequent weekly inspection for both these occasions. The third period of elevated water levels was observed from 8/5/2019 to 9/16/2019 and was caused by a combination of heavy rains, loss of the brine concentrator and heavy blowdown of cooling towers to control chemical balance of water in the systems.

Figure 4. Liquid Elevations for Ash Cell #2 and Piezometer

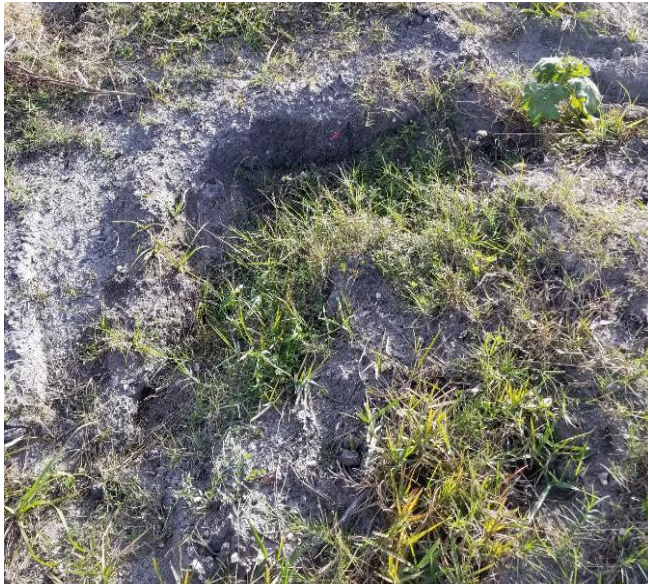
The Northern Drainage Ditch accepts CCR contact water from the landfill and gravity drains to a pump station located at its eastern extent. As shown in Figure 5, soil erosion was observed around the south-east corner of the Northern Drainage Ditch. The erosion appears to have been caused by stormwater runoff. If not remediated, this area will continue to erode.

Figure 5. Erosion around the south-east corner of the Northern Ditch

1. GRU should consider jet cleaning the underdrains to ensure the freeflow of contact water from the landfill into the Northern Drainage Ditch.
2. GRU should stabilize the southeast corner of the Northern Drainage Ditch, where erosion was observed. Vegetation must be established to avoid erosion in the future.
3. The vegetation around the inlets and outlets of all downcomers and culverts should be trimmed to ensure the freeflow of stormwater.
4. Loose soil surrounding the Cell 2 downcomer inlet should be compacted and stabilized with vegetation.
5. GRU should stabilize the area surrounding the LF-3 groundwater well concrete pad, where erosion was observed. Vegetation must be established to avoid further erosion.

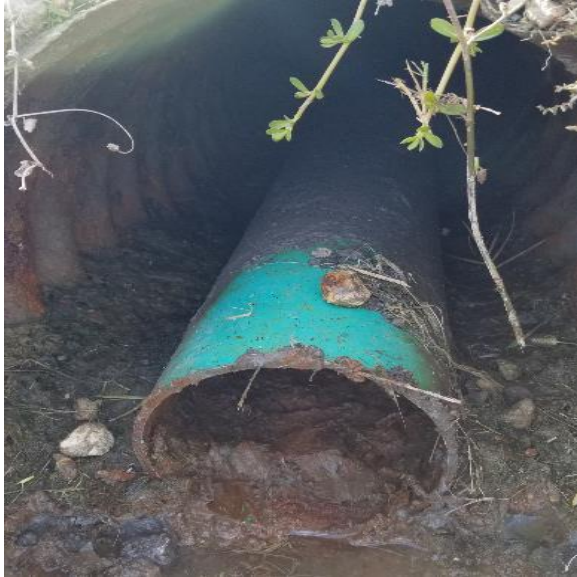
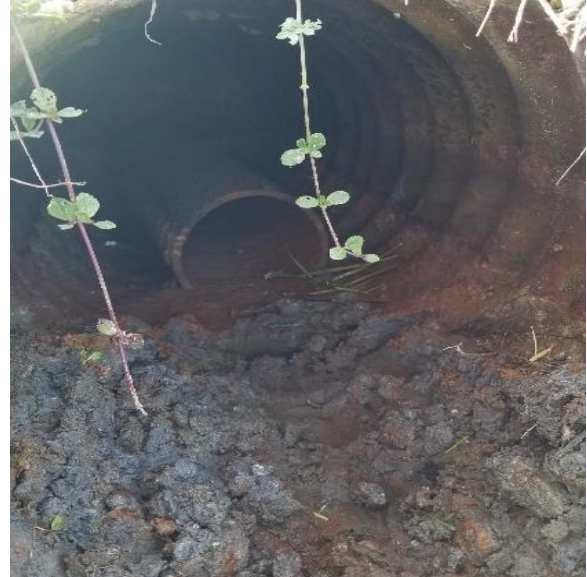
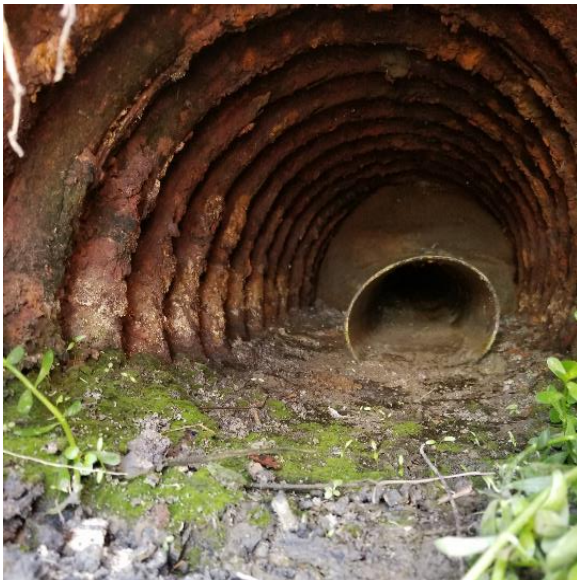
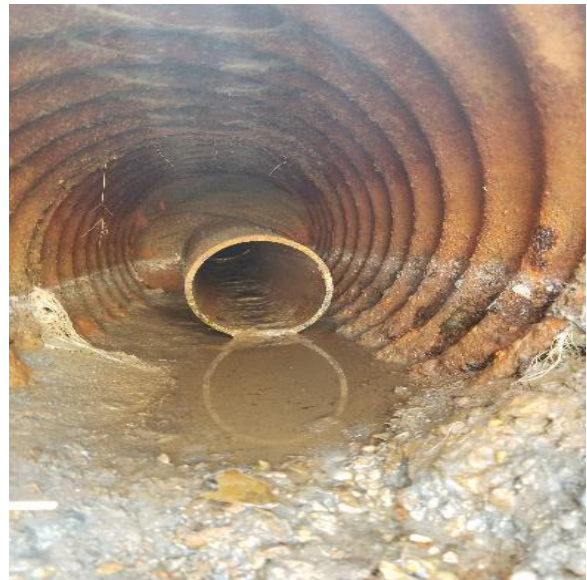
All underdrains (Cells 1, 2, 3, and 4) were observed to have accumulated sediment (Figure 6). These underdrains route the contact water accumulated on the landfill bottom to the Northern Drainage Ditch. Sediment built-up in the underdrains will obstruct the flow of contact water, which may lead to water build-up in the landfill, which, in turn, may cause seepages and slope stability issues.

Figure 6. Sediment build-up in underdrain of (a) Cell 1, (b) Cell 2, (c) Cell 3, and (d) Cell 4

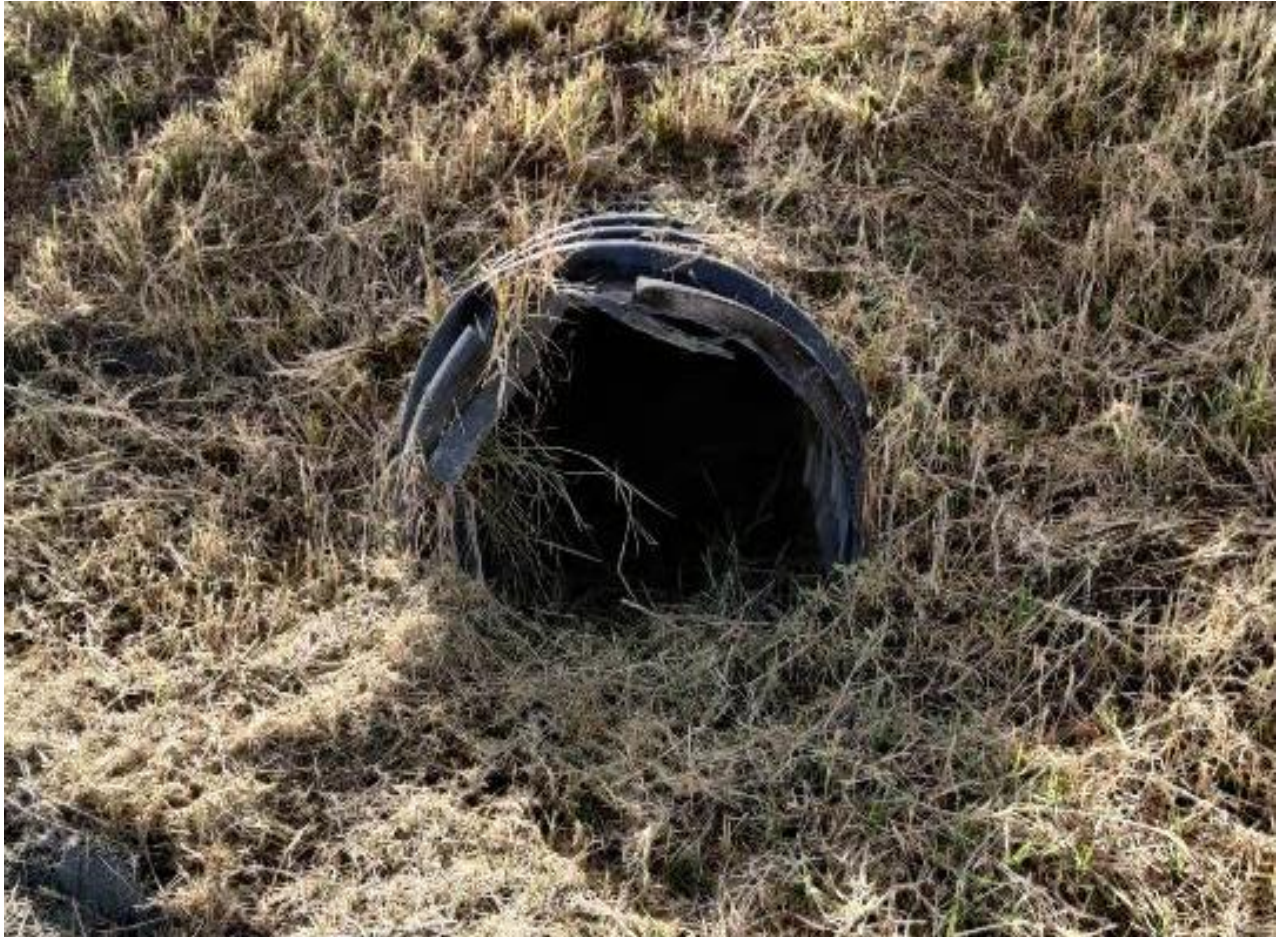
Thick vegetation built-up was observed around the Cell 4 culvert outlet (Figure 7). This culvert conveys contact water from Cell 4 area to the swale located northeastern toe of the landfill. Thick vegetation was also observed around the inlets of Cells 3/4 culverts that drain into the Northern Drainage Ditch (Figure

Figure 7. Thick vegetation around the Cell-4 culvert outlet

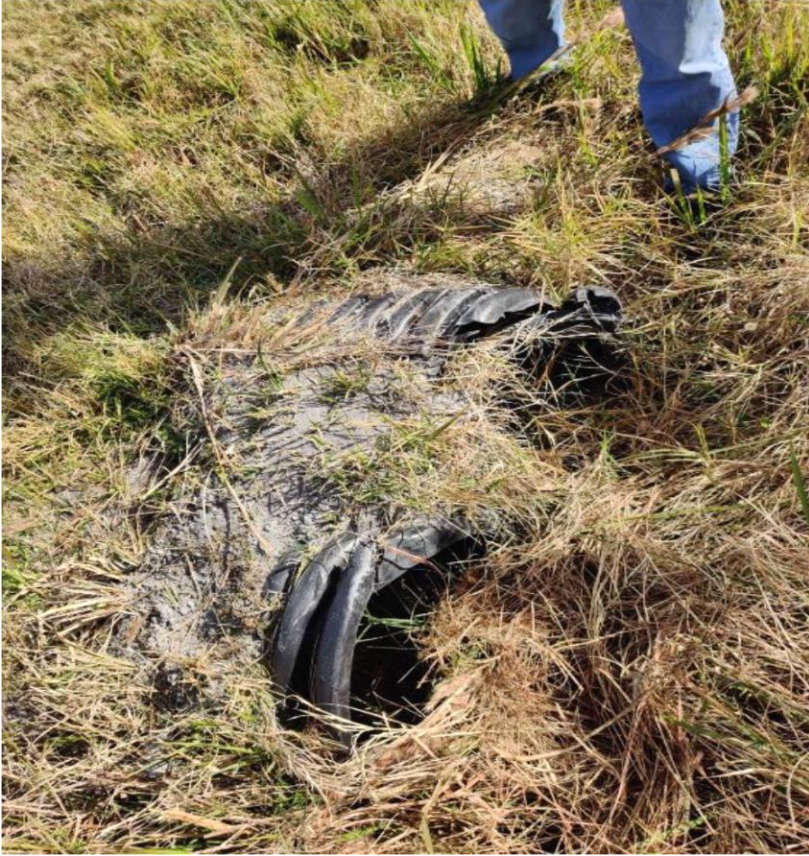
8). The presence of thick vegetation around the culverts outlets or inlets would impede the flow of stormwater/contact water and may lead to water accumulation on the toe of the cell and/or the area between the culverts.

Figure 8. Thick vegetation around the Cells 3 and 4 culvert inlets

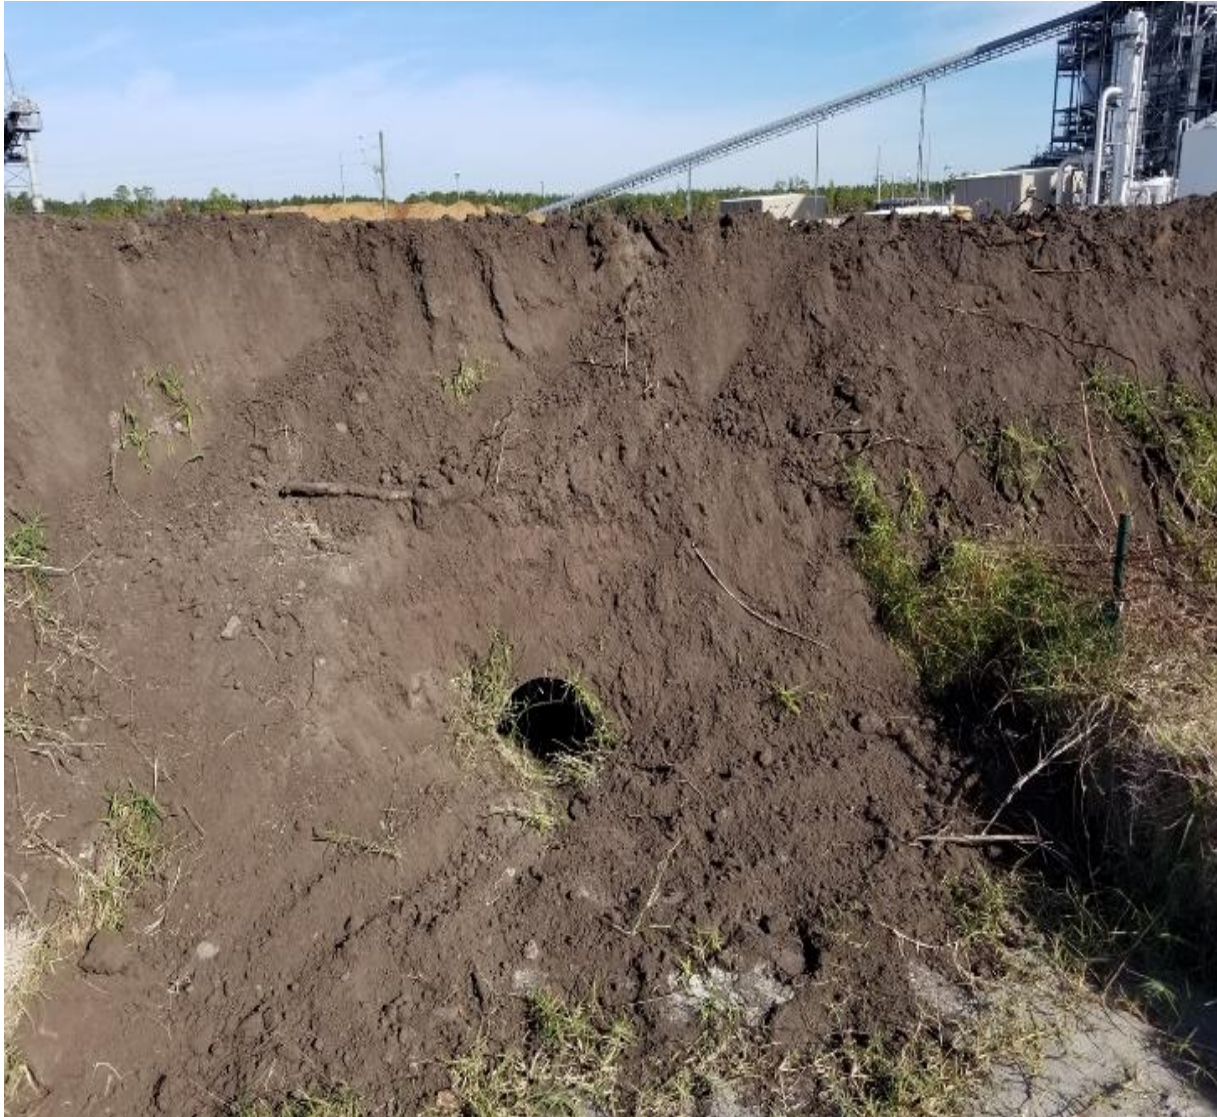
The Cell 2 downcomer inlet was observed to be surrounded by the topsoil applied to the newly constructed peripheral berm of the Cells 1 and 2 (Figure 9). Loose soil around the downcomer inlet would build-up in the downcomers and/or may discharge into the Northern Drainage Ditch, reducing its capacity.

Figure 9. Cell 2 downcomer inlet surrounded by soil

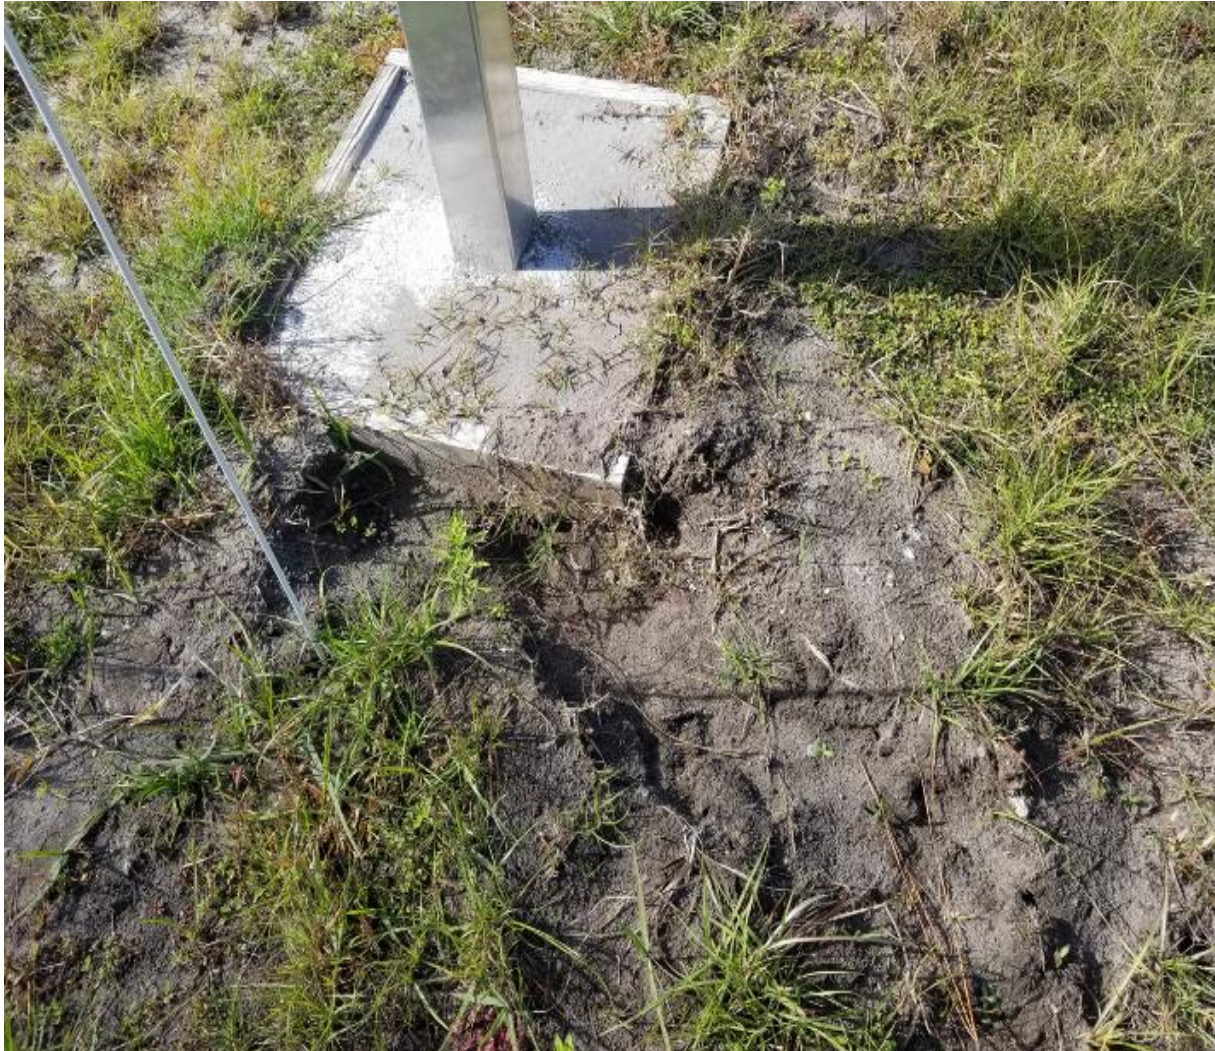
Erosion was observed around one of the groundwater well (LF-3) concrete pad (Figure 10). Erosion of soil under and around the groundwater well may result in more soil erosion, and water accumulation around the well.

Figure 10. Erosion around LF-3's concrete pad

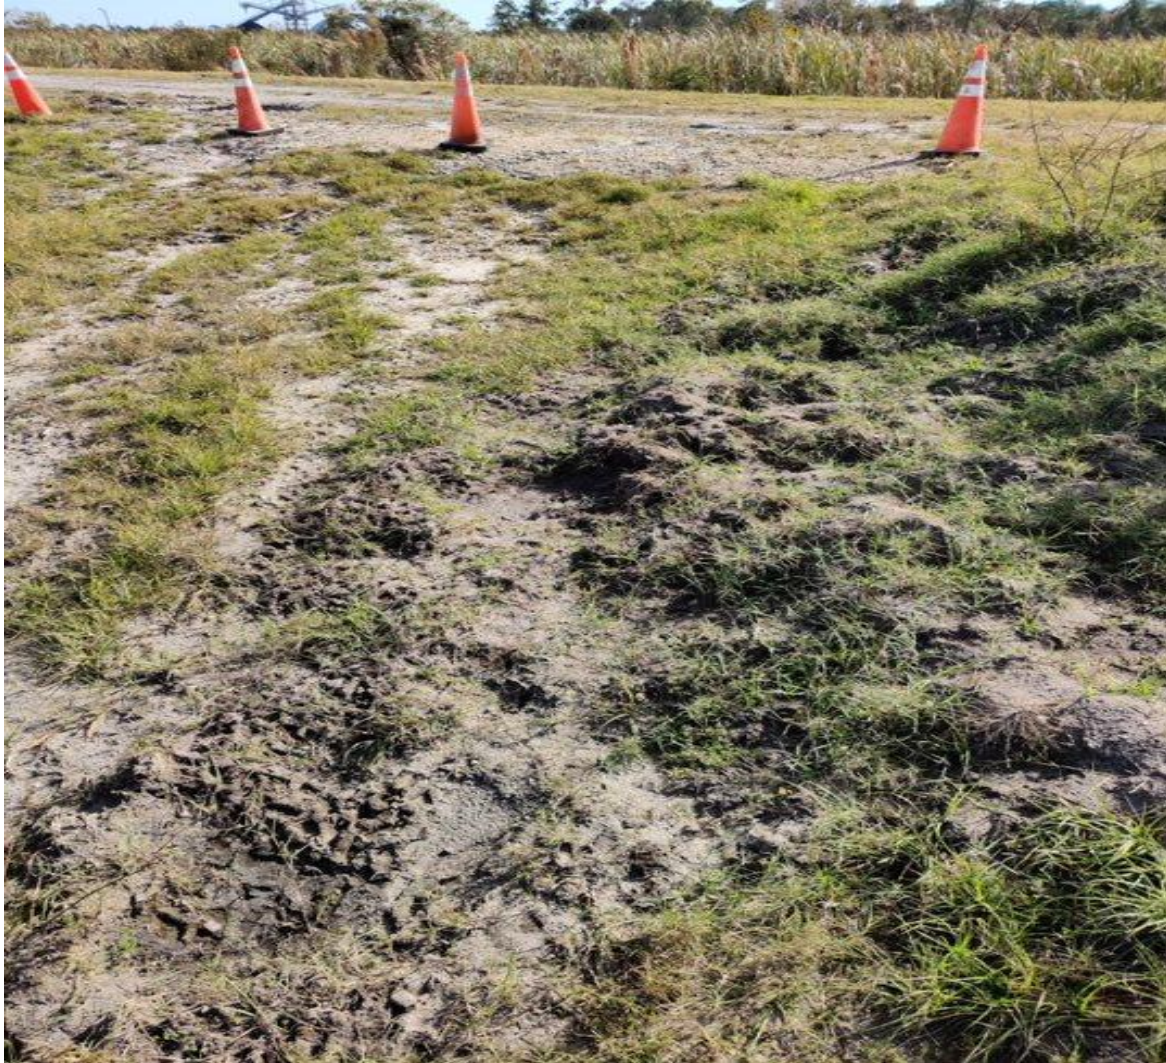
Several bare soil patches were observed in the southeast section of the peripheral stormwater channel of the CCR landfill was observed. Based on the observation recorded on the weekly inspection worksheets, these appear to be caused by feral hogs (Figure 11). These patches should be repaired and vegetated immediately to avoid erosion.

Figure 11. An example of a bare soil patch observed in the southeast corner of the stormwater channel

6. Bare soil patches observed in the southeast corner of the peripheral stormwater channel should be leveled and seeded to stabilize these areas.
7. GRU should consider removing the sediments from the southeastern stormwater culvert to minimize sediment migration and deposition into the stormwater pond.

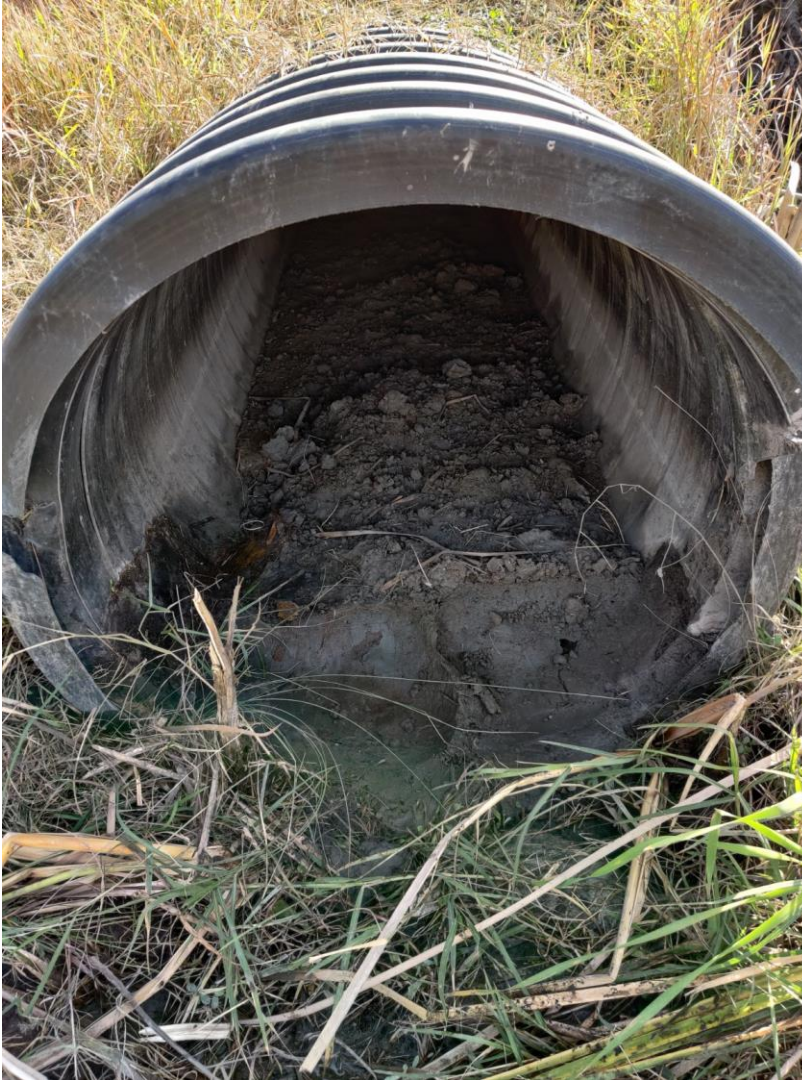
Sediment accumulation was observed for one of the stormwater culverts located in the southeast corner of the landfill (Figure 12). With the installation of a new culvert, the run-off carrying capacity of two culverts is more than the estimated peak flow. The observed sediment accumulation is not expected to have a significant impact on the performance of the stormwater management system. The accumulated sediments, if not removed, would migrate and deposit into the stormwater pond. GRU should consider removing the sediments to minimize sediment migration and deposition into the stormwater pond.

Figure 12. Sediments accumulation in one of the culverts located in the southeast corner of the landfill
