Corrective Measures to Address Deficiencies Noted in the Coal Combustion Residuals Units Annual Inspection Report

**(Annual inspection covering the period from December 13, 2018 – December 10,
2019)**

Table 1. Remedies Taken to Address Deficiencies Noted in the 2019 CCR Units Annual Inspection Report

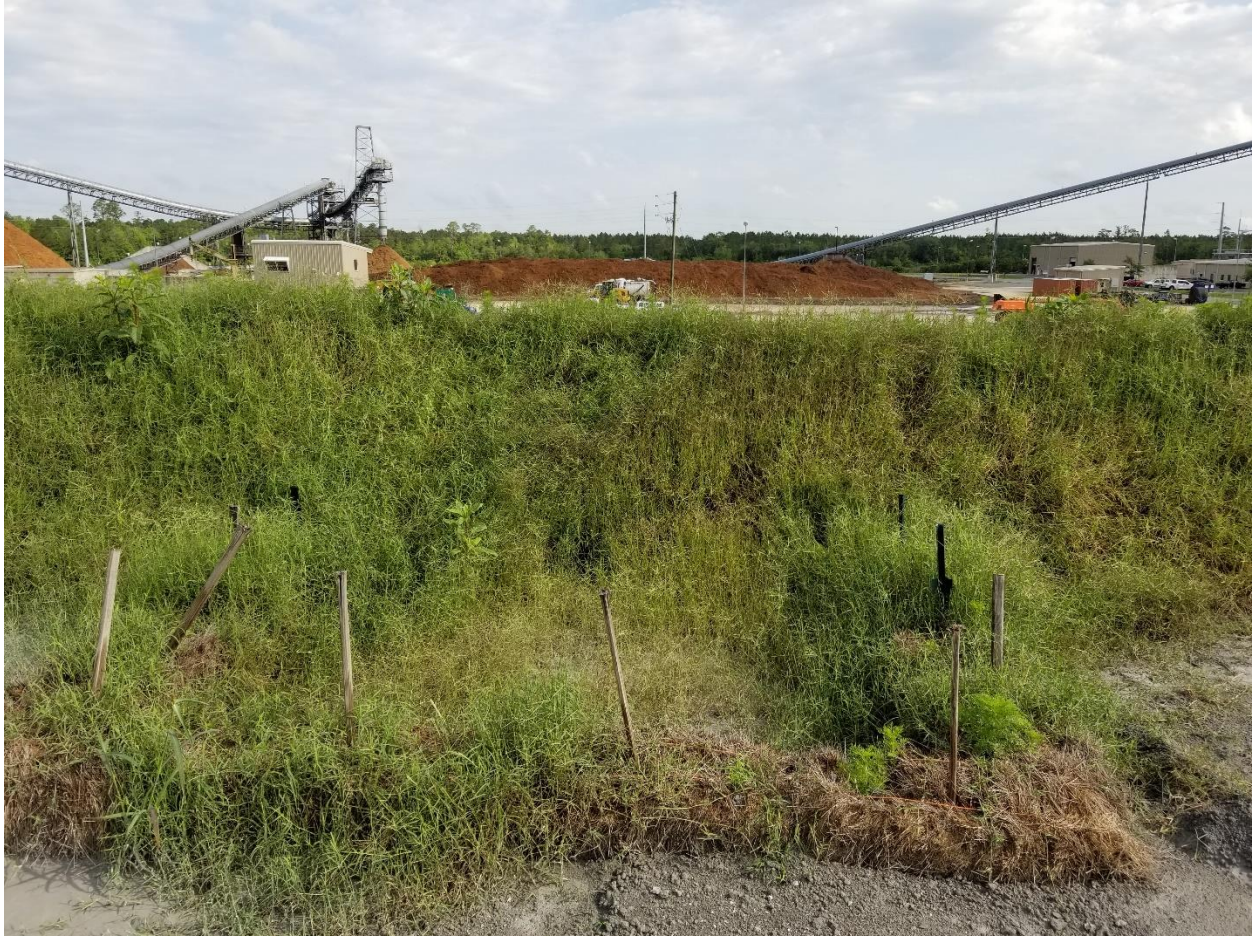
Figure C-1. Well-Established Vegetation Around Cell 2 Downcomer Inlet as Observed on 04/16/2020

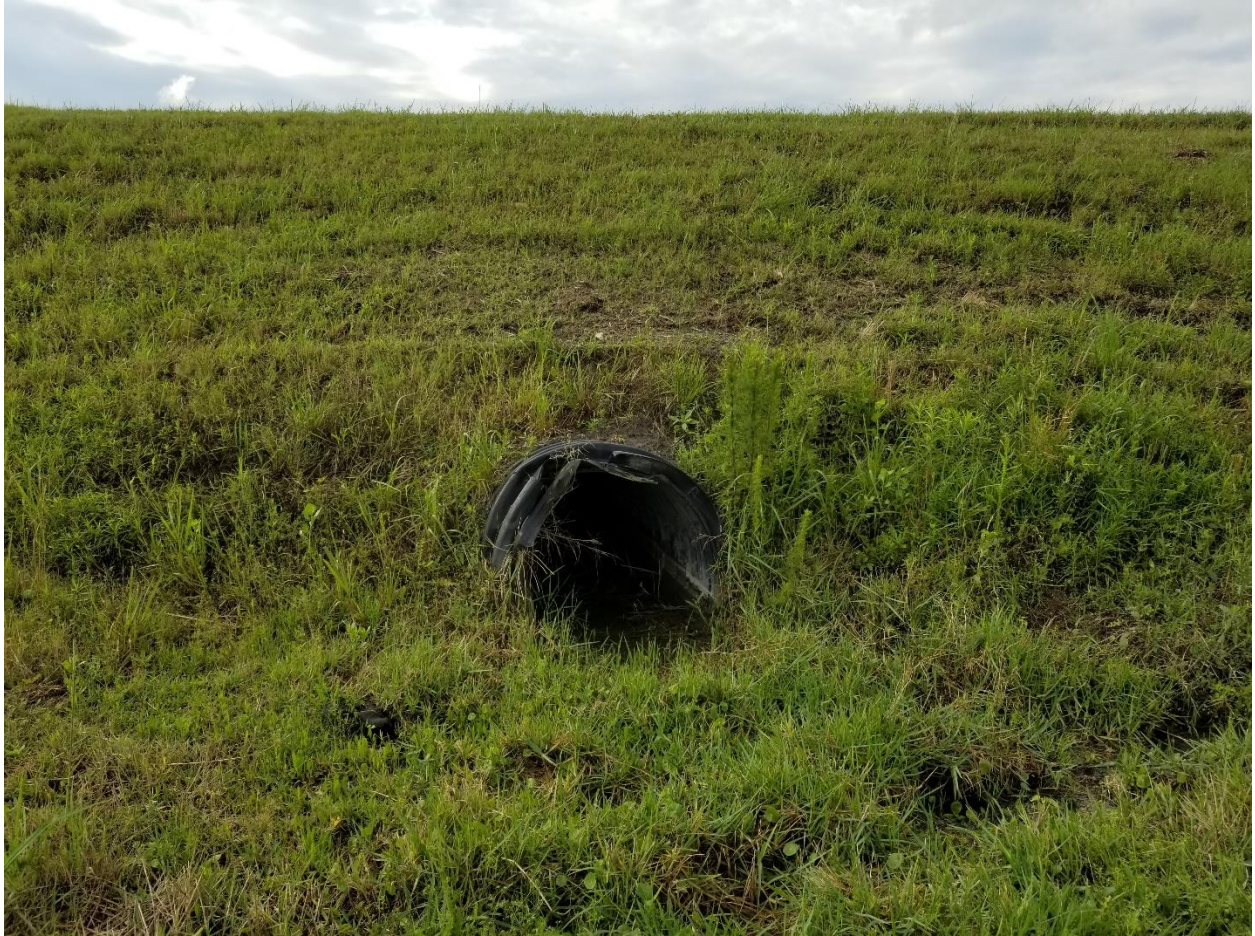
Figure C-2. Well-Maintained Vegetation Height around Cell 4 Culvert Outlet as Observed on 04/16/2020

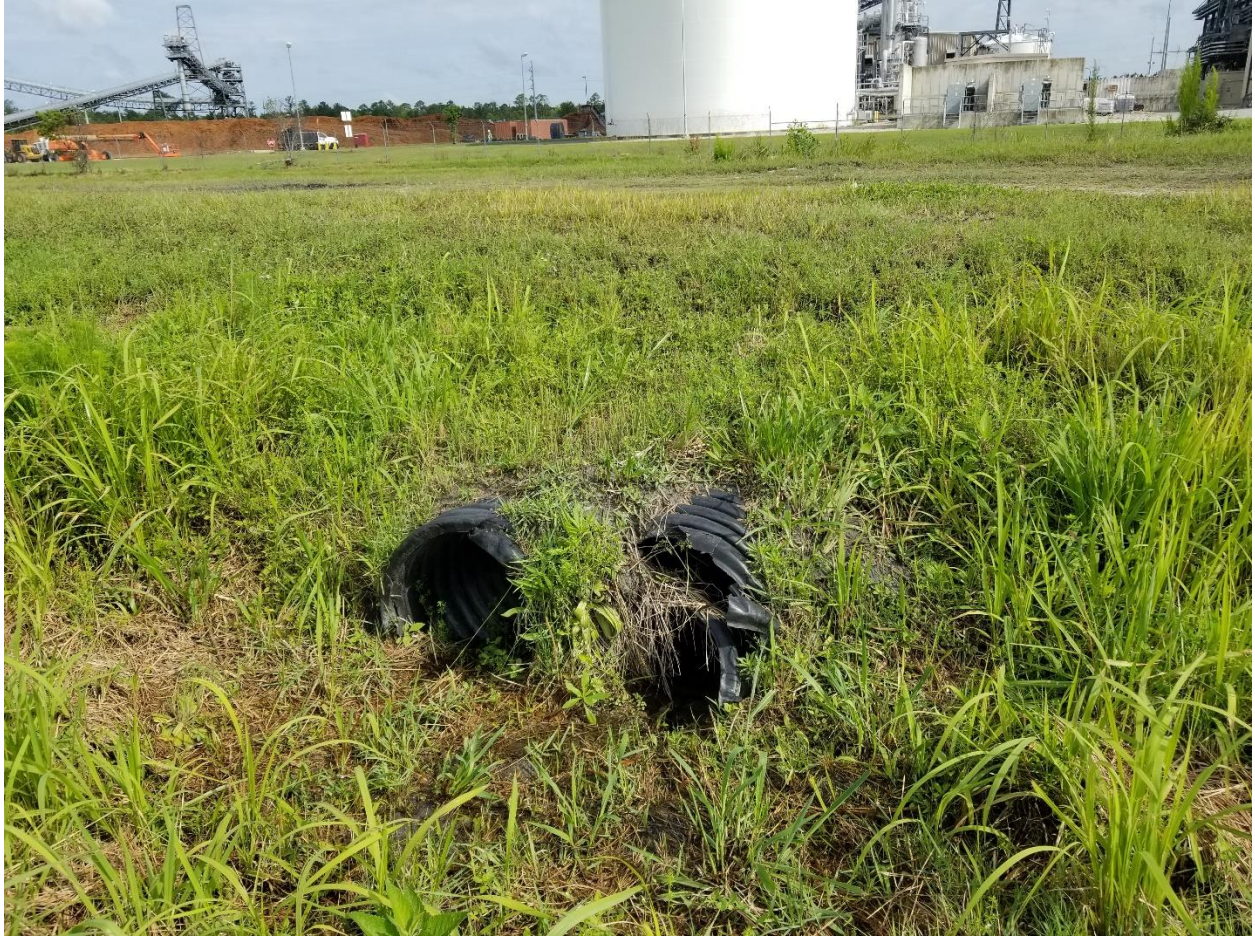
Figure C-3. Well-Maintained Vegetation Height around Cell 3 Culverts Inlet as Observed on 04/16/2020

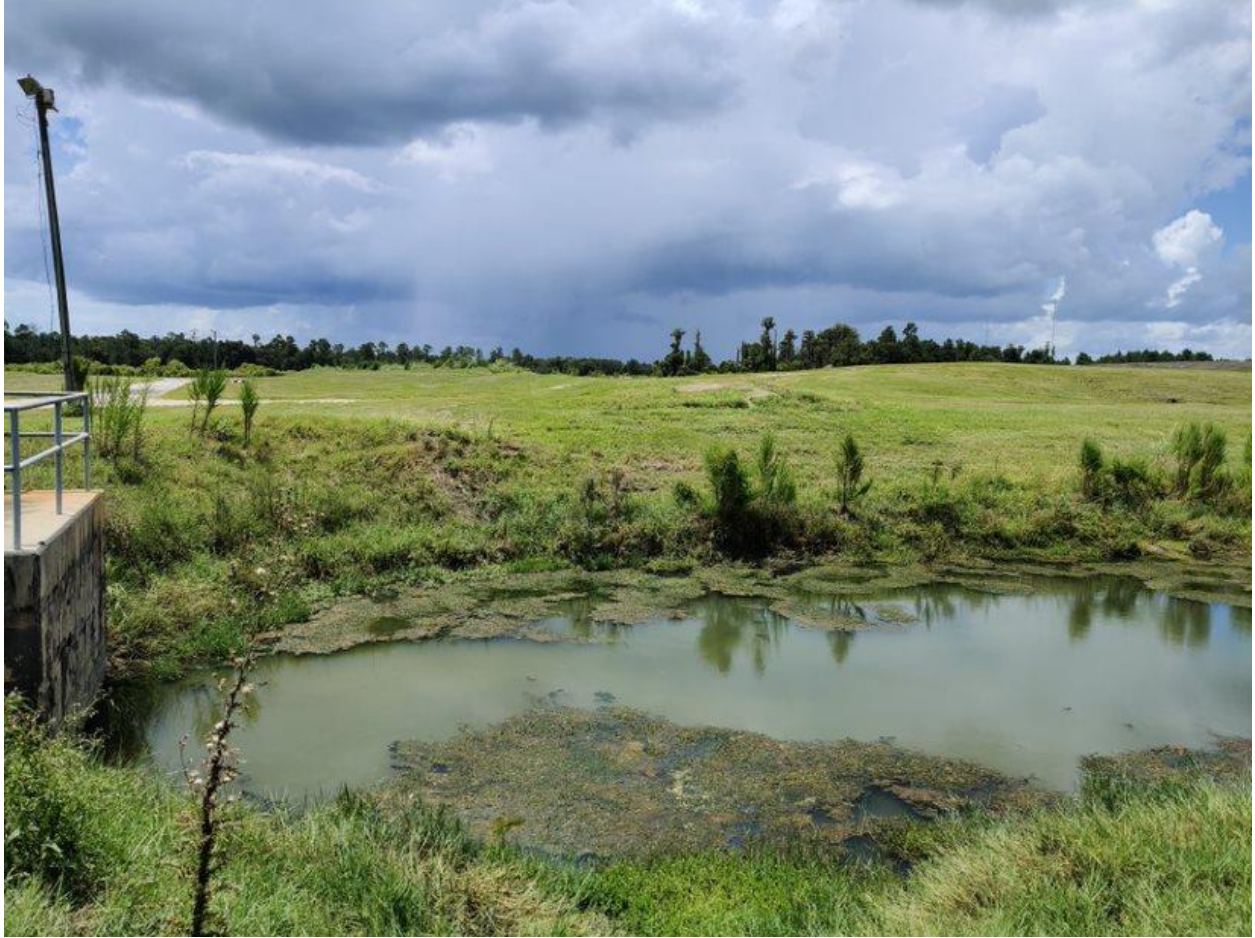
Figure C-4. Well-Maintained Vegetation at the Southeast Corner of Northern Drainage Ditch as Observed on 07/22/2020

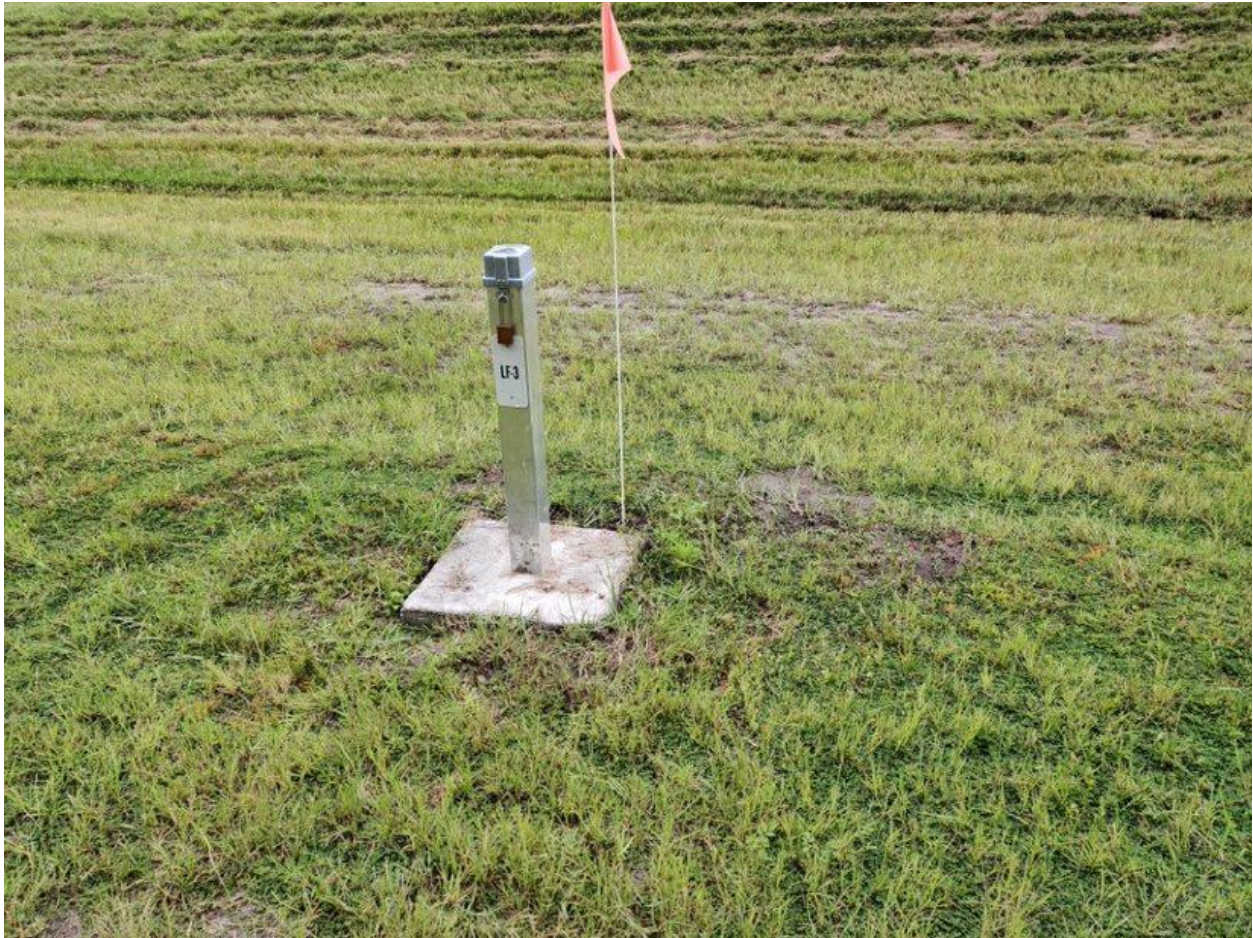
Figure C-5. Well-Maintained Vegetation around LF-3's Concrete Pad as Observed on 07/22/2020

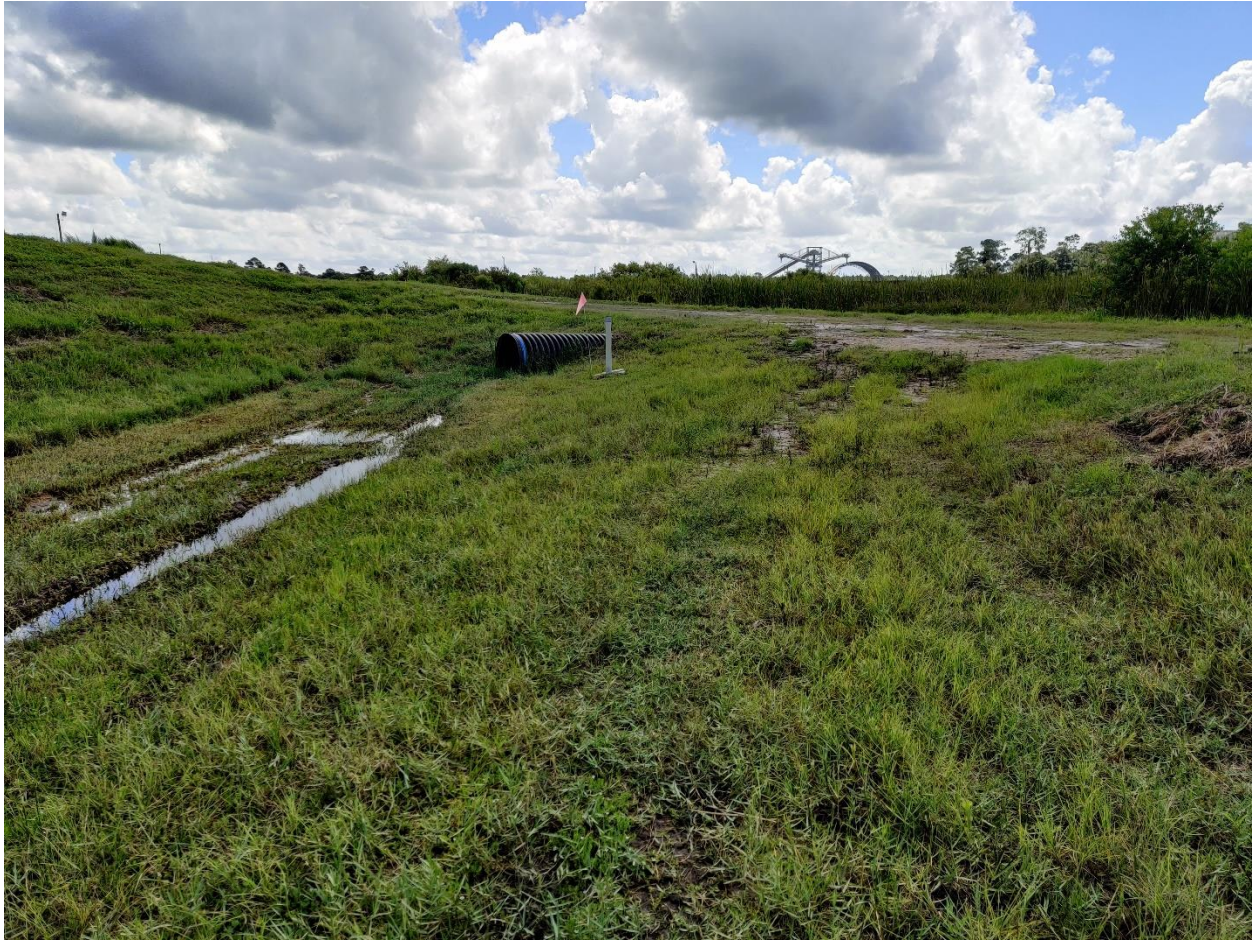
Figure C-6. Well-Maintained Vegetation at the Southeast Corner of the Peripheral Stormwater Channel as Observed on 07/22/2020
