Gainesville Regional Utilities Deerhaven Generating Station

Coal Combustion Residual Units Annual Inspection Report (11 December 2019 – 10 December 2020)

Innovative Technical Solutions
3720 NW 43rd Street, Ste. 103
Gainesville, Florida 32606

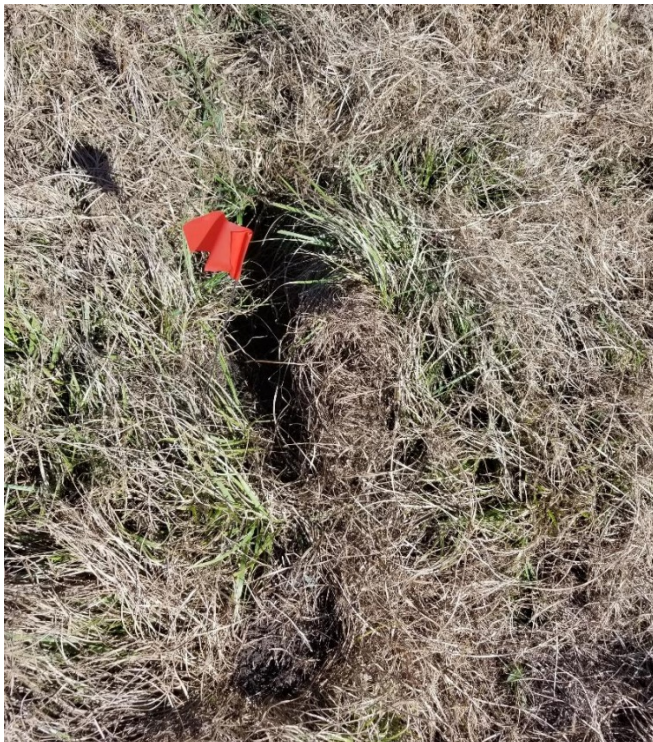
ITS visually inspected the external side slopes of the surface impoundment system and the pump back cells to identify any potential indicators of structural weakness or any other adverse condition including signs of erosion; bulging; depressions; cracks; animal forage holes; boils; or excessive, turbid, or sediment-laden seepage. One animal forage hole was found on the external slopes of the surface impoundment system. Figure 5 shows the animal forage hole found during the annual inspection process; the forage hole was approximately 4-6 inches wide and 10-12 inches deep.

Figure 5. Forage Hole Observed on External Slope of the Surface Impoundment System

1. GRU should relocate resident animal(s) (if any) and backfill the animal forage hole in accordance with federal, state, and local law.
2. GRU should mow/trim the grass and ensure it is not taller than 6 inches. ITS recommends GRU to keep the external slopes of CCR units clear of cut grass.

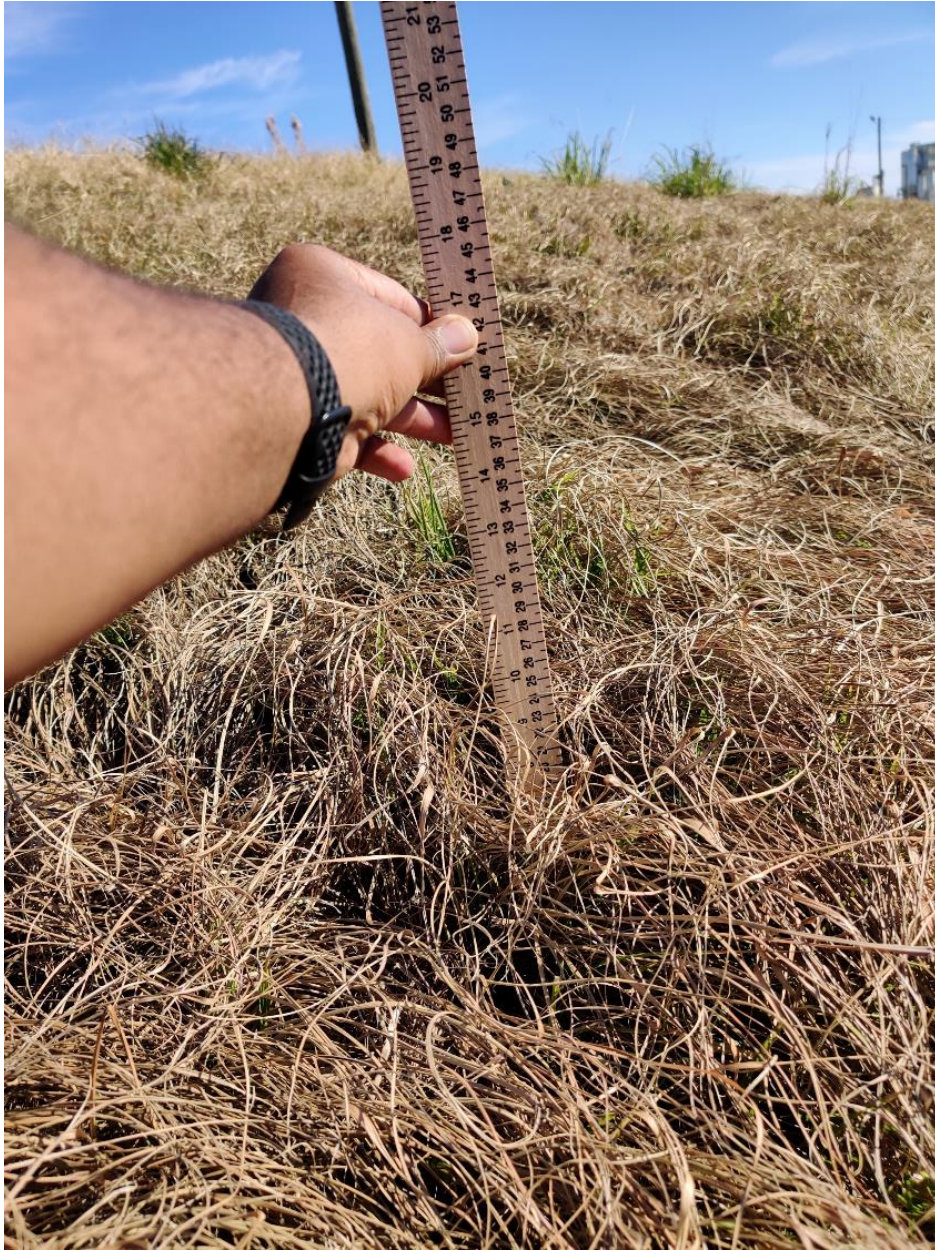
The height of grass on 11 December 2020, on the southern and western slopes of the surface impoundment system was found to be greater than the maximum 6-inch requirement (§257.74(d)(iv)). Additionally, the presence of previously cut grass on the side slopes of the impoundment system was noticed. As shown in Figure 6, the height of grass was approximately 8-9 inches. Figure 7 shows the grass clippings build-up on the side slopes of the impoundment system. Grass greater than 6 inches tall or the accumulation of grass clippings on the side slopes of the impoundment can conceal conditions such as animal burrows, erosion rills, and seeps that impact the structural integrity of the impoundment embankments.

Figure 6. Grass Height Greater than 6 inches Observed on External Slopes of the Surface Impoundment System

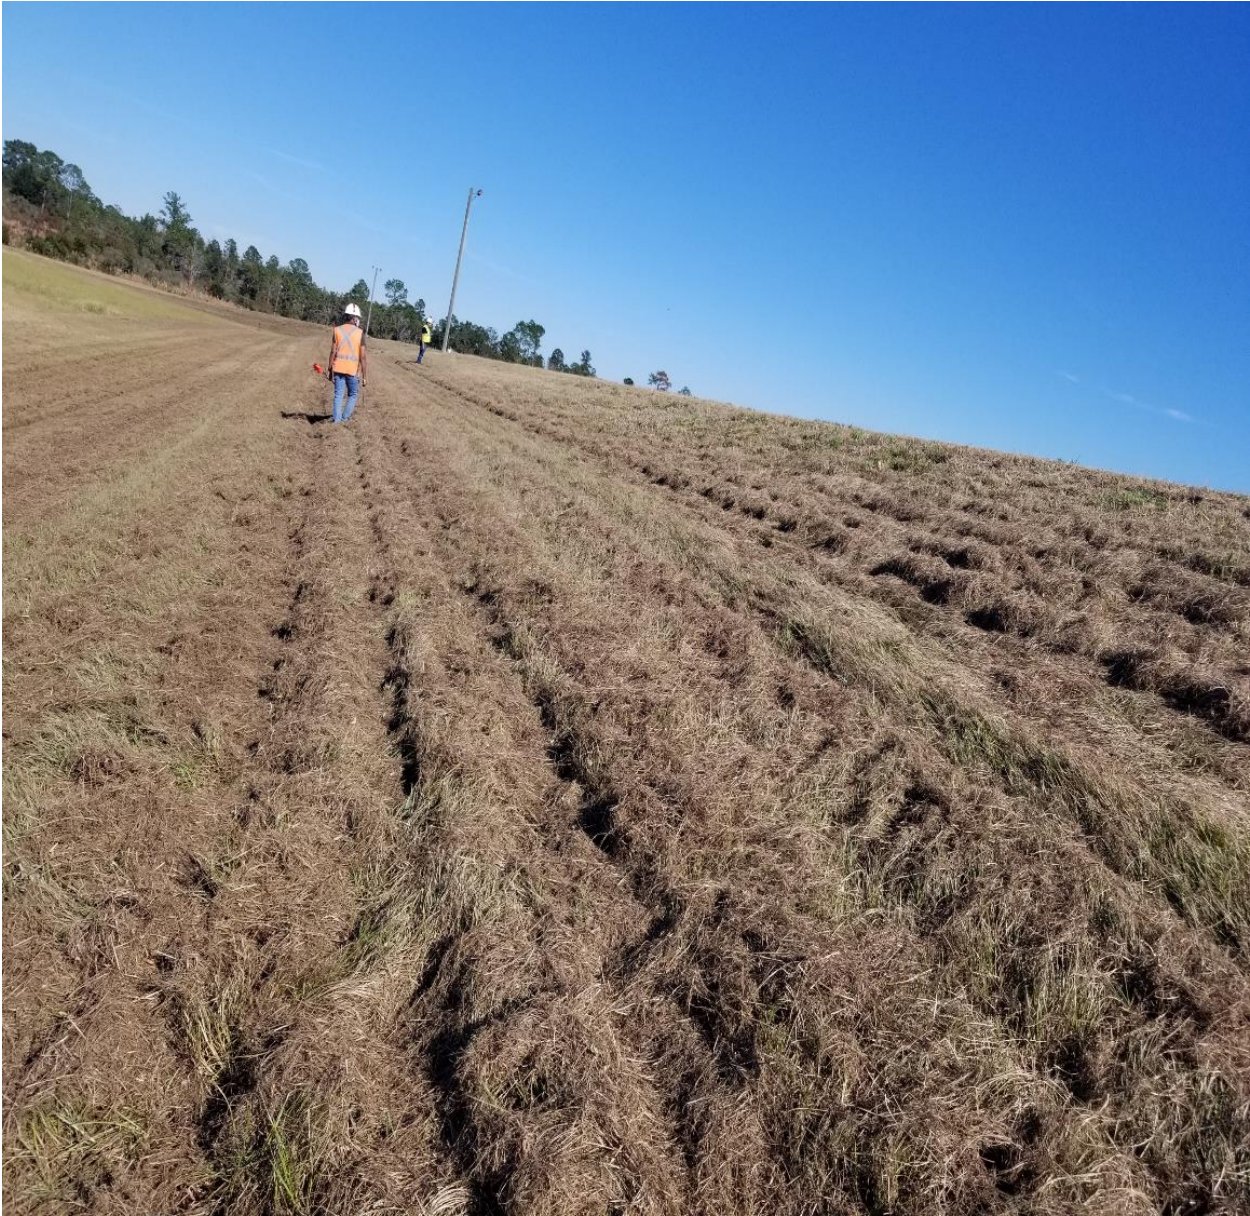
Figure 7. Accumulated Grass Clippings Observed on the External Side Slopes of the Surface Impoundment System

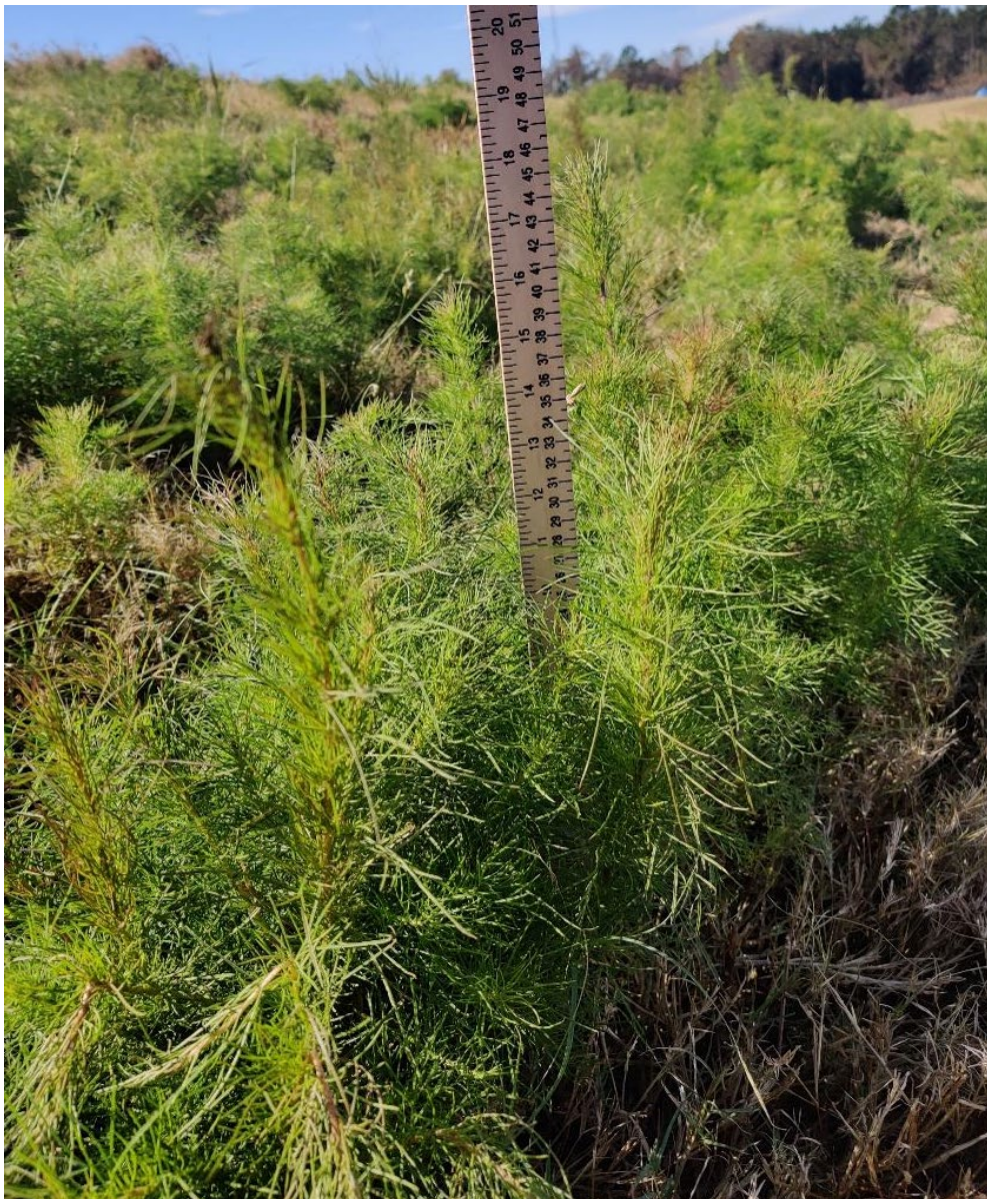
Patches of weeds taller than 6 inches were observed on the northern slopes of CCR Landfill on 10 December 2020. Vegetation taller than 6 inches tall on the side slopes can conceal conditions such as animal burrows, erosion rills, and seeps that impact the structural integrity of the landfill side slopes. As shown in Figure 8, the height of weeds was approximately 10-11 inches. Figure 9 shows the patches of weeds on the northern slope of the CCR Landfill.

Figure 8. Weed Height Greater than 6 inches Observed on Northern Slope of the CCR Landfill

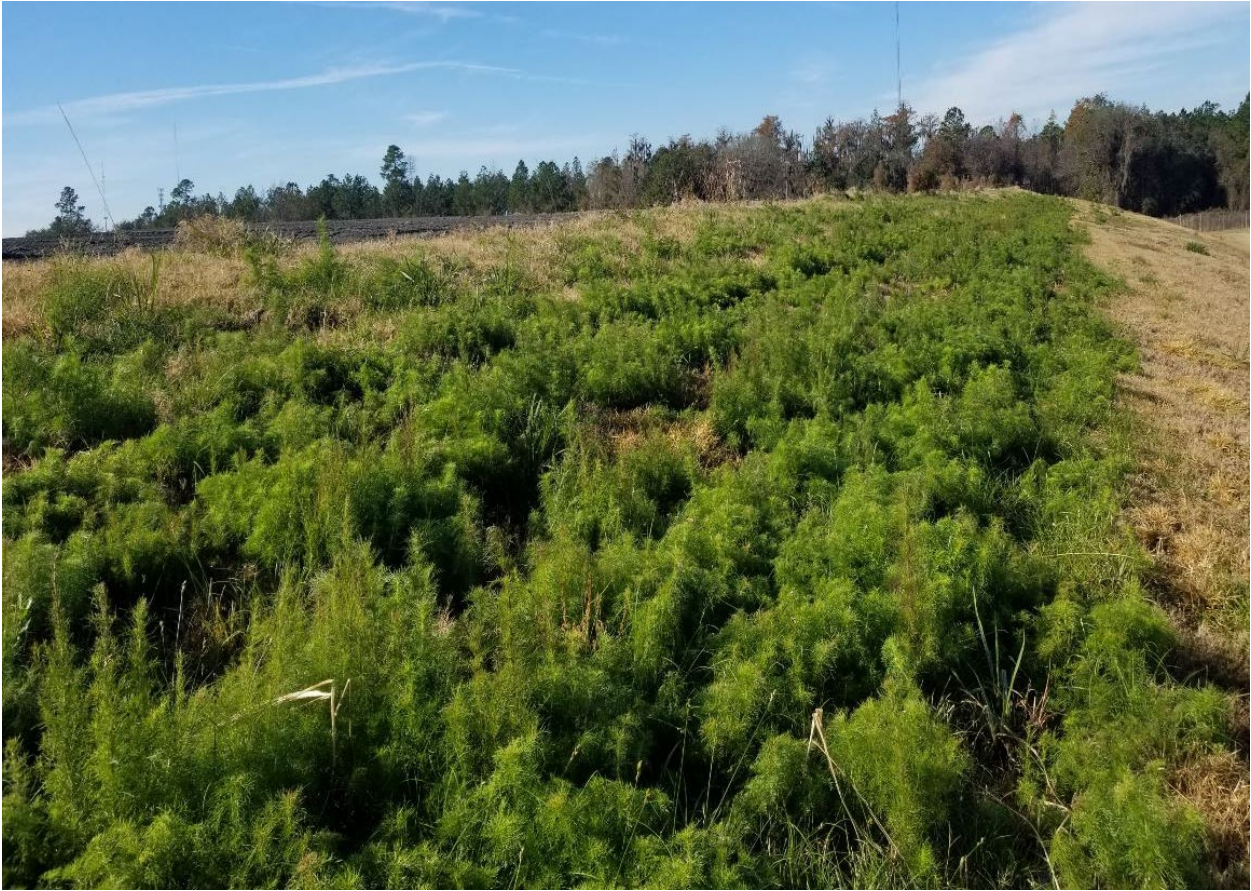
Figure 9 Patches of Tall Weeds on the Northern Slope of CCR Landfill
