## **Corrective Measures to Address Deficiencies Noted in the Coal Combustion Residuals Units Annual Inspection Report**

**(Annual inspection covering the period from December 11, 2021 – December 10,  
2022)**

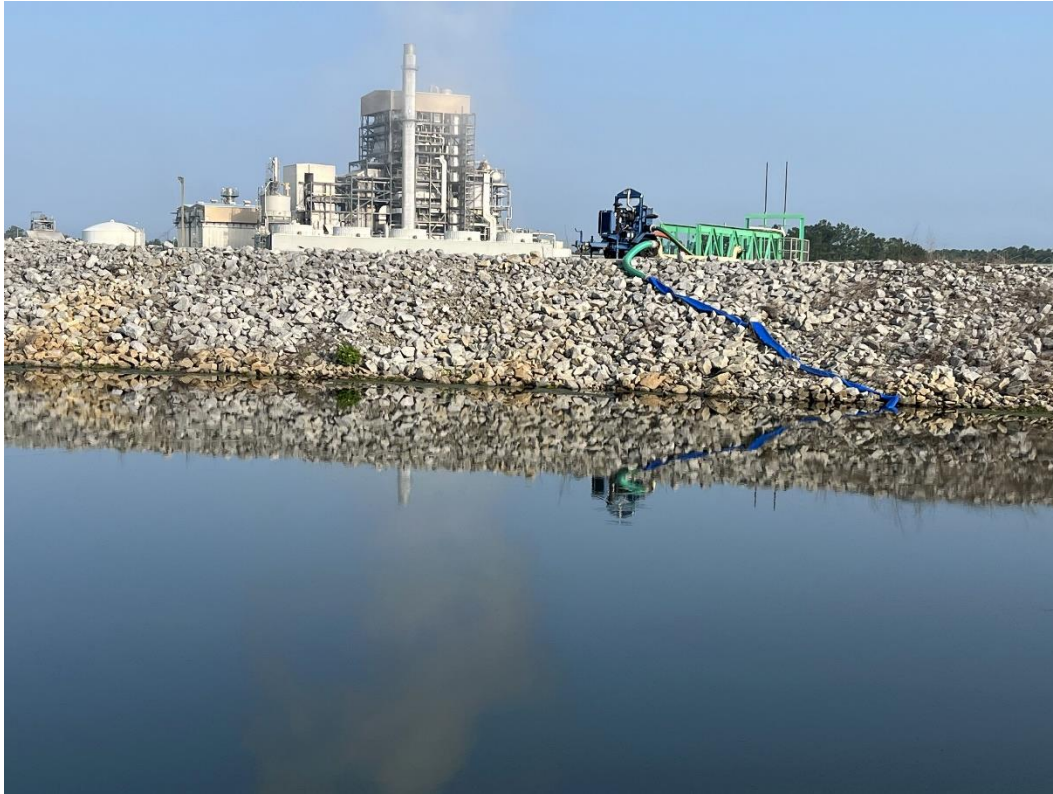
**Figure A1. North Interior Slope of Pump Back Pond #2; 6/30/2023**

CCR Unit	Location	Previous Condition	Remedy Action	Attach.	Date of Remedy Completion
Surface Impoundment System	Ash Cell #2	Butterfly valve malfunctioning	None	-	NA
		Erosion of embankment (between Ash Cell #2 and Pump Back Cell #2) and riprap displacement	Eroded area was filled in and 12 inch layer of rip rap was placed	A1 and A2	January 24, 2023
CCR Landfill	Northern Drainage Ditch	Underwater. Sediment built-up in and around Cells 1 and 2 underdrains was observed.	Underdrains were above water level and sediments were cleared from around the underdrain outlets	A3	July 10, 2023
	Around LF-3	Unvegetated area	Bare area has been seeded a total of three times and watered daily, grass is returning to area	A4 and A5	June 30, 2023

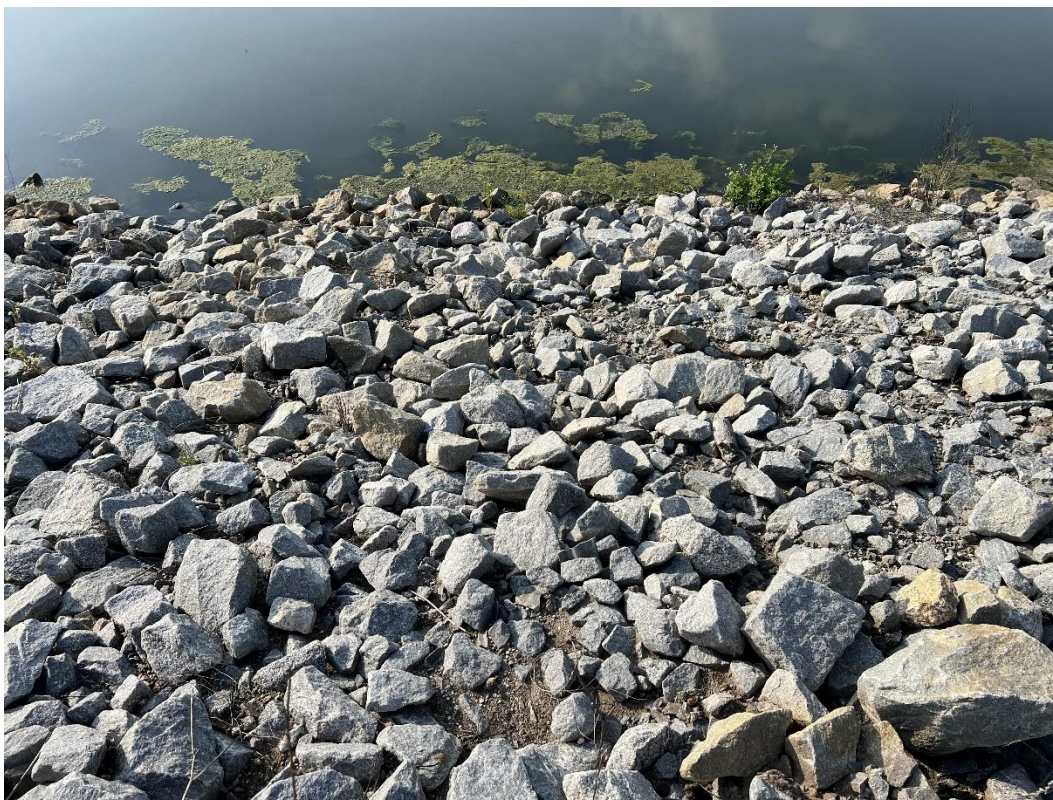
**Figure A2. North Interior Slope of Pump Back Pond #2; 6/30/2023**

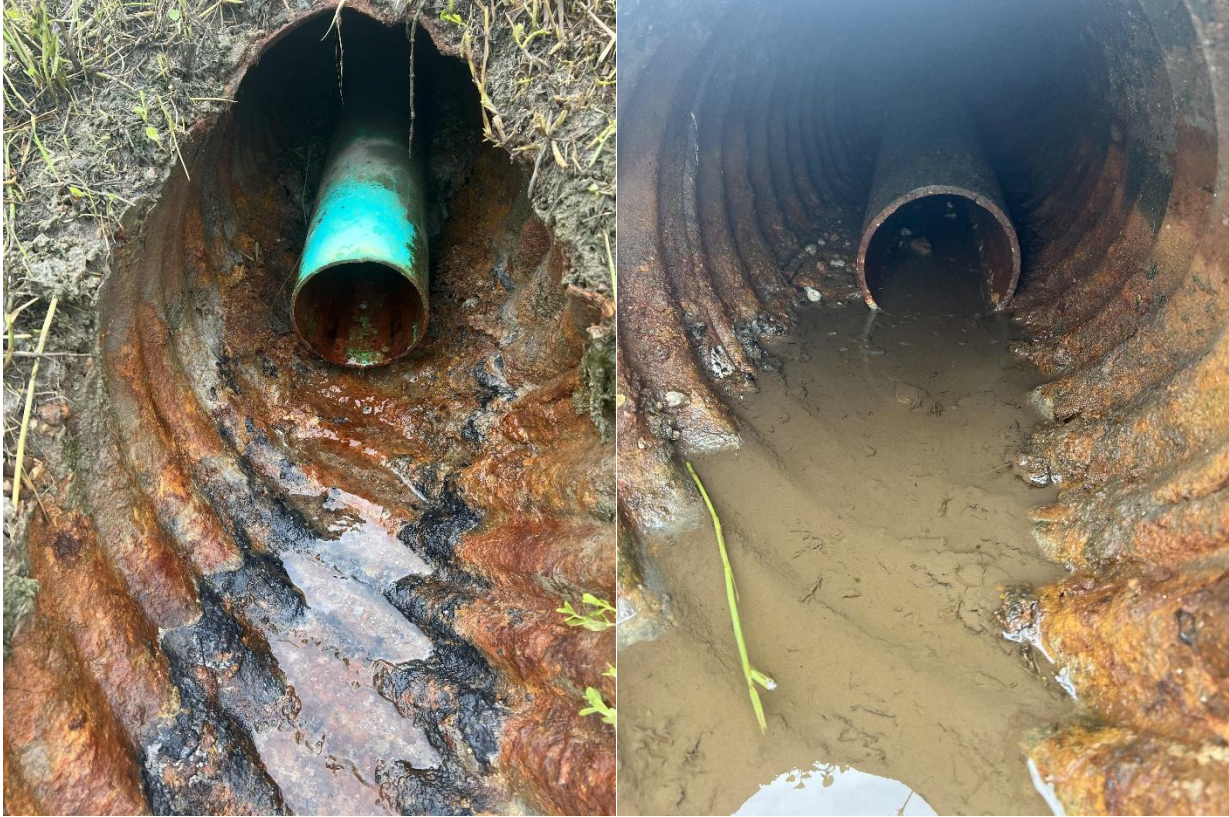
**Figure A3. CCR Landfill Cell 1 (Left) and Cell 2 (Right) Underdrain Outlet; 7/10/2023**

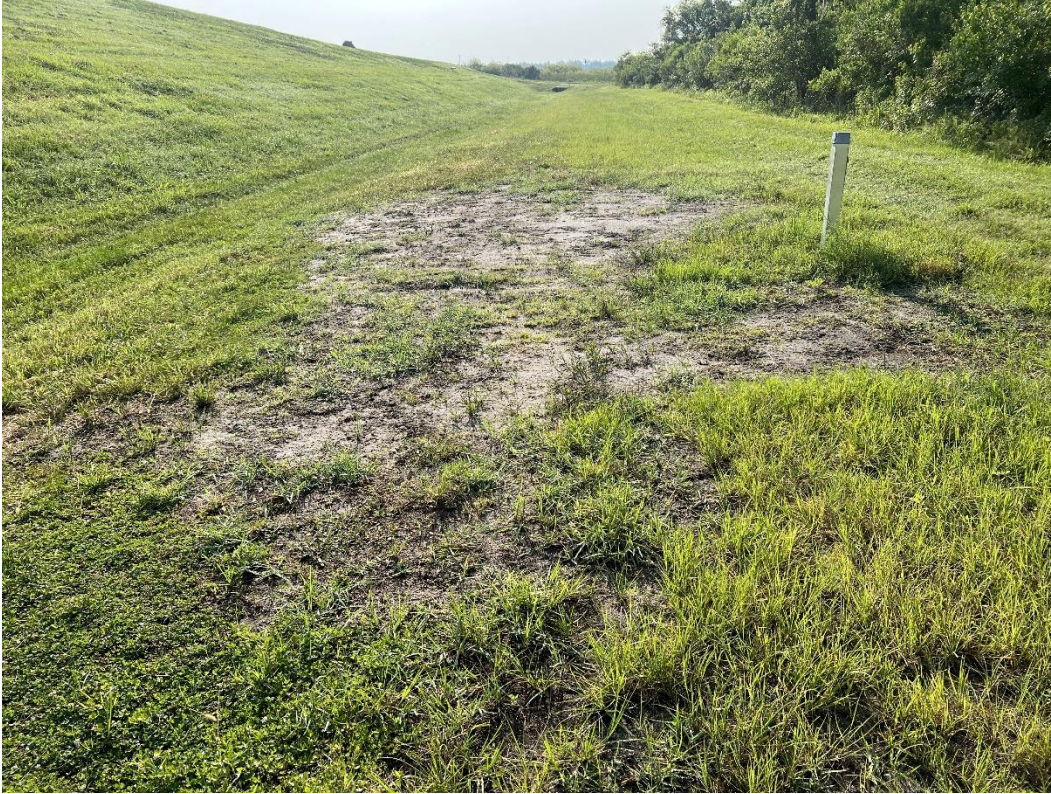
**Figure A4. Seeded Area Around LF-3; 6/30/2023**

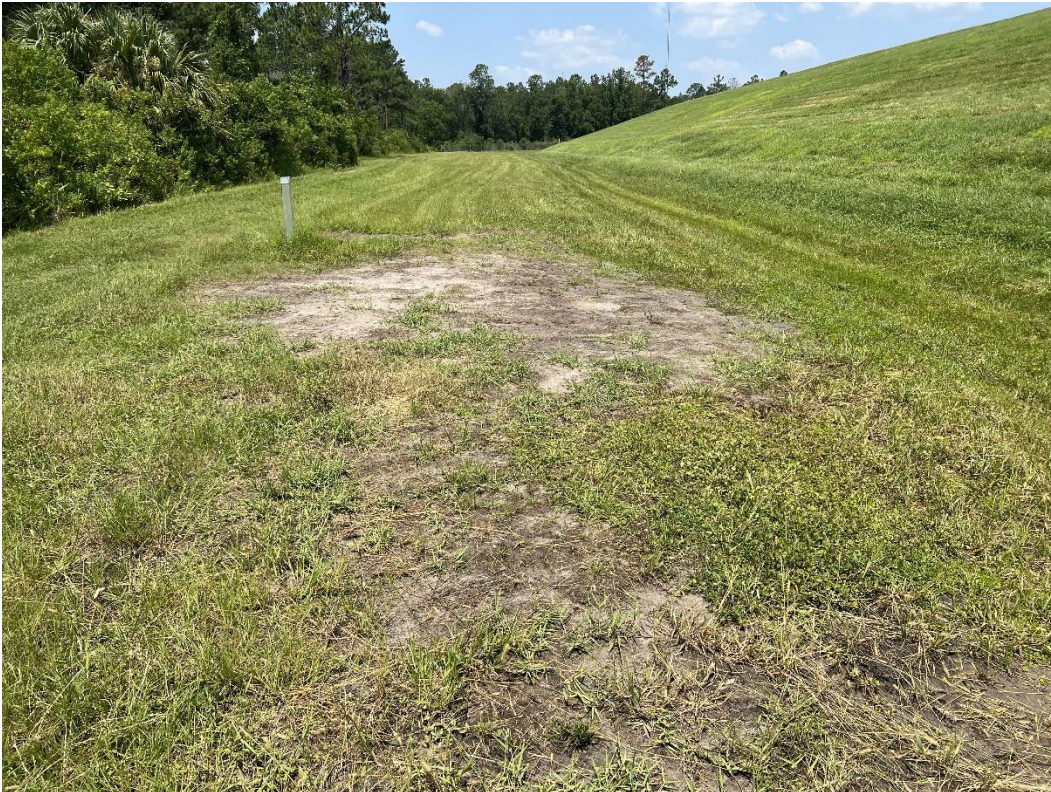
**Figure A5. Seeded Area Around LF-3; 6/29/2023**
