Gainesville Regional Utilities Deerhaven Generating Station

Coal Combustion Residual Units Annual Inspection Report (December 6, 2022 – December 5, 2023)

Innovative Technical Solutions
3720 NW 43rd Street, Ste. 103
Gainesville, Florida 32606

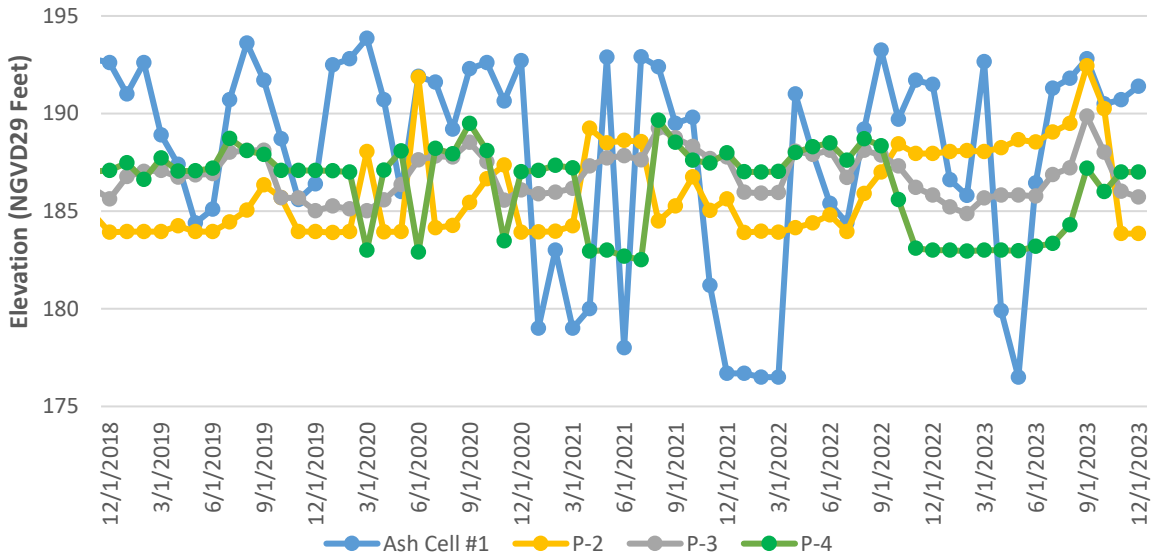
Figure 3. Liquid Elevations for Ash Cell #1 and Piezometers

- a) Elevated Ash Cell Water Levels – The top of the peripheral berm surrounding each of the ash cells is at an elevation of 195 feet, referenced to the National Geodetic Vertical Datum of 1929 (NGVD29). The ash cells are operated with a maximum operating level of 193 feet (NGVD29) to provide 2 feet of freeboard in case of heavy rain/storm events and other contingency events (e.g., during the brine concentrator outage). Water levels higher than 193 ft NGVD29 were observed for eight (8) weekly inspections for Ash Cell #2 during the time period covered by this report. During all weekly inspection events, the water level was reported to be lower than 193 ft NGVD29 for Ash Cell #1.

During each monthly inspection, depth-to-liquid readings in the piezometers located on the Ash Cell #1 and Ash Cell #2 embankments were measured. The water levels measured in these piezometers are used to qualitatively assess potential embankment seepage areas; Piezometers P-2, P-3, and P-4 are used to monitor exterior embankments for Ash Cell #1, and P-1 is used to monitor the exterior embankment of Ash Cell #2 (Figure 1). The liquid elevation in the piezometers was compared to the liquid elevation in each adjacent ash pond. Figures 3 and 4 present a comparison of the measured liquid levels for Ash Cell #1 and corresponding piezometers and Ash Cell #2 and corresponding piezometer(s), respectively. The measurements taken by ITS engineers on the day of the annual inspection were within the range of the measurements recorded by GRU during the reporting period.

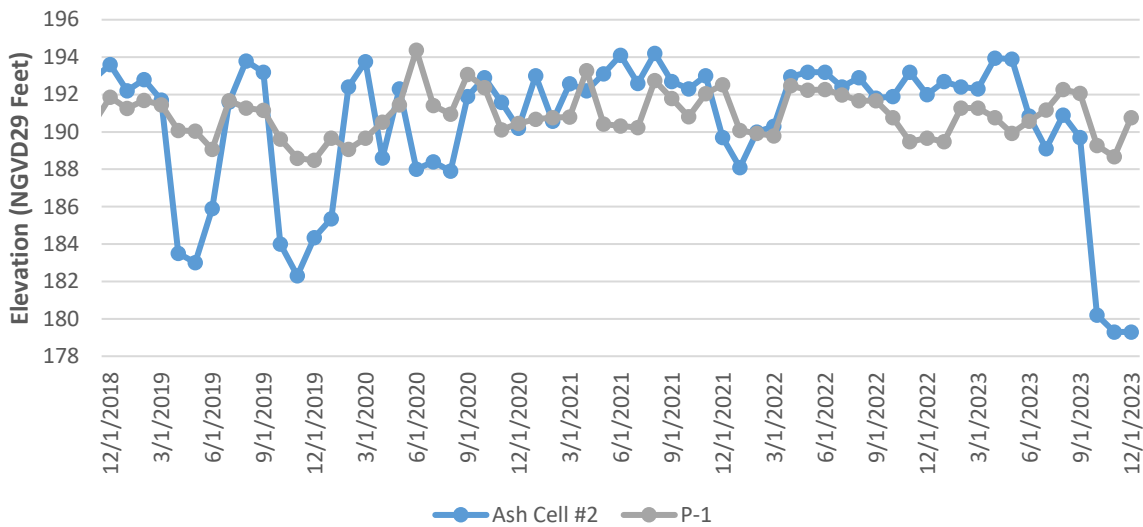
Figure 4. Liquid Elevations for Ash Cell #2 and Piezometer

For Ash Cell #2, the first incidence of elevated water levels was reported on 2/14/2023 due to unit outages. The water elevation in Ash Cell # 2 was reported to be intermittently above 193 feet (NGVD29) due to lack of storage capacity during cleaning of Ash Cell #1 (during March-May 2023) and outage of the brine concentrator unit (in May 2023). The operators closely monitored pond levels and adjusted pumping to the ponds to expeditiously reduce the ash pond levels during these events.

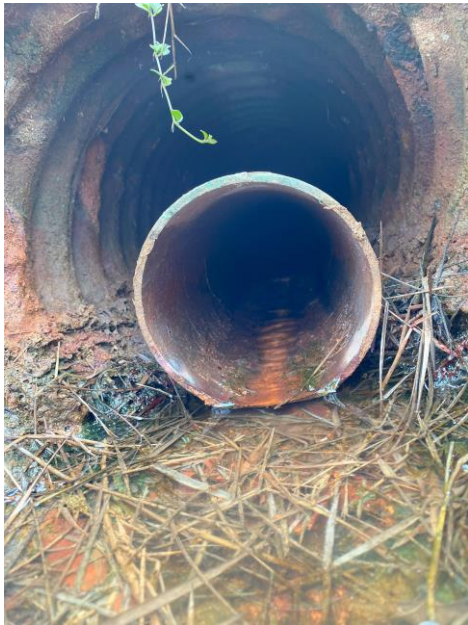
Cells 1-4 underdrains appear to be performing as designed, and no submergence was observed (Figure 5).

Figure 5. Condition of Underdrain Outlets of (a) Cell 1, (b) Cell 2, (c) Cell 3, and (d) Cell 4 on December 4, 2023.
