GREC April 2015 Tertiary Superheater Outlet Header Replacement

Shutdown Report

GRECBFB – GREC April 2015 outage report

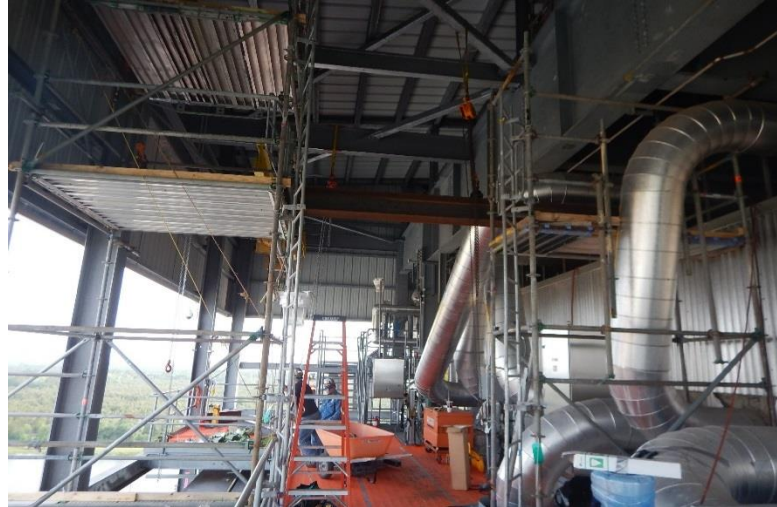
Monorail installation inside building

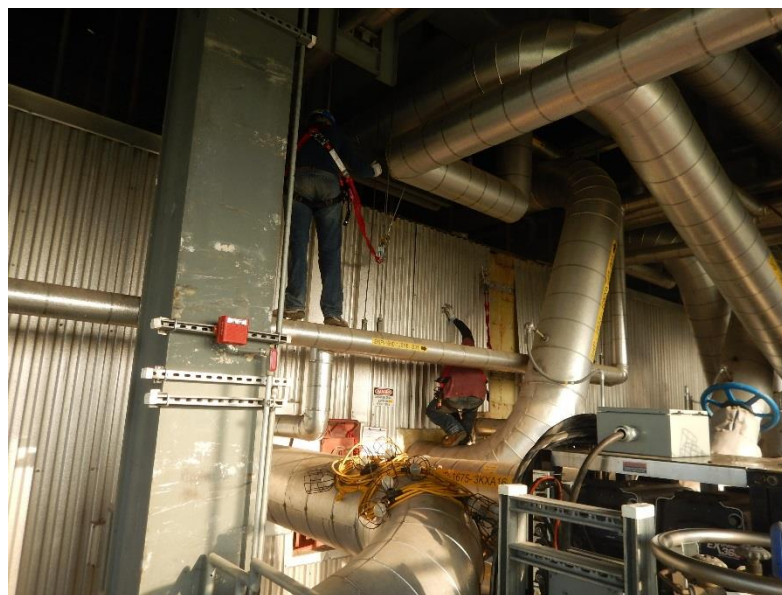
Penthouse dismantling started

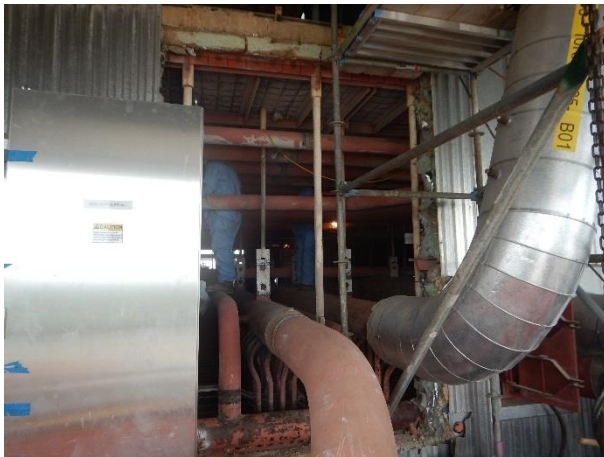
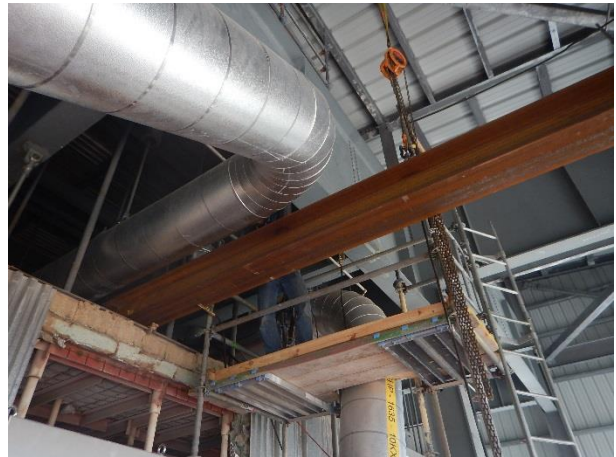
Penthouse opening and monorail

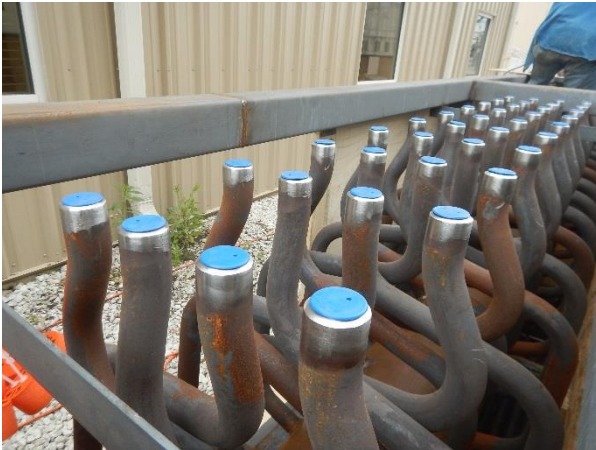
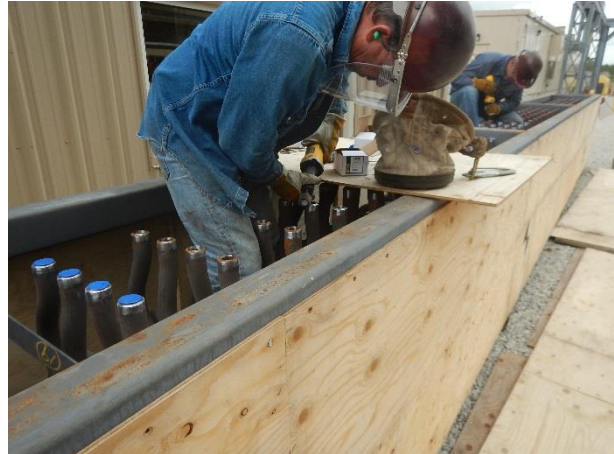
Early prepping header tube stub ends

- Early continues to prep and clean weld ends on header
- Early given go ahead to start implementing cut lines for new header
- Titan to install monorail beams into upper furnace today.

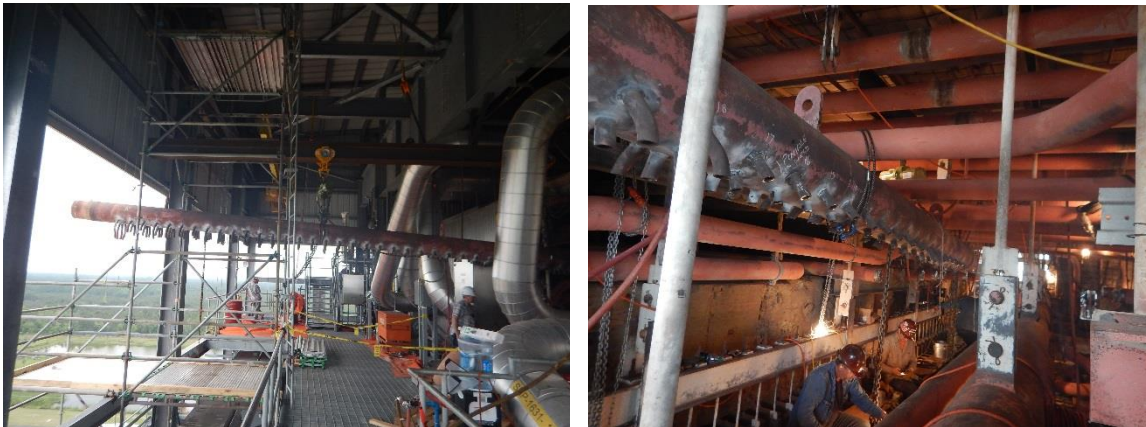
Old header cut out and hanging on monorail

- Monorail set into upper risers for taking out header
 - Early cut and machined the P91 header ends
 - Early is cutting back and beveling SH tube stubs (x212)
 - Header is hanging on the external monorail ready for removing tomorrow
- Work continues on additional hangers
- Crane for header lift will arrive tomorrow around 11 am
- Flat bed will arrive at noon to remove header from site.

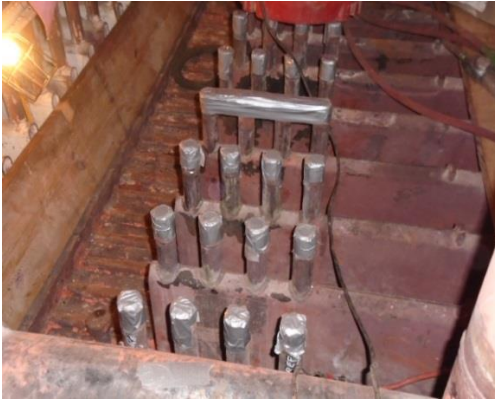
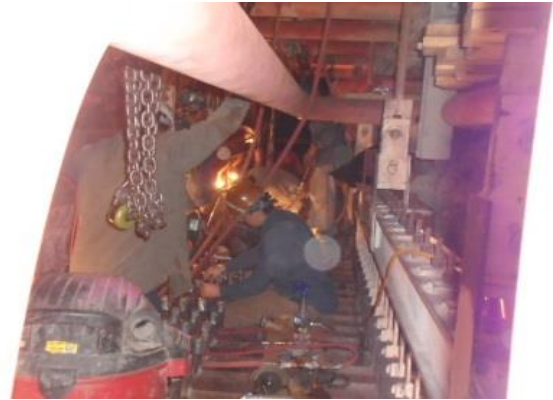
Cut line prep completed on night shift

- Early continues to prep lower SH stub ends. Anticipation is that this work will be complete tonight.

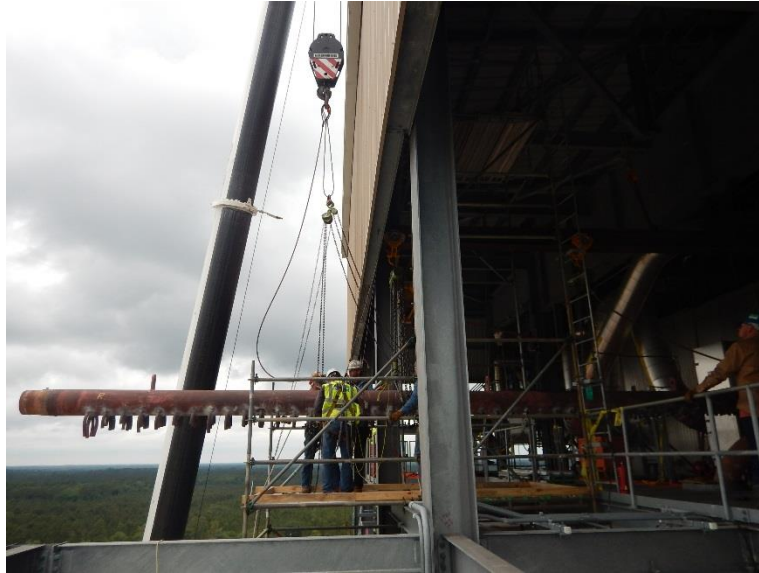
Tertiary header coming out from monorail to crane

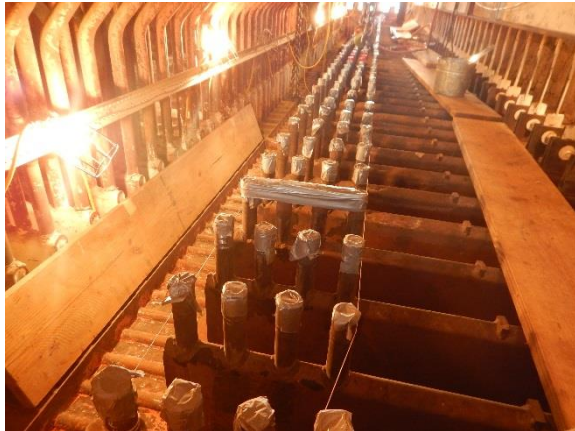
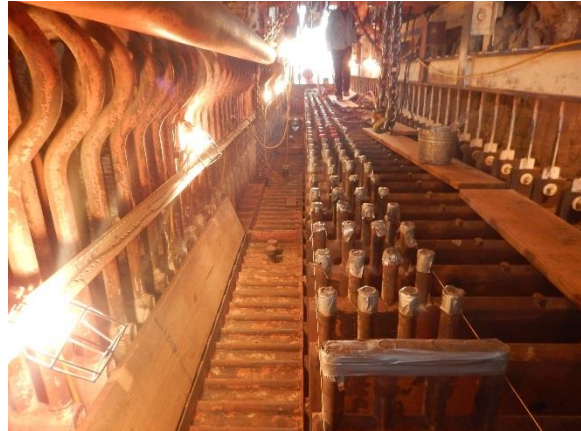
SH tubes prepped and ready for fit up

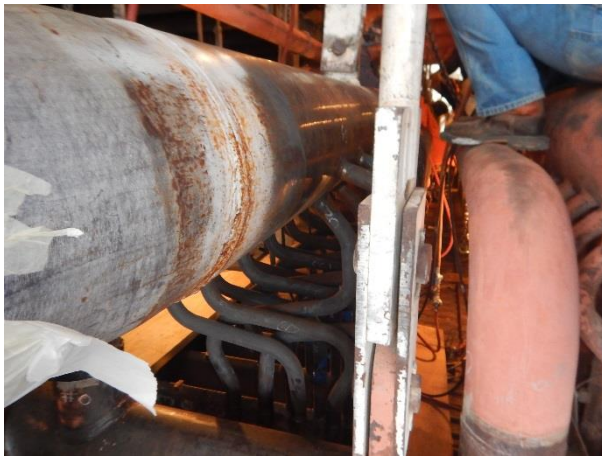
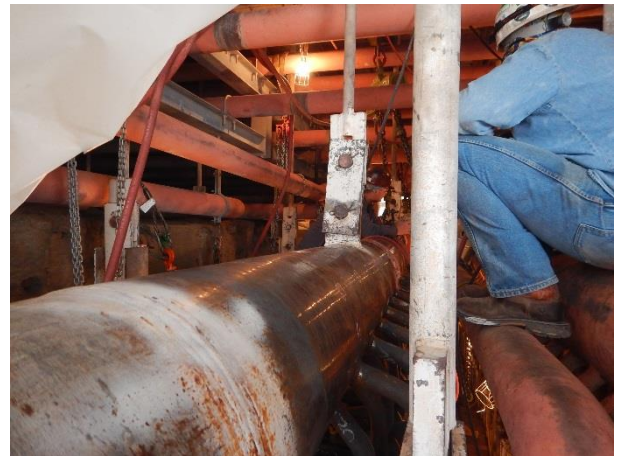
Header set and welding in progress

- Scaffold down for monorail rigging and monorail removed
- Built some wind screens with scaffold around P91 joints
- SH arrived today and equipment set up for preheat and welding. RHS is preheating to start welding
- LHS is being prepped for pre-heat and this will start welding tonight as well
- ATS radiography crew arriving at site at 2am. We will continue with shear wave until RT crews get to site.
- All hands safety discussion held at site today
- Total of 89 welds complete

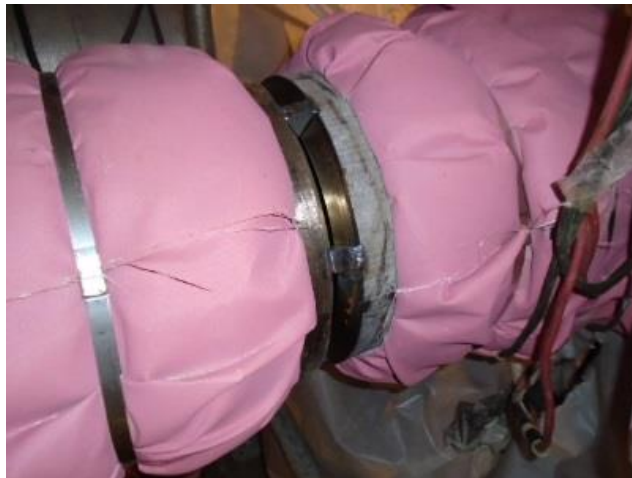
Fit-up and pre-heat

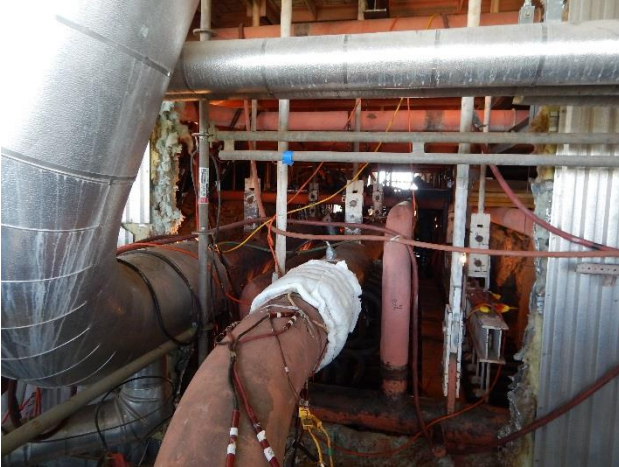
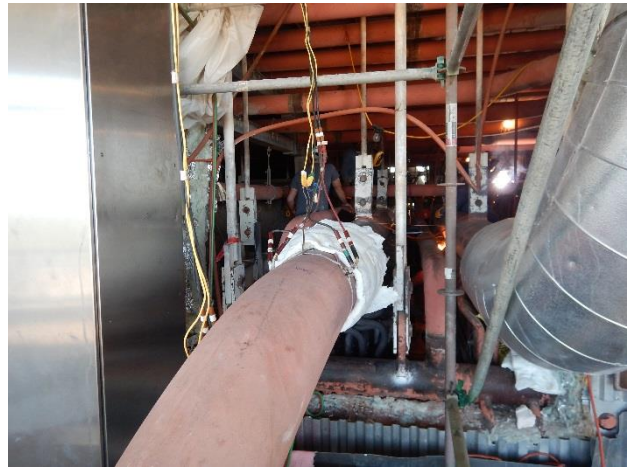
PWHT P91 joints on both sides

- Early is holding true to their name and appears to be ahead of schedule. Hydro is likely Tuesday or Wednesday this coming week. This is pending after RT is complete on butt welds
- Starting to cut the attemperator inspection nozzle holes for installation
- Both P91 outlet weld joints passed RT. Wrapped and PWHT started.
- The belleville washers will have to be reset after the P91 outlet spring hanger rods are installed.

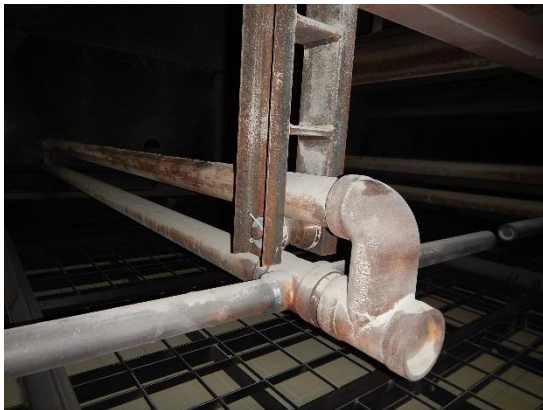
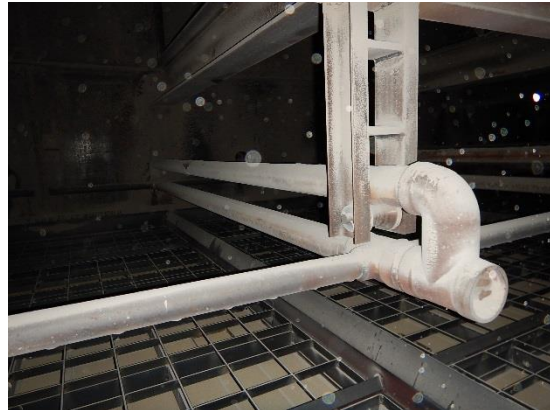
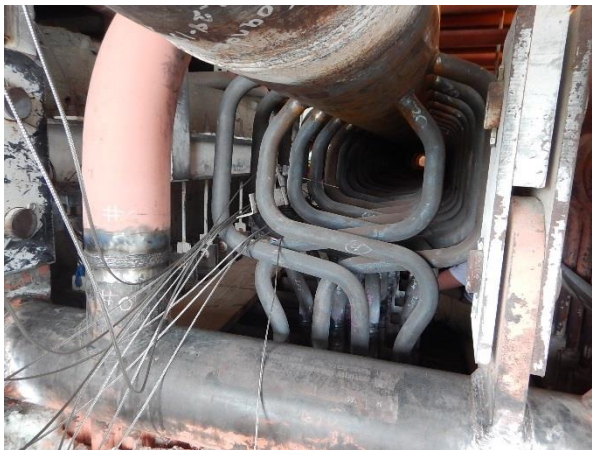
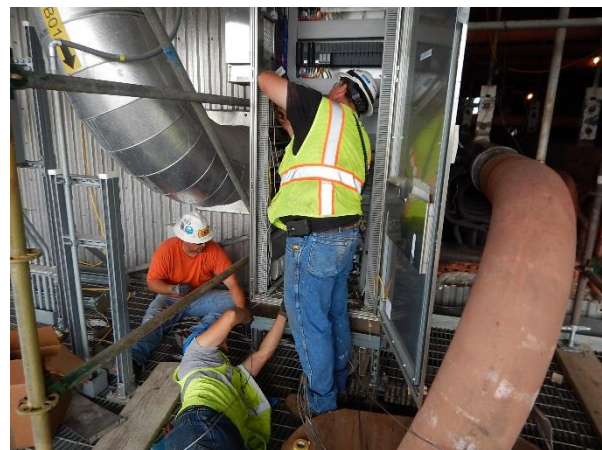
Installing Tertiary SH TC's

2. Couple of weld cap pick ups on tertiary header. All other butt welds are complete.
3. Thermocouples (x 12) terminated to tube clamps and then into junction box and tested. Need NAES ICE techs to complete.
4. Insulation on penthouse frame staged for tomorrow
5. Insulation on tertiary outlet headers staged for tomorrow
6. Insulation on tertiary outlet and primary II outlet header inside penthouse. Will be scheduled for Thursday morning

- Tertiary SH TC's check out complete and good continuity with graphics on DCS.

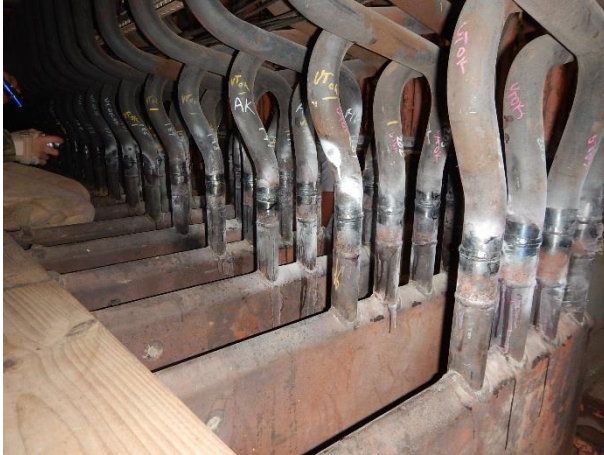
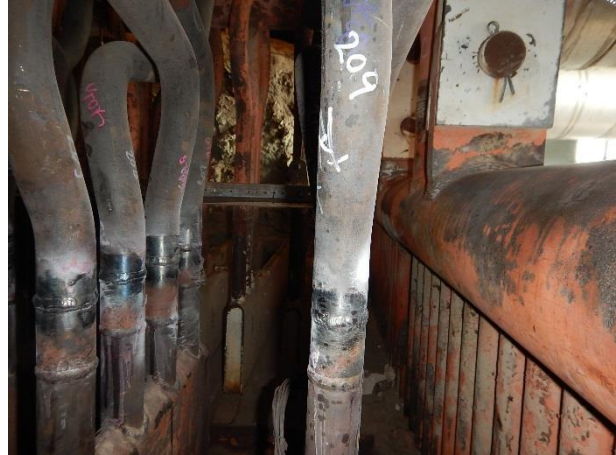
Tertiary SH butt welds and PT UT NDE

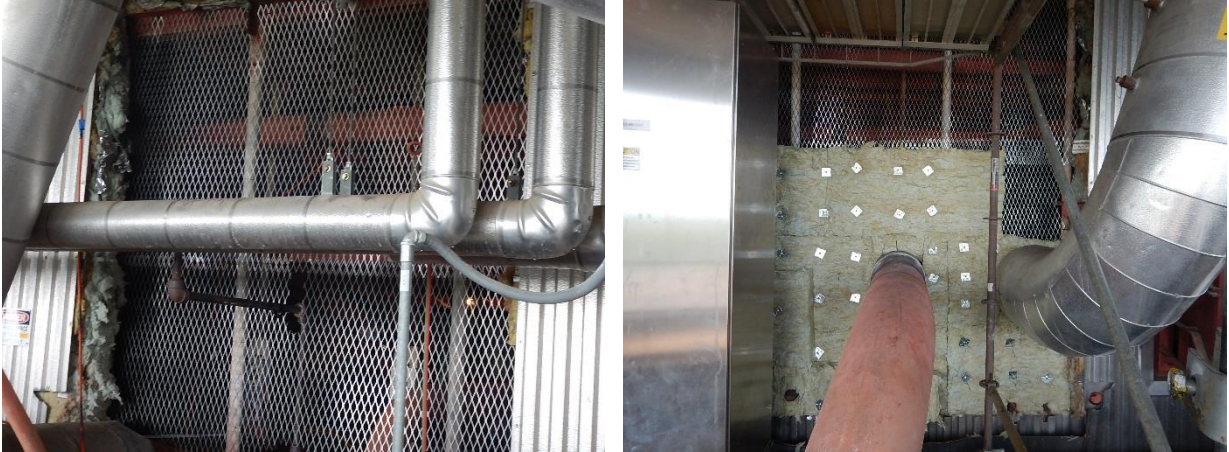
PH side framing on and starting insulation

- Insulators working on the following: but leaving the welds and inspection nozzles exposed
 - Penthouse Frame and insulation on both sides
 - Tertiary SH outlets
- They will come back in tomorrow morning to complete the remainder of the work.
 - Tertiary SH and Primary SH internal insulation
 - The areas left off for the hydro above
- Early welders working on the repairs and should be complete around noon.
- NAES is installing the hydro plugs on all 3 safety valves and will be complete around noon as well.
- NAES Ops crew will manage the hydro. Valmet will perform the hydro inspection.

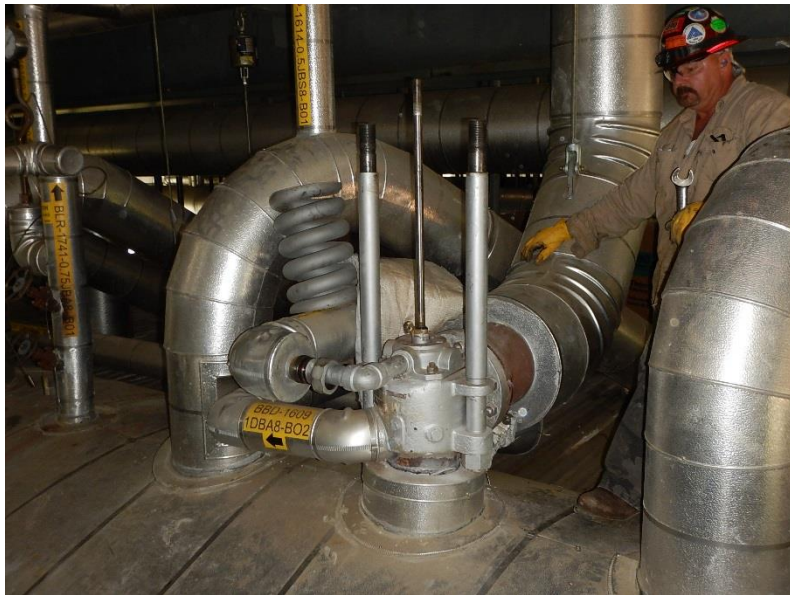
Installing hydro plugs on safety valves

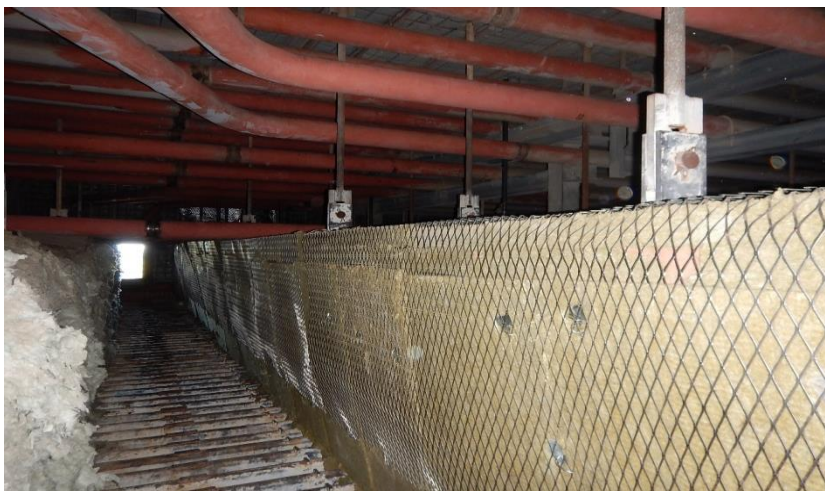
Tertiary and Primary SH reinsulated

- Insulation crews in for PH reassemble, attemperator nozzles and Tertiary outlet lines.
- Completed at 3pm
- They required some cladding to complete one outlet header
- Early and Titan packing and cleaning up
