# ZLD Outage Report April 2015

## ZERO DISCHARGE SYSTEM

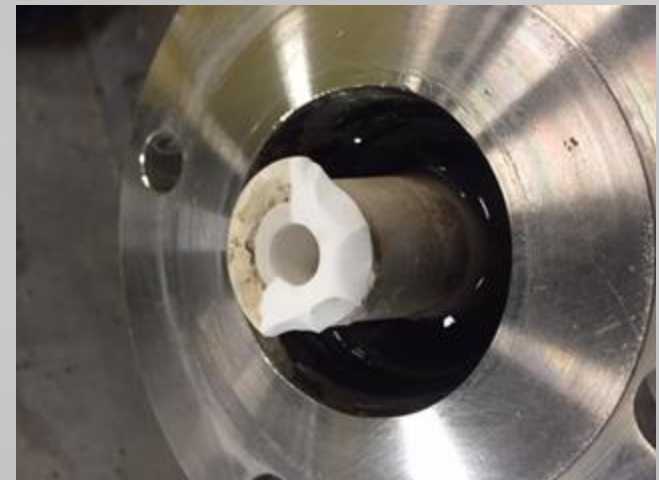
Hydro cyclone ceramic piece broke

- Maintenance modified connection with isolation valve was added.
- Inspected F. Press 3 way valve. Remove stationary belts, stationary belt and grating. Ready for inspection.
- Removed hydro cyclone (ceramic cone broke).
- Removed “new” antifoam injection coil.
- BC drains unplugged, ready for tomorrow cool down/drain. Stage needed hoses for this job.
- Sample room new cabinet assembled.

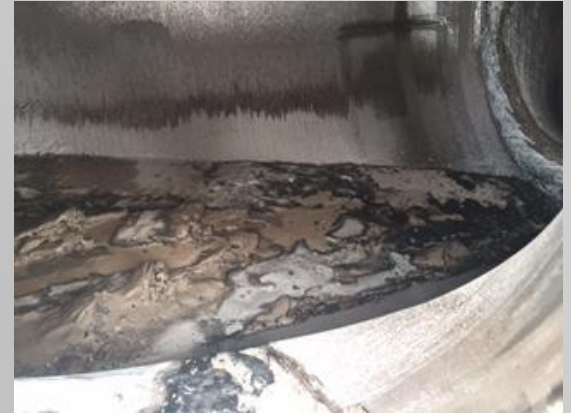
Door at mist eliminator

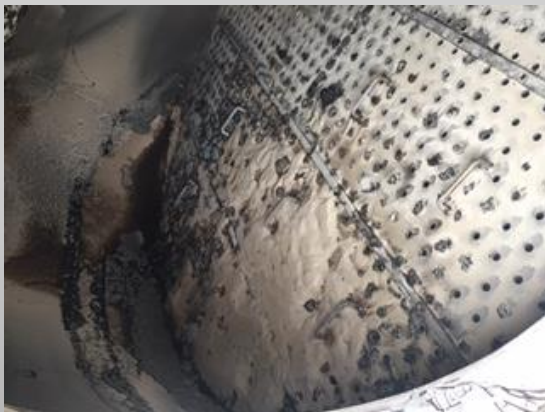
Distribution plate

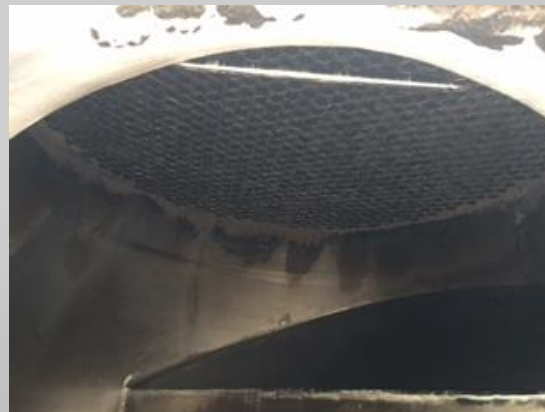
Bottom of BC tube sheet

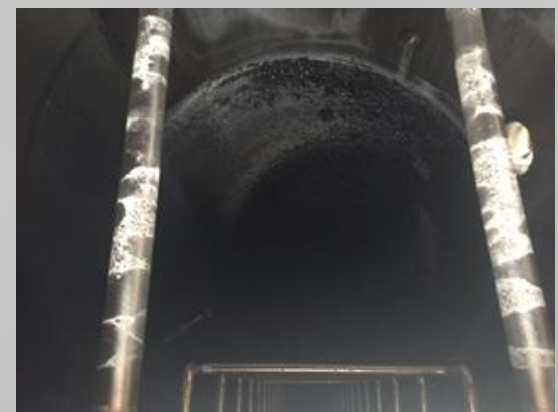
BC sump

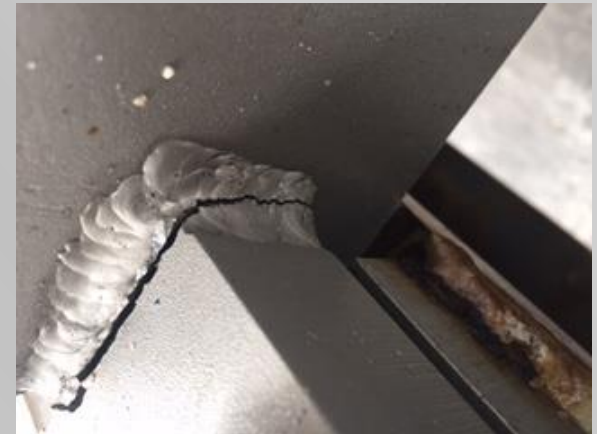
F. Press weld failure

- Opened VC suction inspection door and wash out ports.
- Opened BC distribution header flange.
- 0800: Veolia on site. Prep for BC hydro-blast in progress.
- 1015: Veolia started hydro-blast BC distribution header, then they will move to tube sheet.
- 1130: Inspected distribution header, not good enough. They will re-visit.
- 1310: Veolia starting on BC tube sheet.
- Filter press under dome drain line leak has been repaired.
- Broken weld on F. Press, structure under the dome.

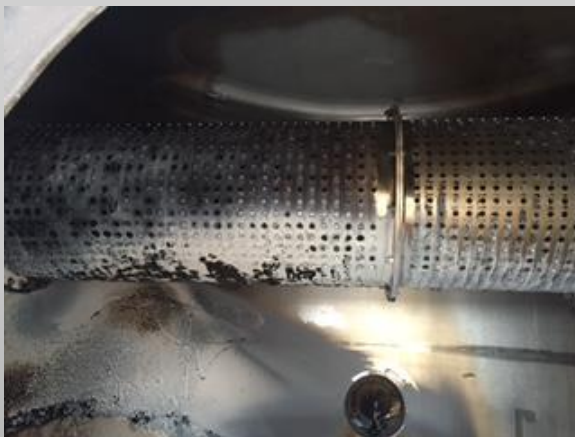
Distribution header

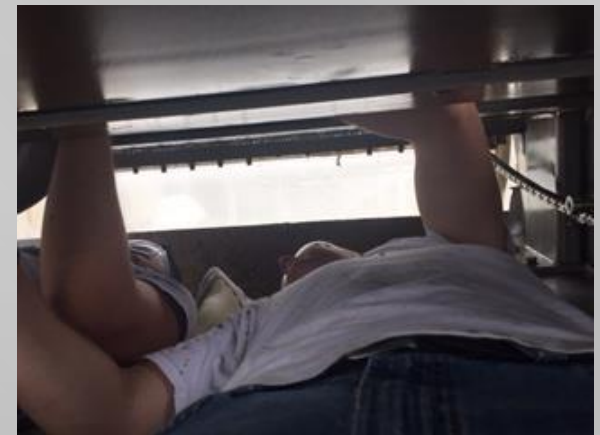
Hard at work WTO's repairing F. P leak

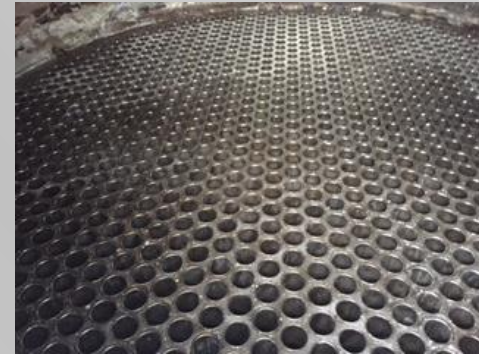
BC tube sheet after hydro-blast

- BC hydro-blast completed at 2300.
- Veolia hydro-blast ZLD lines and FHE (17 tubes were plug).
- Veolia finished hydro-blasting at 1700.
- A lot of build up on Crystallizer flash tank.
- New spool piece at VC have been installed.
- New check valves have been installed on RO caustic lines.
- Pre-heater HTR-1004 A has been opened and inspected. No build up.

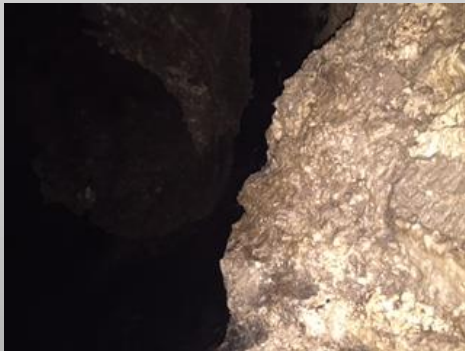
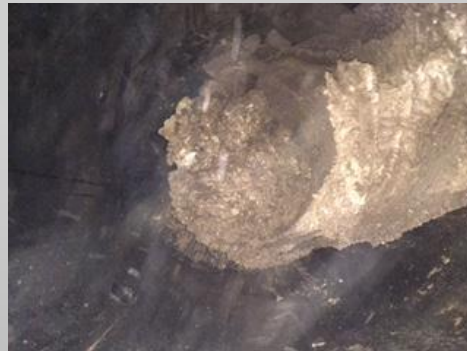
Crystallizer solids build up

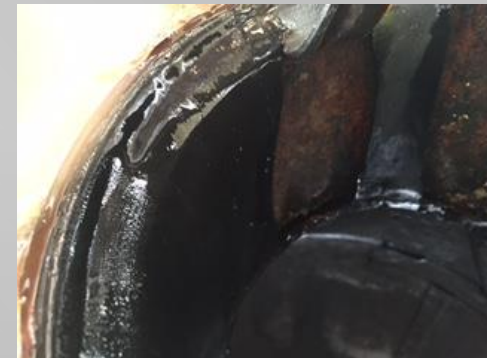
Crystallizer missing rubber liner

- Veolia is done with BC chemical cleaning. Inspection completed; looks good.
- Vapor compressor impeller cleaned.
- Impeller wash nozzle installed.
- Crystallizer rubber liner repair started..  
Cure time estimated to be 24 hrs.

- BC seeding completed. Will recirculate until temp reaches 180 °F then the 20 hrs cure time will begin. After that the evaporator is fully operationally.
- Crystallizer repair failed. Contractor will re-line .

- BC TS @ 3% wt achieved.
- Crystallizer re-lining completed successfully.
- Crystallizer condenser failed, tube leaks.

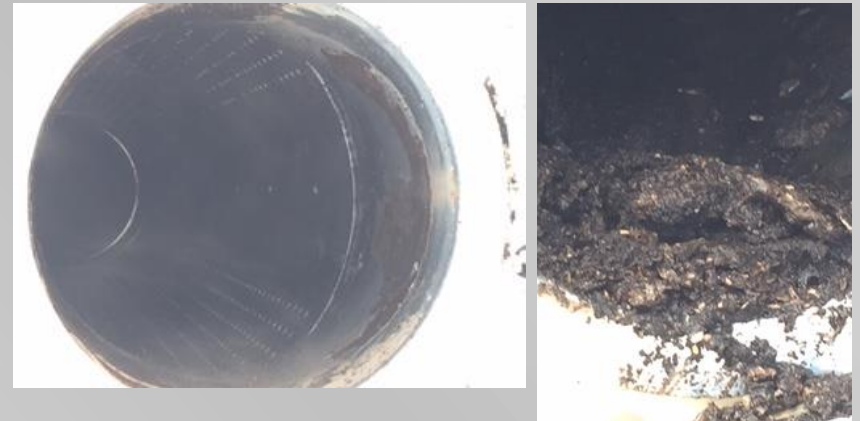
BC distribution header after chemical cleaning

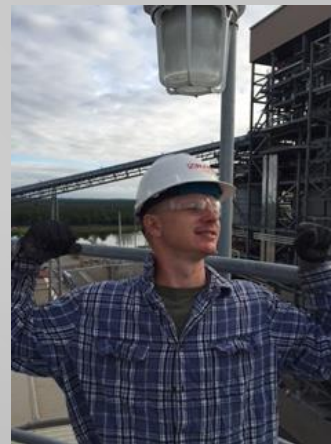
VC new wash nozzle installed and the proud installer

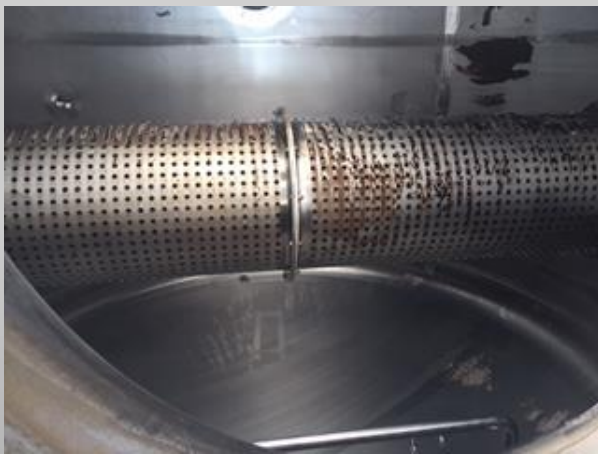
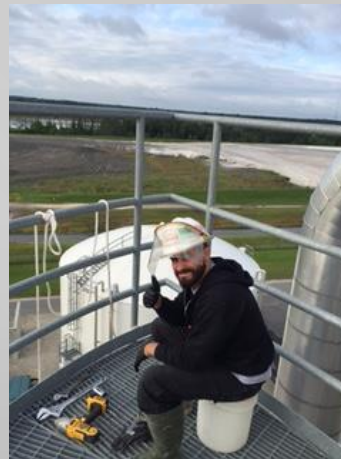
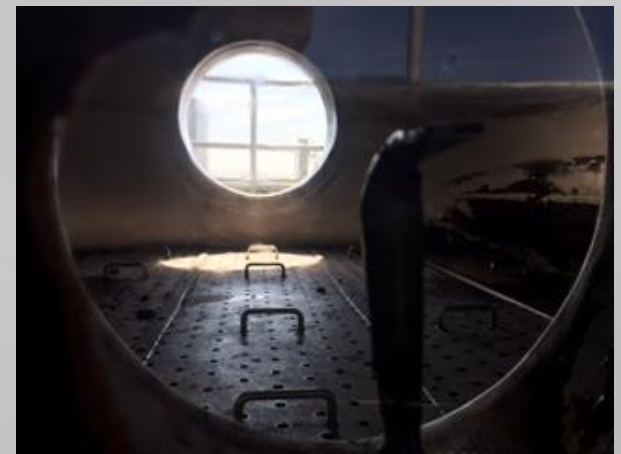
BC distribution header and plates after chemical cleaning. Looking good , right Marcus?

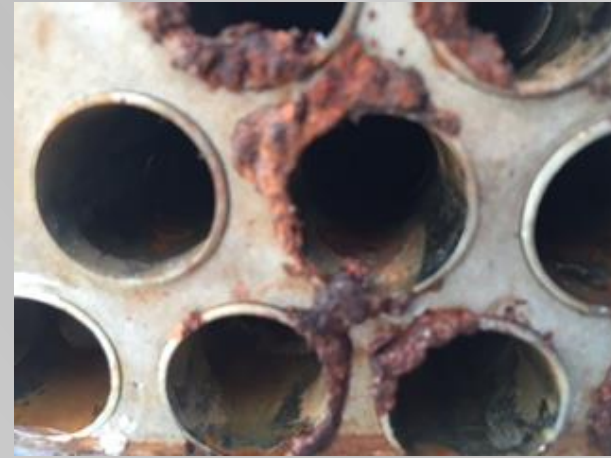
Tube sheet face plate; cooling water side

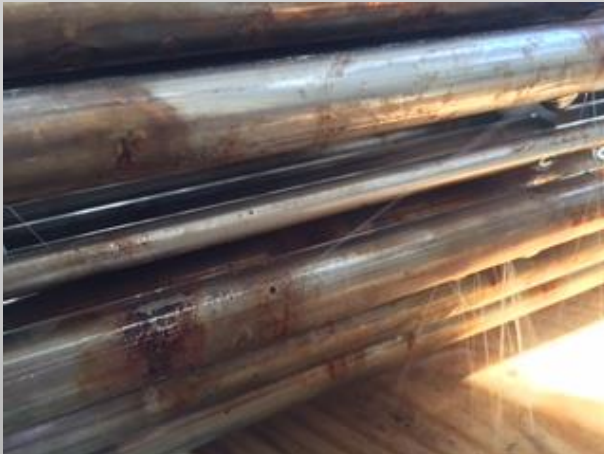
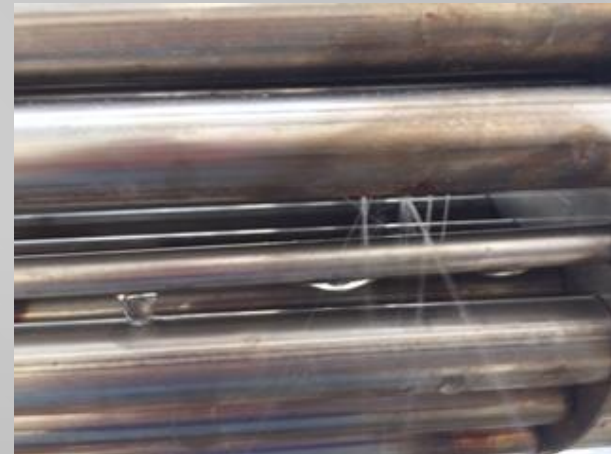
Condenser tube leaks.

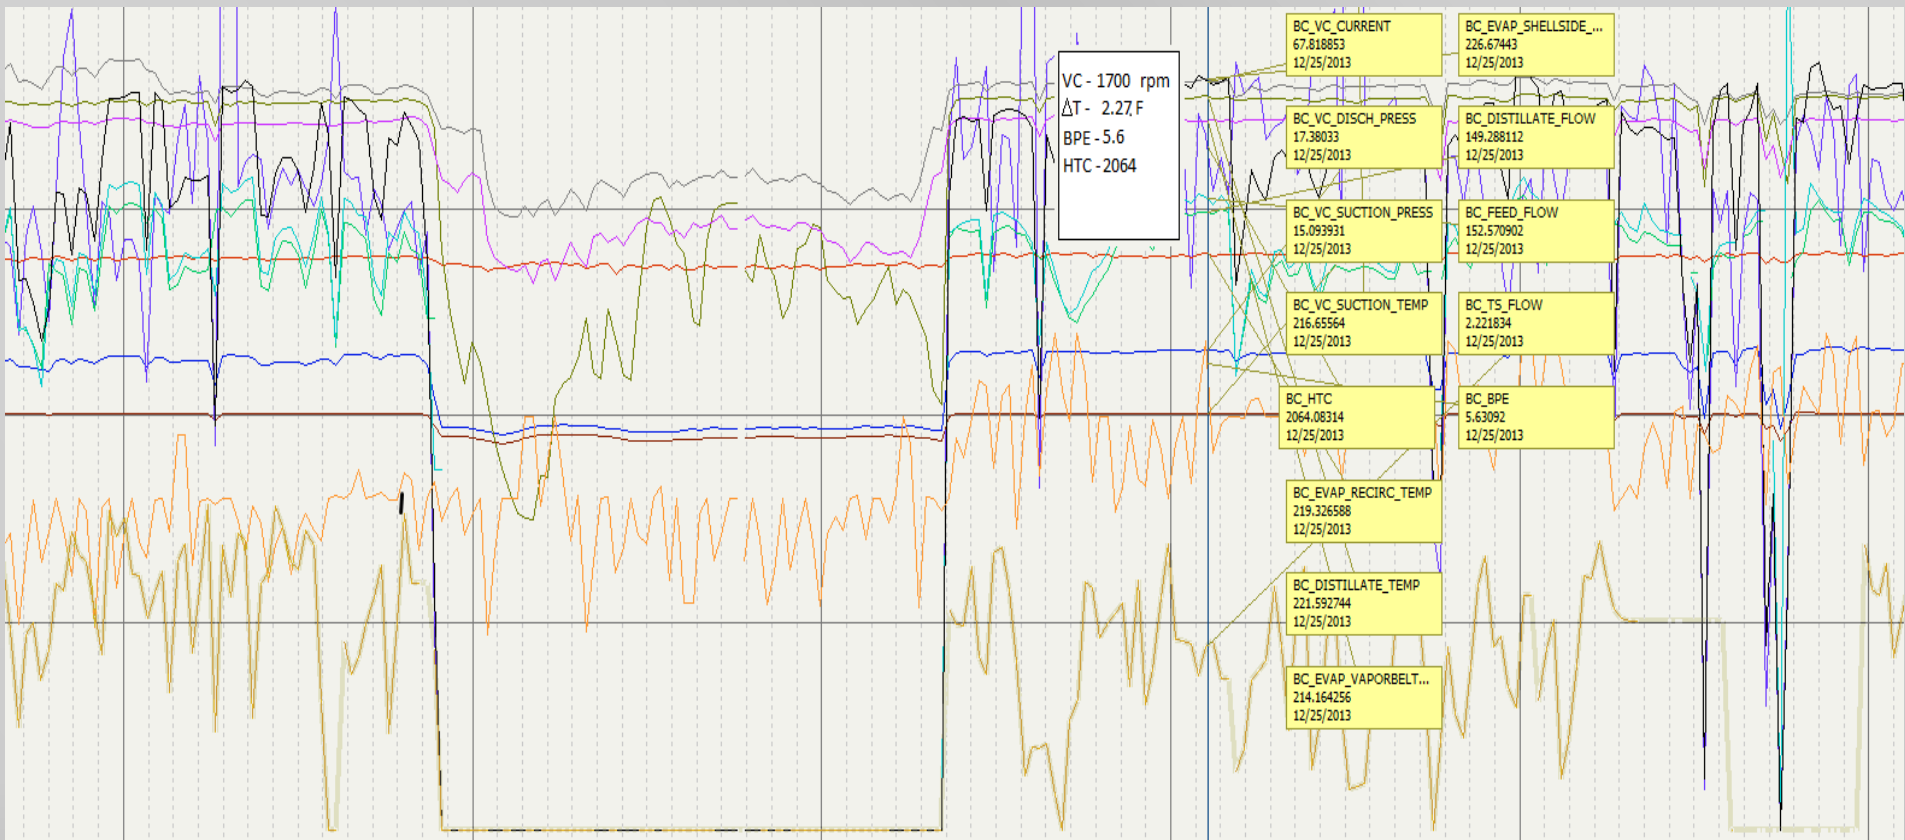
# BC Start up data (December 2013)

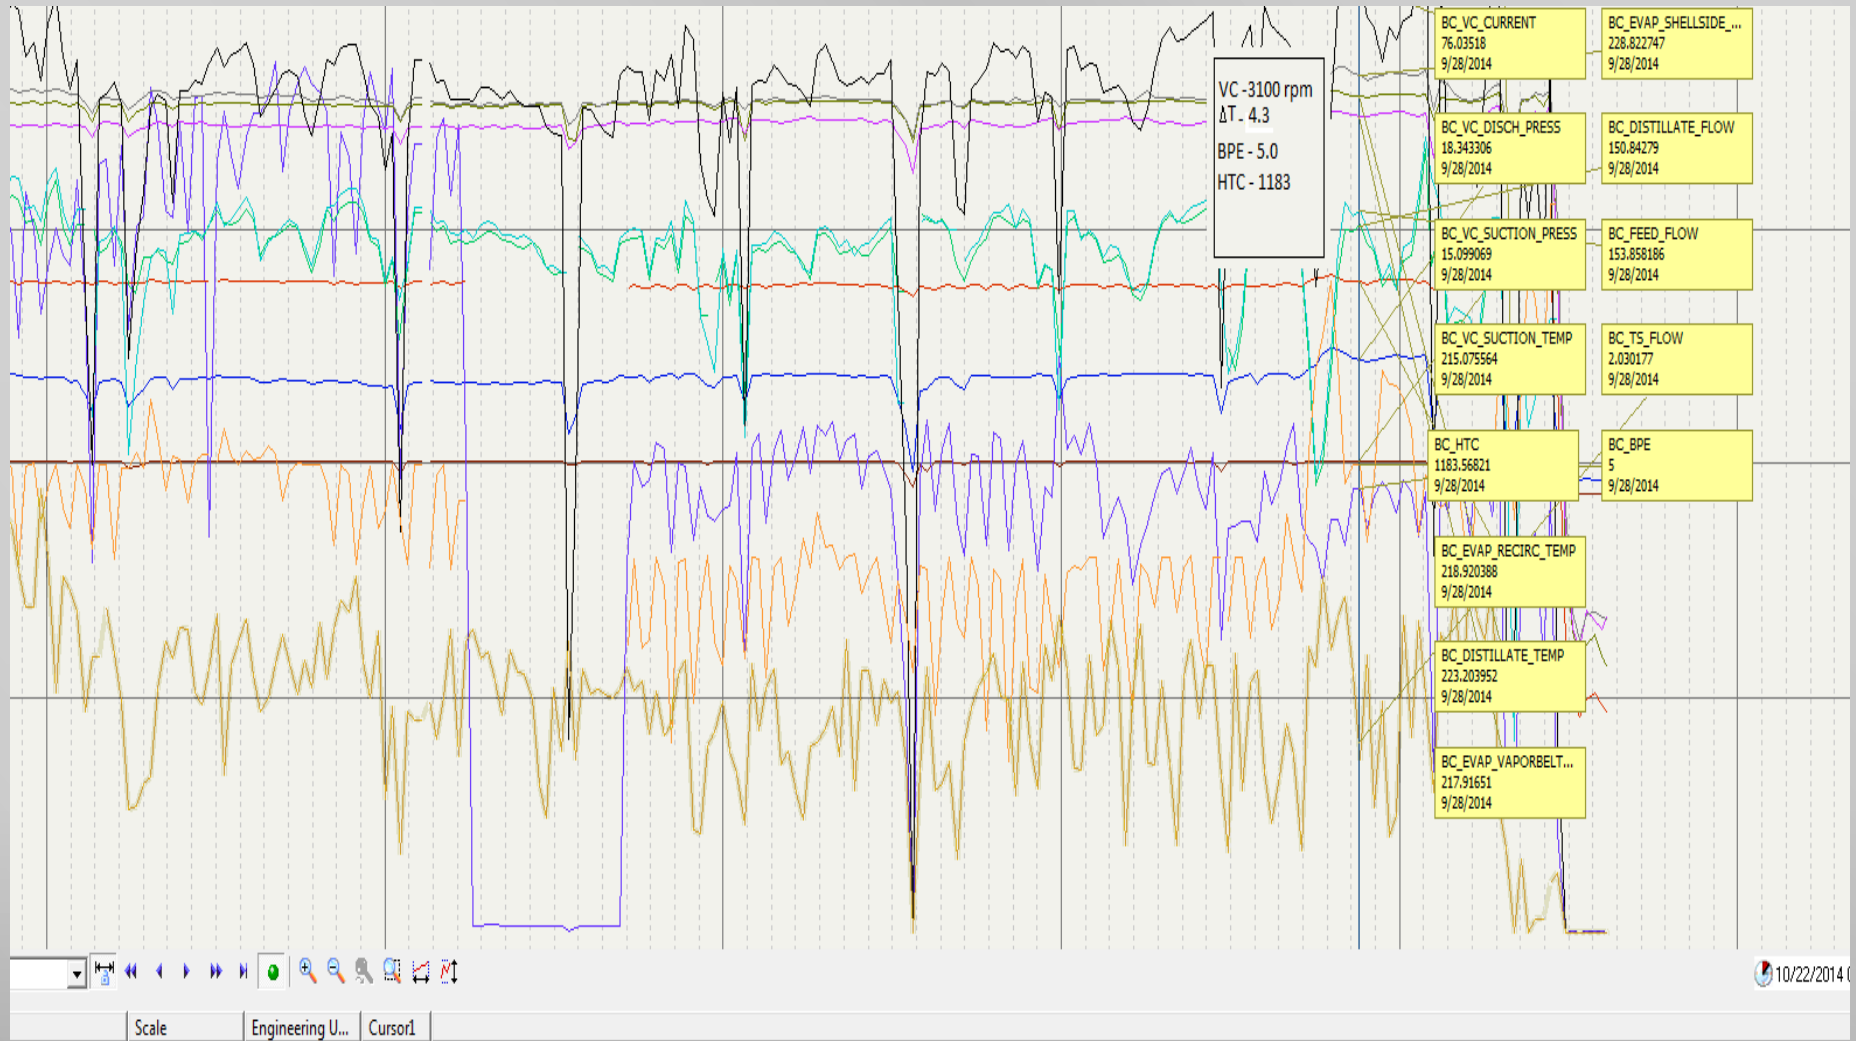
# BC 1<sup>st</sup> shut down (October 2014)

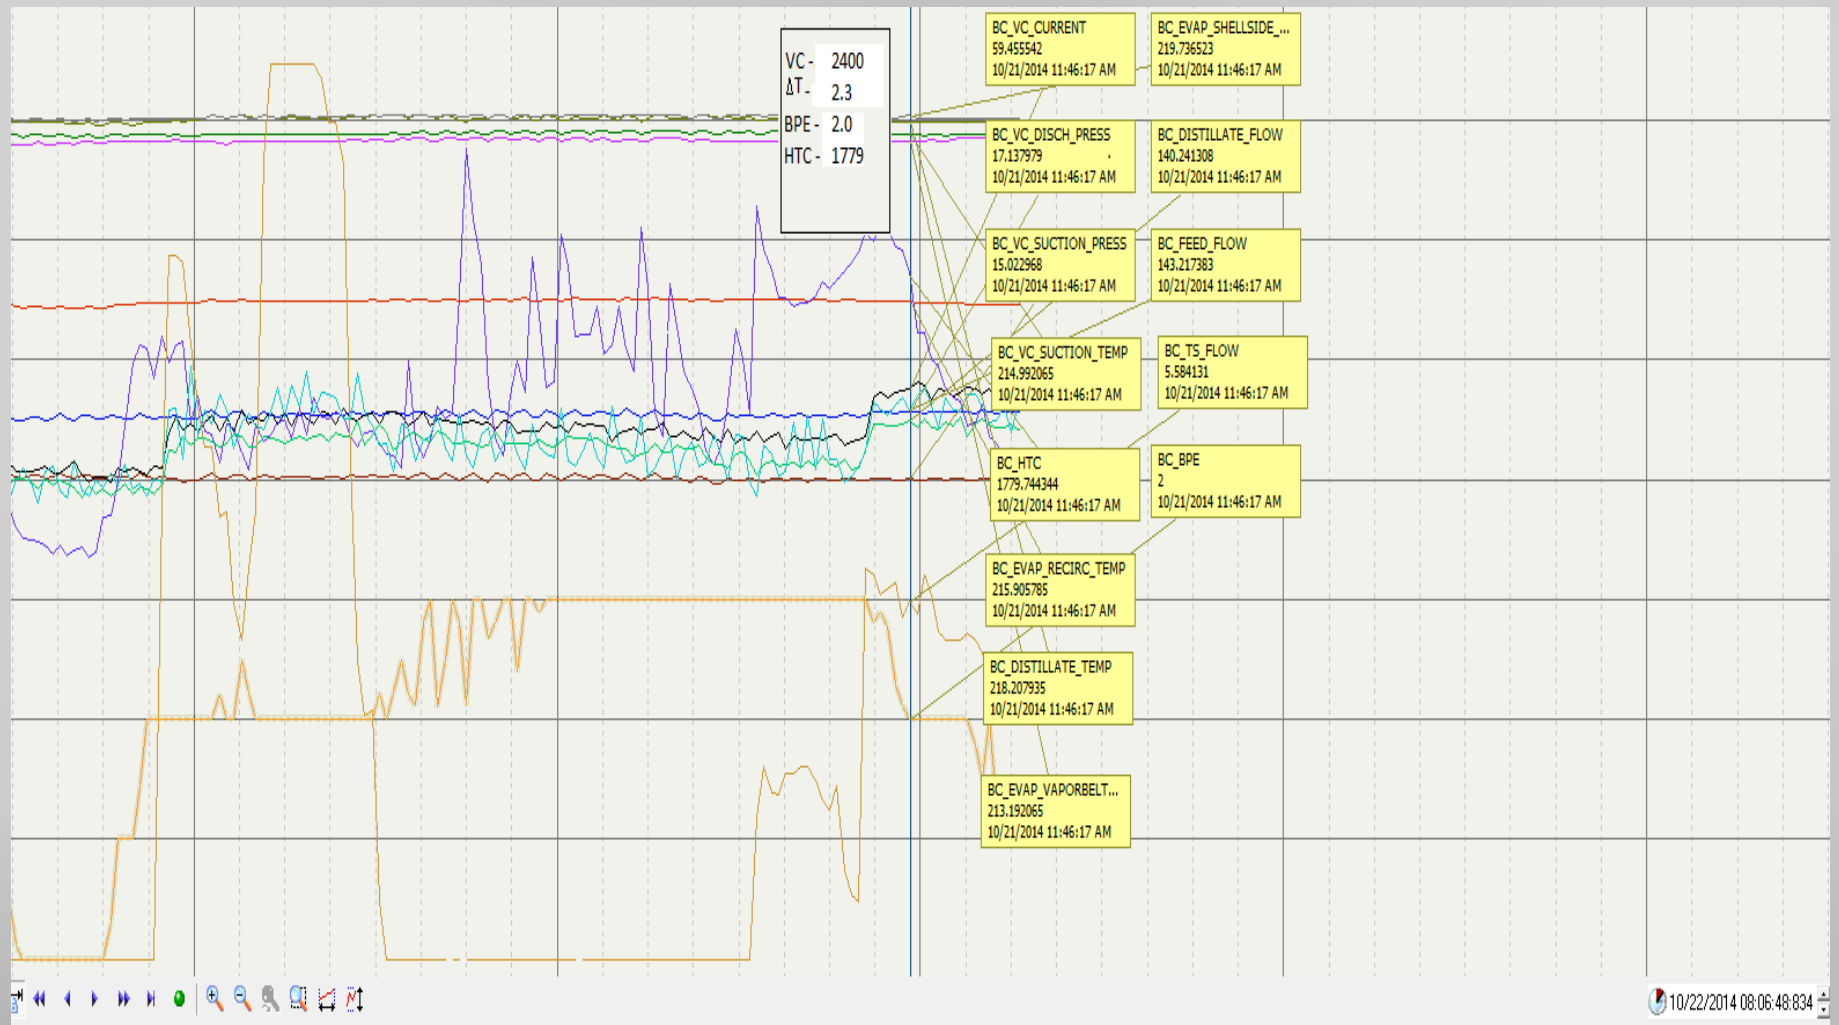
# BC start up after 1<sup>st</sup> outage

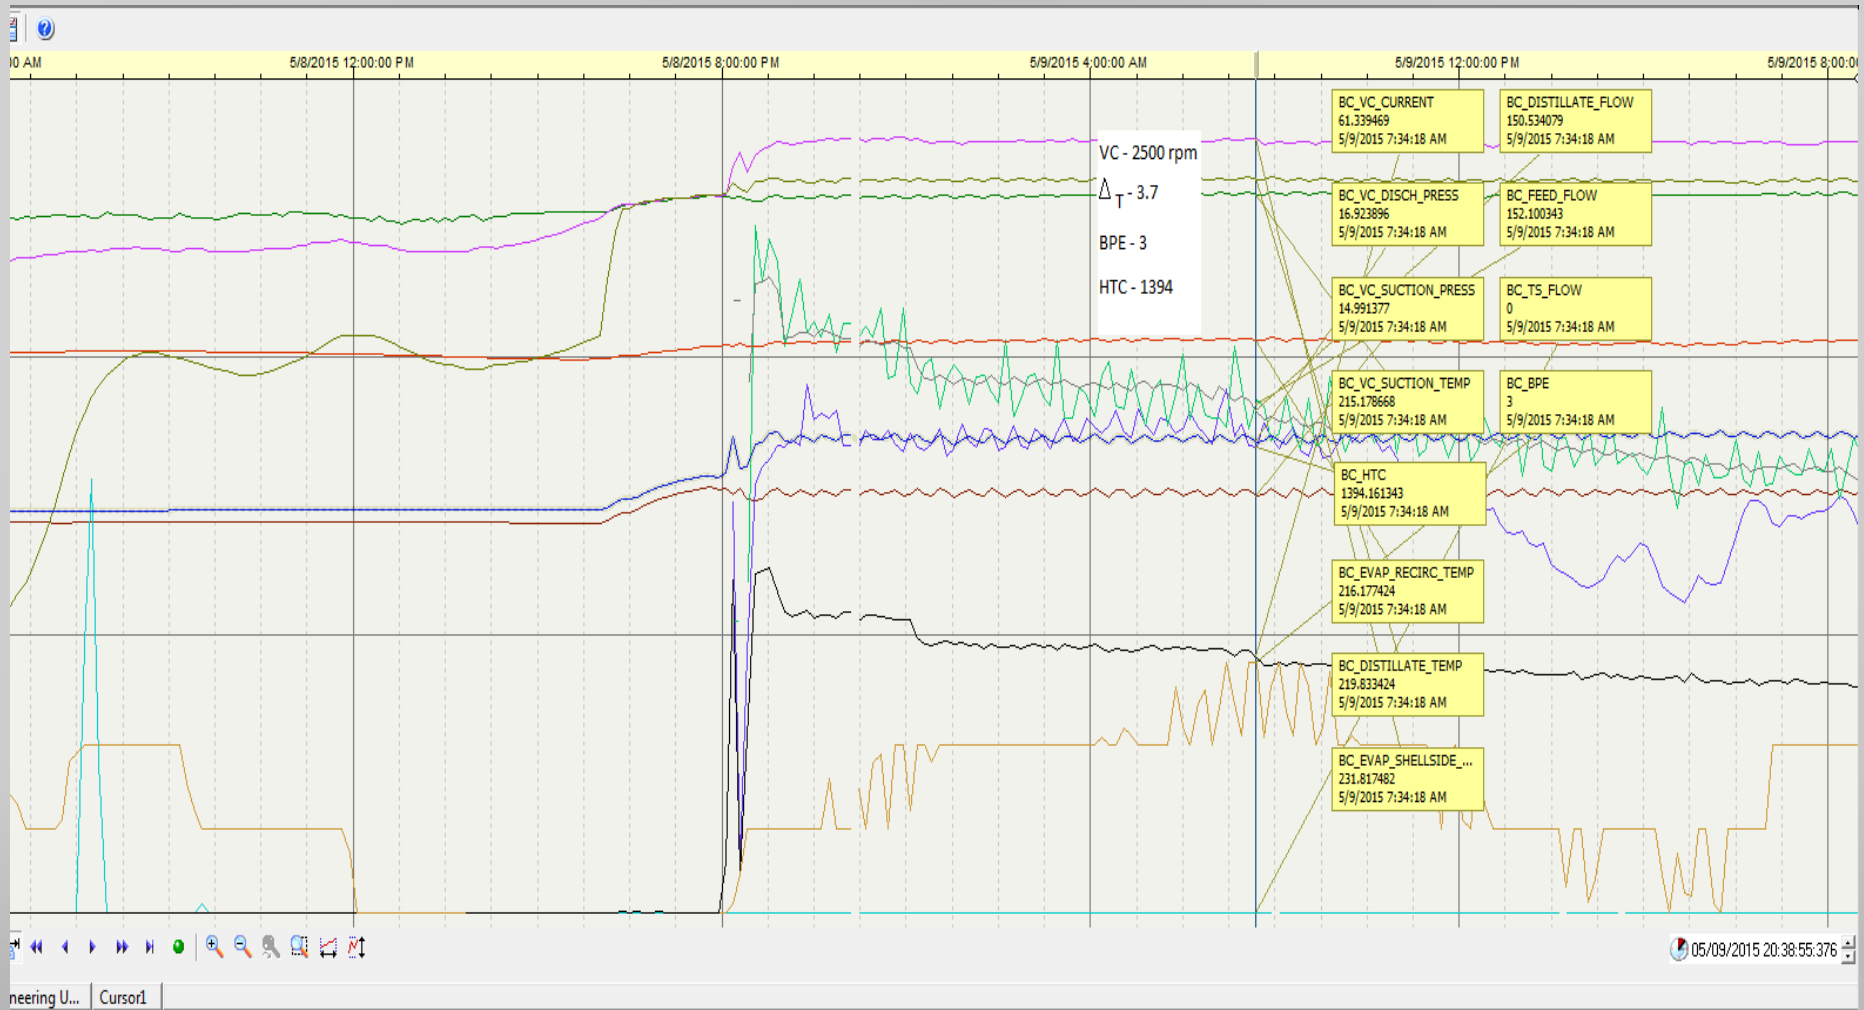
# BC start up after 2<sup>nd</sup> outage
