Environmental Consulting & Technology, Inc.

Re: Noise Measurement Results—Gainesville Renewable Energy Center; Gainesville, Florida

Environmental Consulting & Technology, Inc. (ECT), is submitting this letter report that summarizes the background, methodology, and results of noise measurements conducted at the Gainesville Renewable Energy Center (GREC) facility and Turkey Creek residential subdivision.

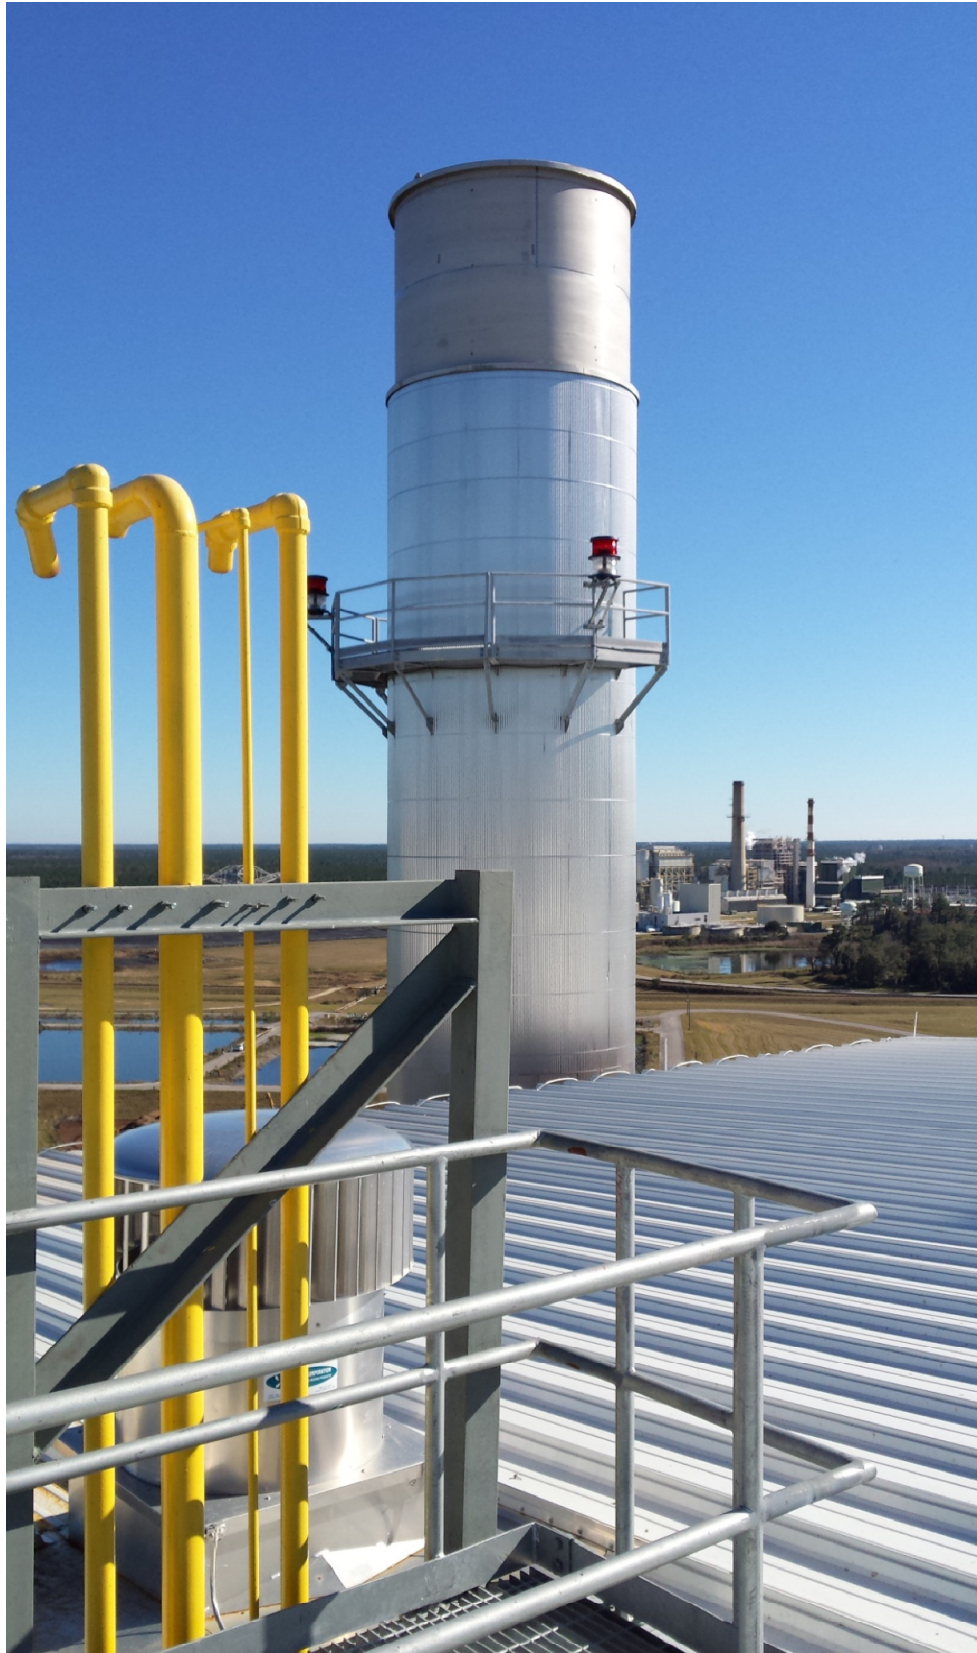
FIGURE 4.

PHOTOGRAPH SHOWING BOILER BUILDING ROOF
NOISE RECEPTOR LOCATION

On Tuesday, December 17, 2013, I again met with Mr. Nist at the GREC facility at approximately 12:30 p.m. to conduct noise measurements on the roof of the boiler building adjacent to the top of the exhaust stack. Noise measurements were conducted using the Larson Davis 831 sound level meter and were taken continuously for a 15-minute period with noise measurements recorded in full and one-third octave bands every 10 seconds. The overall LA_{eq} was measured for the entire 15-minute period. Figure 4 presents a photograph of the access platform on the boiler building roof where noise measurements were conducted.

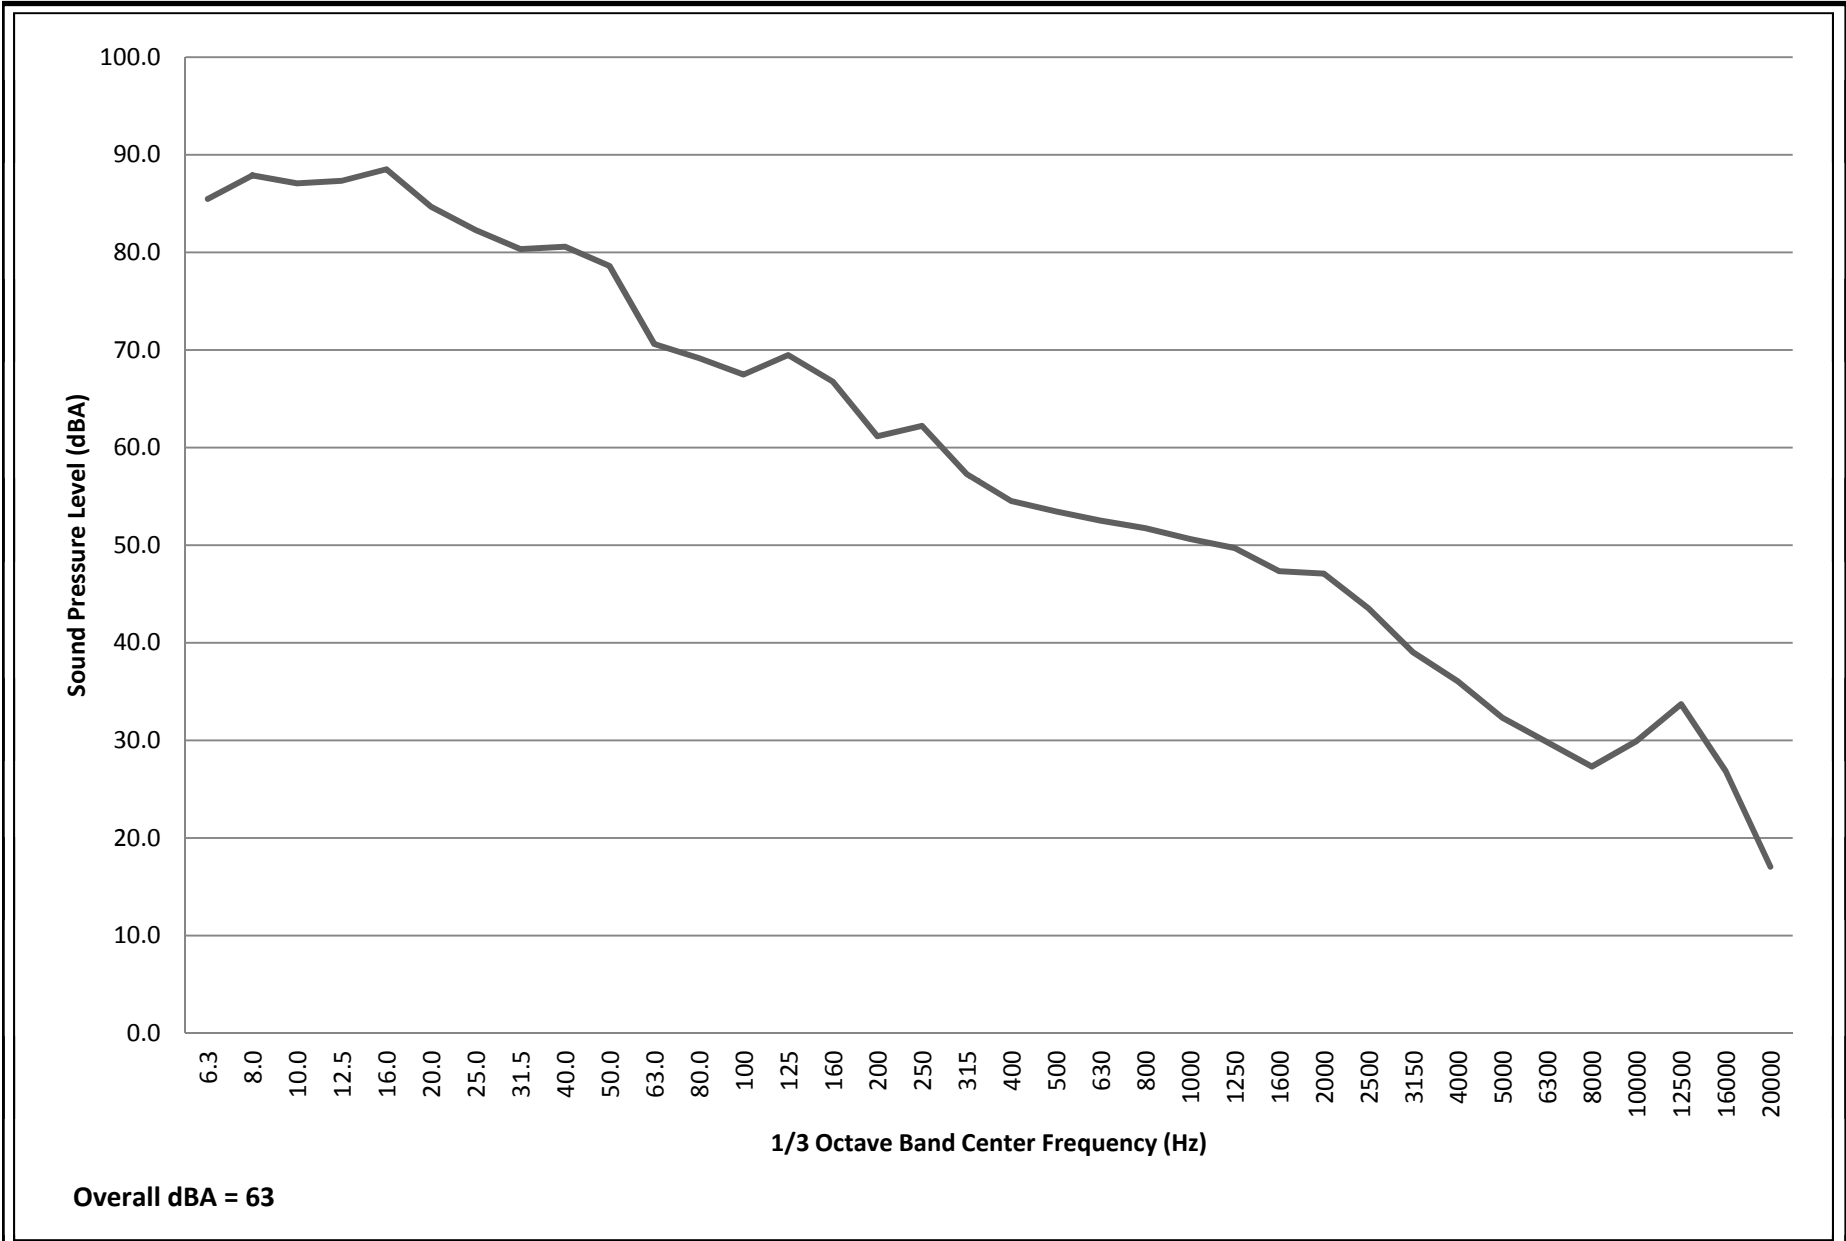
FIGURE 9.

NOISE MEASUREMENT ON BOILER BUILDING ROOF
 DECEMBER 17, 2013

The noise measurements conducted on December 17, 2013, on the roof of the boiler building with the plant operating at 100-percent load and after noise control equipment was installed in the main boiler exhaust stack are summarized in the following table and presented graphically in Figure 9:

| Location | Description | Approximate Time | Octave Band Center Frequency (Hz) | | | | | | | | | Results | |
|---|---|---|---|---|---|---|---|---|---|---|---|---|---|
| Boiler building roof | Adjacent to top of exhaust stack | 1:30 p.m. | 80 | 71 | 70 | 62 | 53 | 51 | 47 | 36 | 27 | 63 | 87 |
