I. Executive summary

The planned outage was completed at a cost of \$-----and required 19 days of downtime for Fuel yard and Boiler Outage. There was one safety incident with contractor working in fuel yard and no environmental incidents. All work and findings were routine with the exception of the following issue. The findings, which are warranty issues with the Siemens Turbine, will require further work in the April 2016 outage.

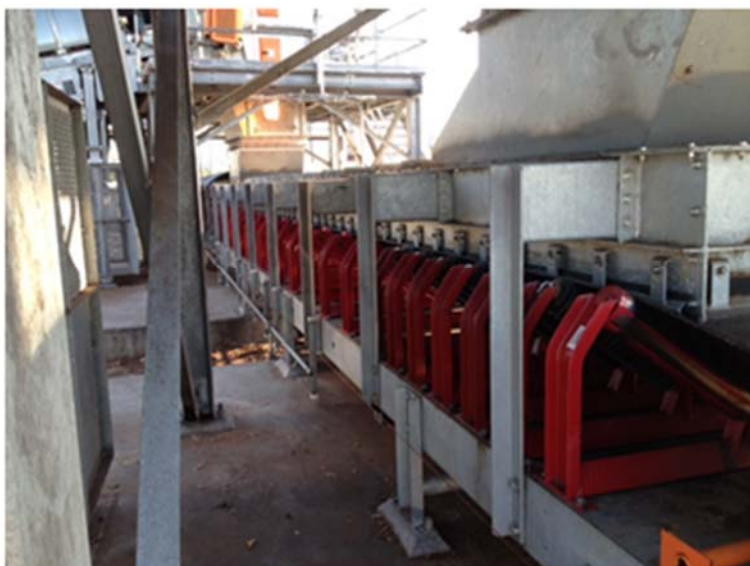
#4 conveyor belt new rollers

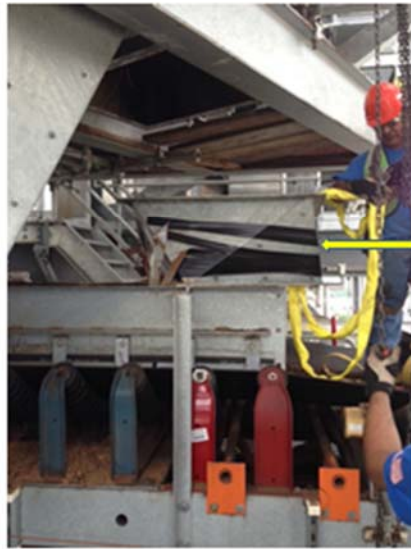
#10 conveyor chute removal

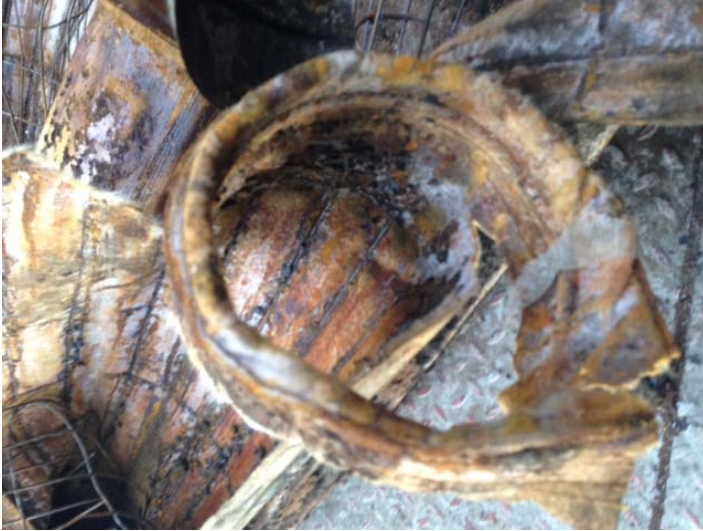
BAD BAGS PULLED FROM # 3 DUST COLLECTOR
