# May 2017 Outage Report

## **A. Executive summary**

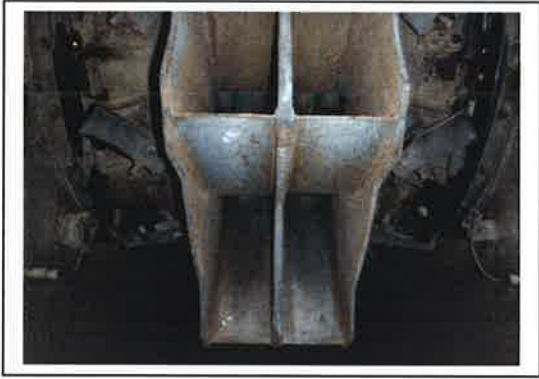
**PA FAN**

All Fans were visually inspected by Tommy Gardner / Tim Stanford and Huck Murray. No visible cracks or dents found. All Fans free of rust and water intrusion, no ash or sand found in fans housing. All fans with internal linkage inspected too.

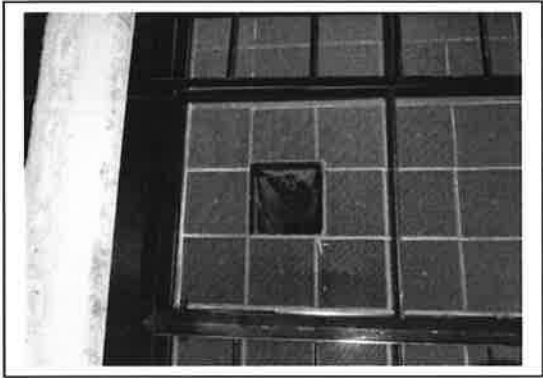
**SAMPLE PULL**

- The SCR inspection revealed no issues and was very clean and dry. One sample was taken and sent to Cream for analysis. Visual inspection by Tommy Gardner and Tony Gravel.
