Gainesville Regional Utilities Deerhaven Generating Station

Coal Combustion Residual Units Annual Inspection Report (December 16, 2016 – December 12, 2017)

**Innovative Waste Consulting Services, LLC
3720 NW 43rd Street, Ste. 103
Gainesville, Florida 32606**

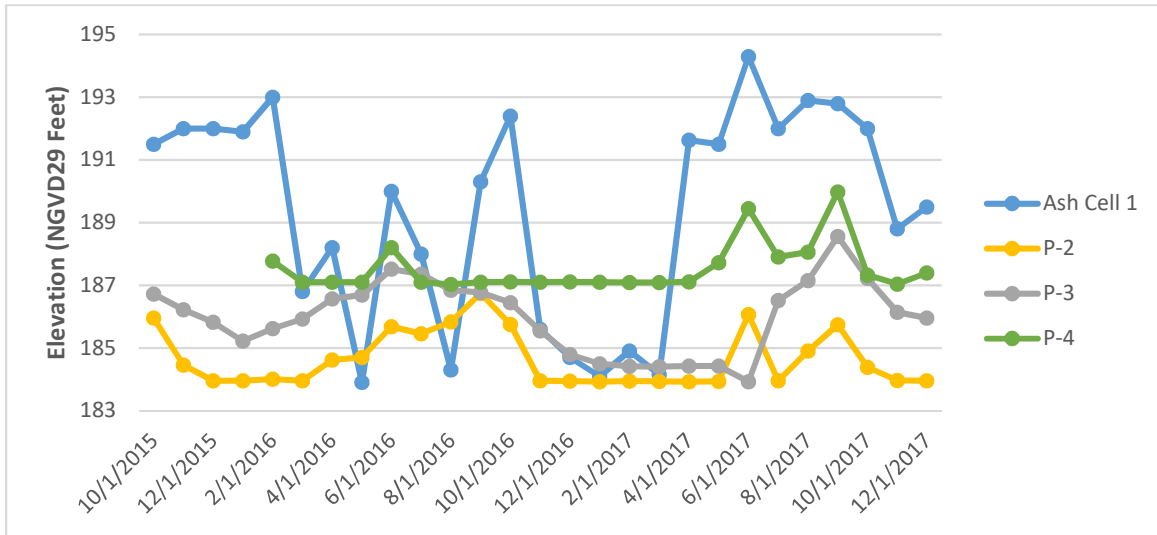
Figure 3. Liquid Elevations for Ash Cell #1 and Piezometers

During each monthly inspection, depth-to-liquid readings in the piezometers located in the embankments of Ash Cell #1 and Ash Cell #2 were measured. The water level measured in these piezometers are used to qualitatively assess potential embankment seepage areas; Piezometer P-2, P-3 and P-4 are used to monitor each outside embankment for Ash Cell #1 and P-1 is used to monitor the outside embankment of Ash Cell #2. The liquid elevation in the piezometers was compared to the liquid elevation in each adjacent ash pond. Figure 3 and 4 present a comparison of the measured liquid levels for Ash Cell #1 and corresponding piezometers and Ash Cell #2 and corresponding piezometer, respectively. IWCS measurements on the day of the inspection were consistent with those measured by GRU during the most recent monthly inspection.
