Gainesville Regional Utilities Deerhaven Generating Station

Coal Combustion Residual Units Annual Inspection Report (13 December 2017 – 12 December 2018)

**Innovative Waste Consulting Services, LLC
3720 NW 43rd Street, Ste. 103
Gainesville, Florida 32606**

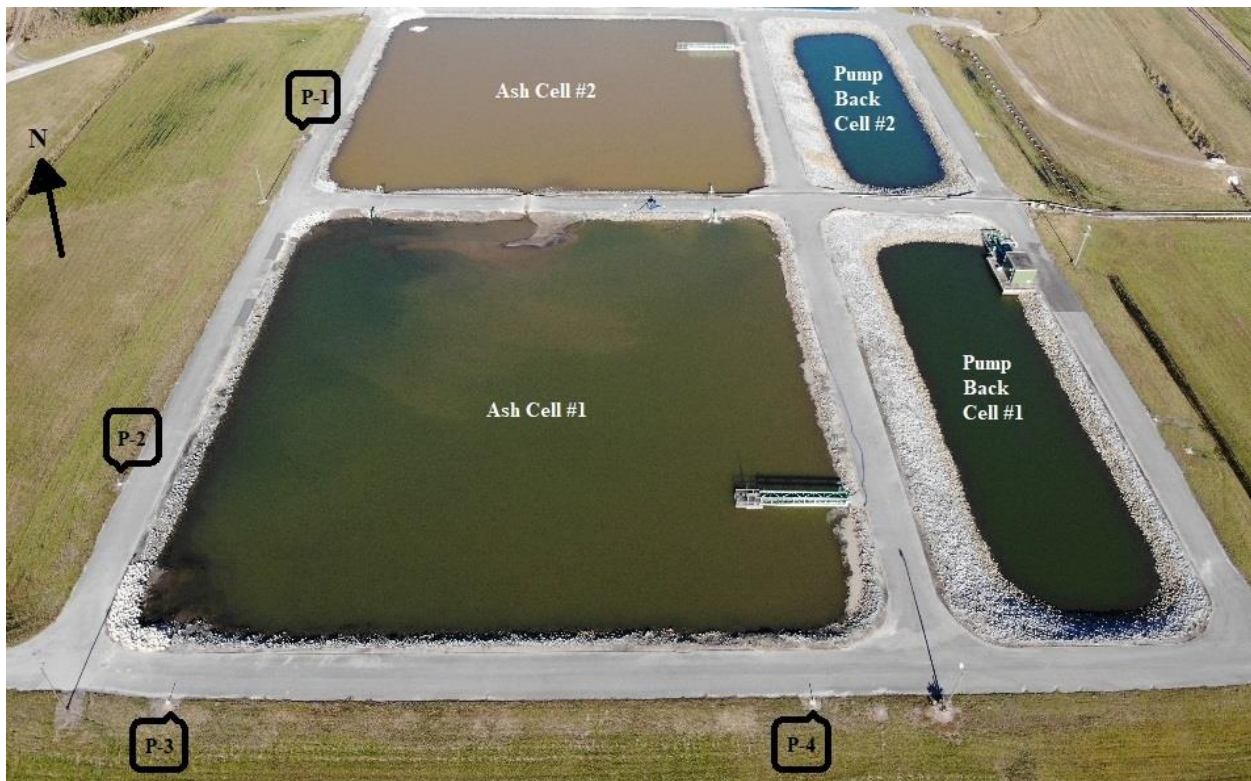
Figure 1. Layout of the CCR Surface Impoundment System and Adjacent Pump Back Ponds (IWCS 2018a)

The CCR surface in the ash ponds was mostly inundated at the time of this inspection (as shown in Figure 1 aerial image); the current CCR storage capacity of the surface impoundment systems could not be estimated. However, based on construction records, it is estimated that the CCR surface impoundment system has a total volumetric capacity of 17.3 million gallons (or approximately 85,400 cubic yards) not including the capacity associated with the 2 feet of freeboard.
