# Gainesville Regional Utilities Deerhaven Generating Station

## Coal Combustion Residual Units Annual Inspection Report (11 December 2020 – 8 December 2021)

Innovative Technical Solutions  
3720 NW 43<sup>rd</sup> Street, Ste. 103  
Gainesville, Florida 32606

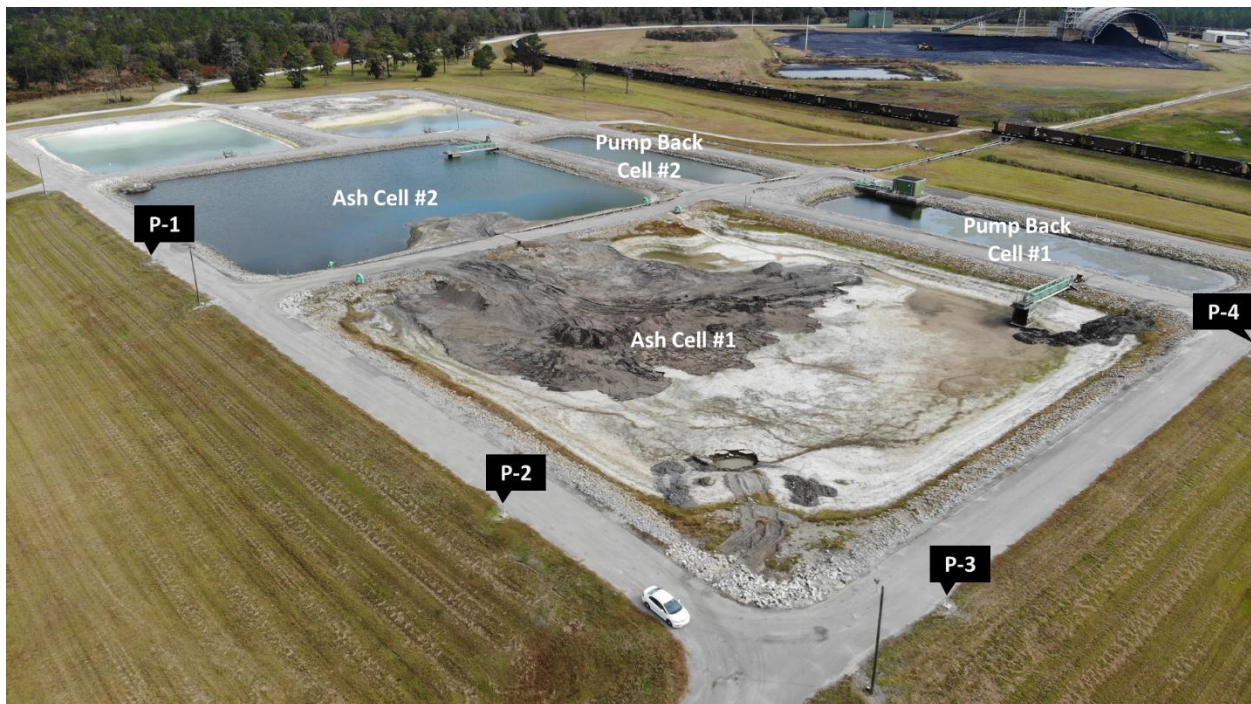
**Figure 1. Layout of the CCR Surface Impoundment System, Adjacent Pump Back Cells, and Piezometers**

A large portion of the CCR surface in Ash Cell #2 was inundated at the time of this inspection (as shown in Figure 1 aerial image); the current CCR storage capacity of the surface impoundment systems could not be estimated. However, based on construction records, it is estimated that the CCR surface impoundment system has a total volumetric capacity of 17.3 million gallons (or approximately 85,400 cubic yards), not including the capacity associated with the 2 feet of freeboard.

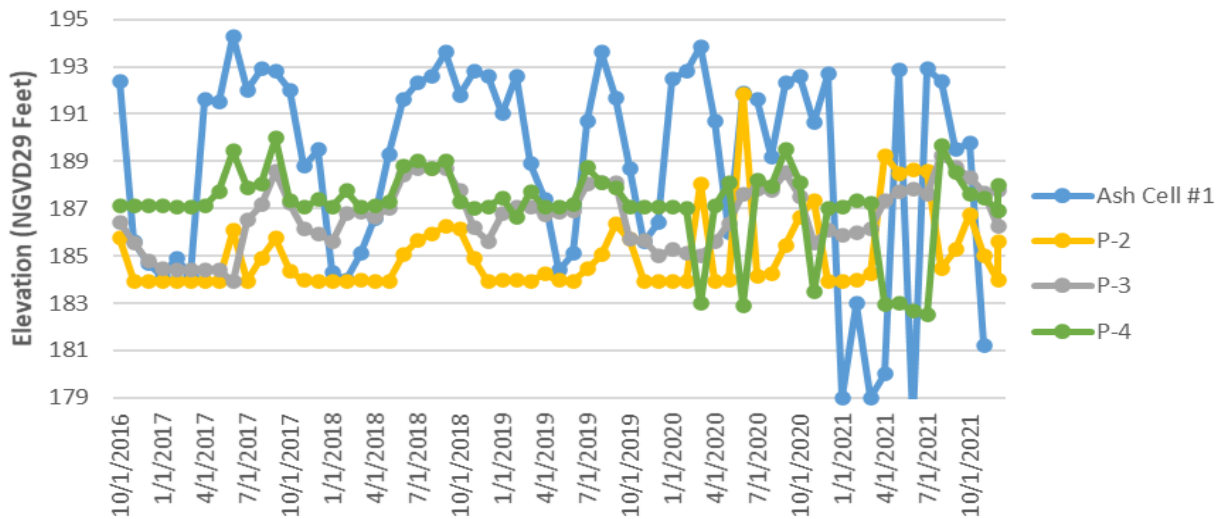
**Figure 3. Liquid Elevations for Ash Cell #1 and Piezometers**

For Ash Cell #1, the first occurrence of elevated water levels was reported on 6/29/2021 due to heavy rains. The water level in Ash Cell #1 was observed to be below 193 feet for the subsequent two weekly inspections but was elevated for the following three weekly inspections (from 7/20/2021 through 8/3/2021) due to heavy rain from Hurricane Elsa. The water level in Ash Cell #1 was reported to be below 193 ft elevation starting the weekly inspection on 8/10/2021.

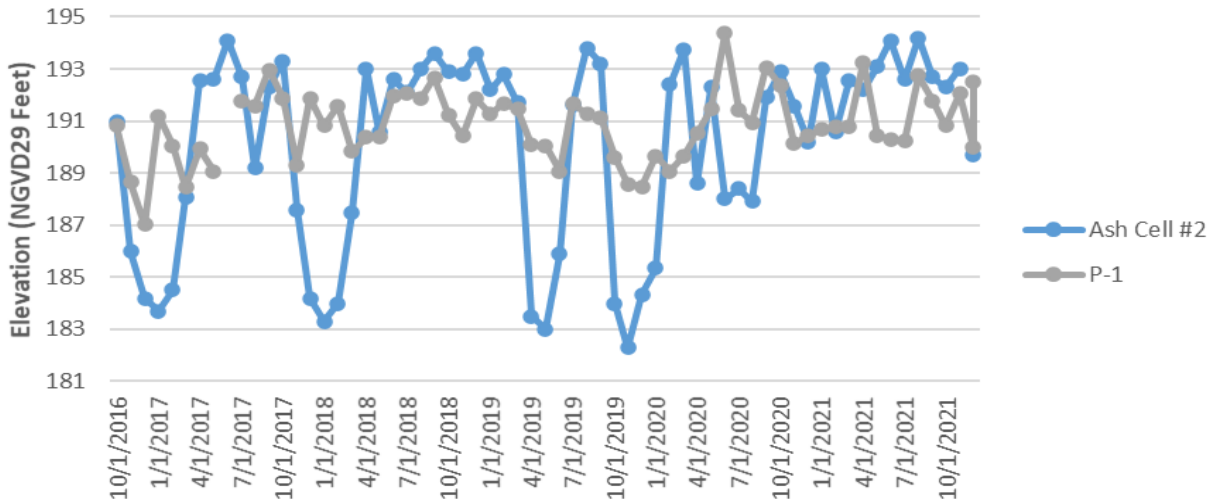
**Figure 4. Liquid Elevations for Ash Cell #2 and Piezometer**

other ten incidences of elevated water levels were observed during the weekly inspections from 4/19/2021 through 8/10/2021. The water elevation in Ash Cell # 2 was reported to be intermittently above 193 feet (NGVD29) due to multiple factors, including heavy rain before and from Hurricane Elsa, pump and valve failure, and the Ash Cell #1 outage. The operators closely monitored pond levels and adjusted process water and stormwater pumping to the ponds to reduce the ash pond levels expeditiously during these events.
