Gainesville Regional Utilities Deerhaven Generating Station

Coal Combustion Residual Units Annual Inspection Report (December 9, 2021 – December 6, 2022)

Innovative Technical Solutions
3720 NW 43rd Street, Ste. 103
Gainesville, Florida 32606

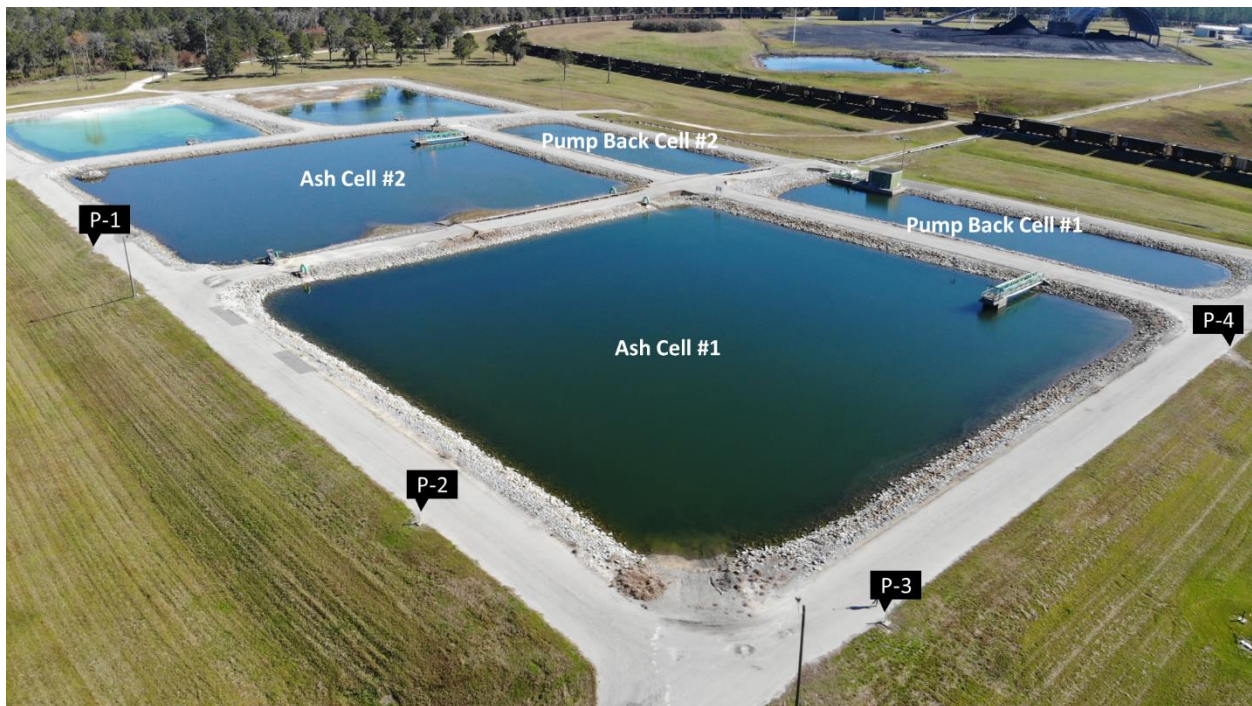
Figure 1. Layout of the CCR Surface Impoundment System, Adjacent Pump Back Cells, and Piezometers

A large portion of the CCR surface in Ash Cell #2 was inundated at the time of this inspection (as shown in Figure 1 aerial image); the current CCR storage capacity of the surface impoundment systems could not be estimated. However, based on construction records, it is estimated that the CCR surface impoundment system has a total volumetric capacity of 17.3 million gallons (or approximately 85,400 cubic yards), not including the capacity associated with the 2 feet of freeboard.

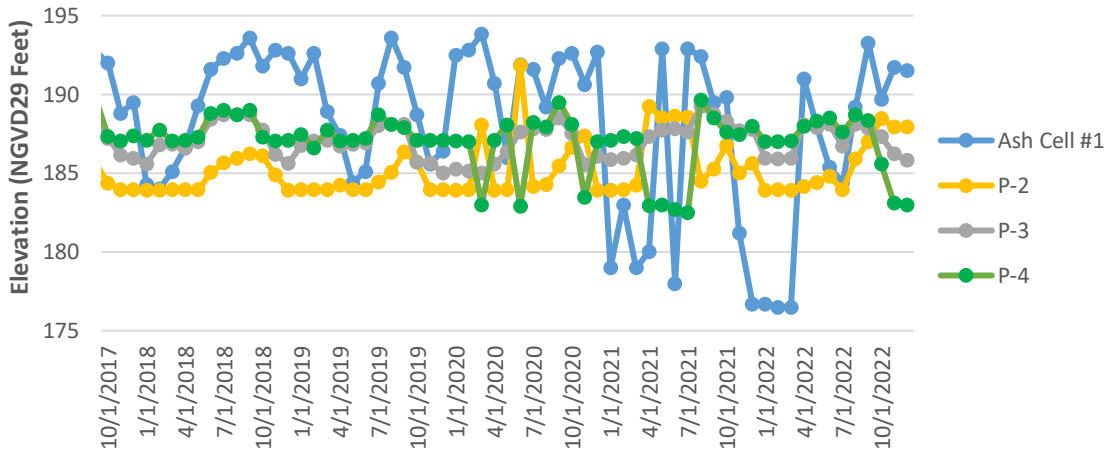
Figure 3. Liquid Elevations for Ash Cell #1 and Piezometers

For Ash Cell #1, the first occurrence of elevated water levels was reported on 9/6/2022 due to heavy rains. The water level in Ash Cell #1 was again observed to be higher than 193 feet for two consecutive weeks, 11/15/2022 and 11/22/2022, which was a result of a unit outage.
