**COAL COMBUSTION RESIDUALS (CCR)  
ABUTMENT AND BASE SURFACE IMPOUNDMENT SYSTEM EVALUATION**

**DEERHAVEN GENERATING STATION (DGS)  
10001 NW 13<sup>th</sup> STREET  
GAINESVILLE, ALACHUA COUNTY, FLORIDA**

**PROJECT NO. 0230.1500077  
REPORT NO. 1352022**

Reference: **Report of Geotechnical Consulting Services – Desktop Assessment**  
Deerhaven Generating Station  
CCR Abutment and Base Impoundment Evaluation  
10001 NW 13<sup>th</sup> Street  
Gainesville, Alachua County, Florida  
UES Project No. 0230.1500077  
UES Report No. 1352022

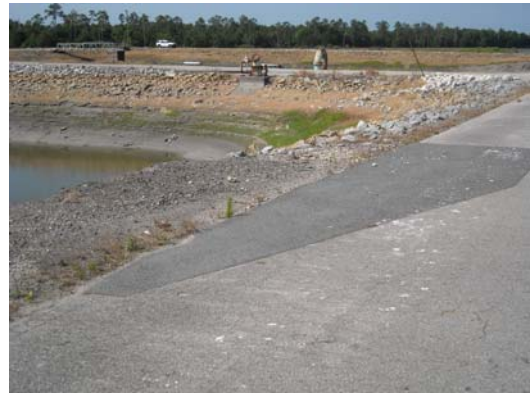
**Photograph 20**

Pavement cracking along the interior edge of the dikes was noted at the northwestern edges of each ash pond, as well as alligator cracking in the pavement atop the interior dike between both ash ponds. See **Photos 17 through 19** for the aforementioned pavement cracking. Previous pavement repair (patching) was apparent along the northwest edge of Ash Cell #2, as shown in **Photo 20**. The water level in the ash ponds was relatively low at the time of inspection. See **Photos 21 and 22** for the approximate ash pond water elevations.
