**COAL COMBUSTION RESIDUALS (CCR)  
ABUTMENT AND BASE SURFACE IMPOUNDMENT SYSTEM  
PERIODIC STRUCTURAL STABILITY ASSESSMENT**

**DEERHAVEN GENERATING STATION (DGS)  
10001 NW 13<sup>th</sup> STREET  
GAINESVILLE, ALACHUA COUNTY, FLORIDA**

**PROJECT NO. 0230.1500077  
REPORT NO. 1892167**

September 29, 2021

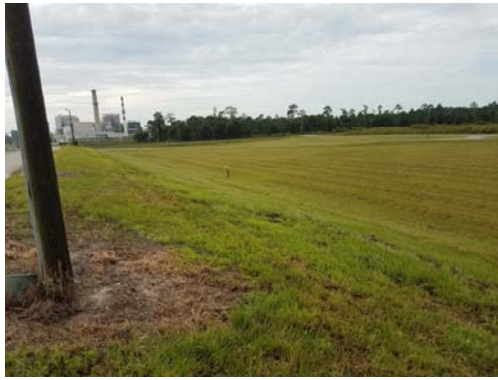
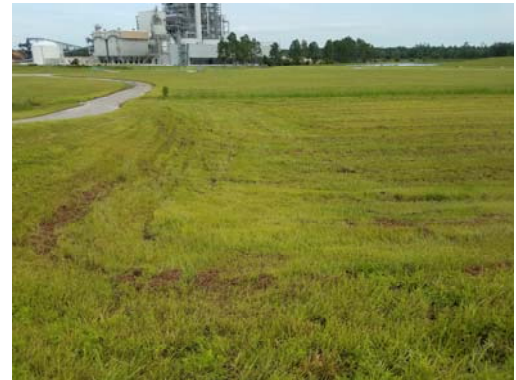
During our August 11, 2021 site visit, visual observations showed that the exterior embankment slopes were covered with grass vegetation which appeared to be more than 6 inches in height. Subsequent visit (August 23, 2021), indicated that grass vegetation was mowed, well maintained with less than 6 inches in height (**Photos 7 and 8**).

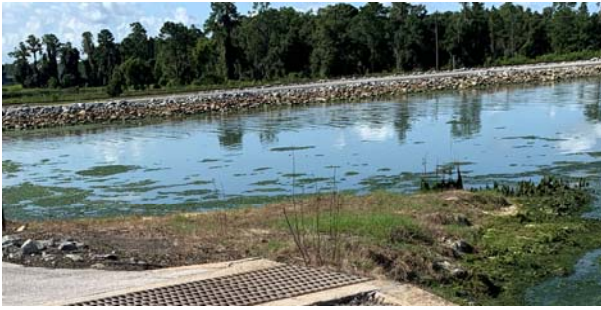
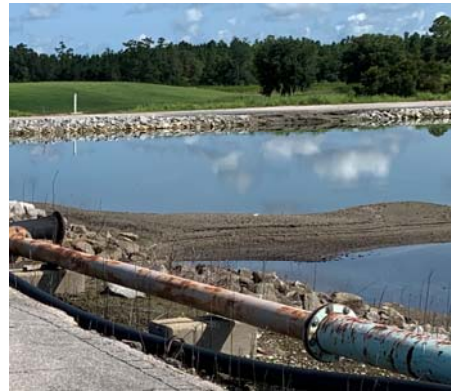
The inside slope toe and much of the slope is covered with ash, particularly along the center of the northeastern slope of Ash Cell #1, and the center of the southwestern slope of Ash Cell #2. See **Photos 11 and 12** where ash is accumulated over the slope of the surface impoundment

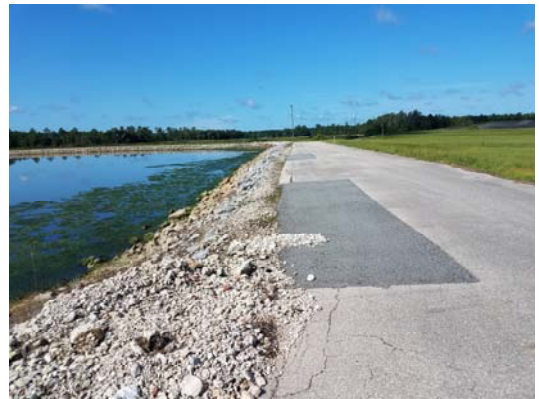
The crest of the CCR Surface Impoundment System dikes is accessible with vehicles. The crest had no signs of depression, tension cracking or other indications of settlement or shear failure. The pavement surface was generally observed to be in fair condition. Some localized areas of distress were noted along the pavement surface (**Photos 17 through 19**). Asphalt surface cracks typically associated with shrinkage of the asphalt (longitudinal/transverse cracks – **Photo 17**) and weakened subgrade near the edge of pavement (edge cracking), were encountered along the service road at the top of the embankments in some areas. See **Photograph 20** for a typical view of the crest/pavement edge cracking, with areas of patching.

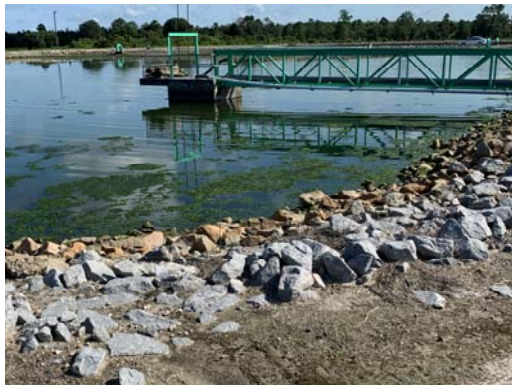
**Photograph 21**

The outlets of Ash Cell #1 and Ash Cell #2 consist of concrete drop structures (**Photos 21 and 22**) with stop logs that provide ash containment. The concrete drop structures hydraulically connect to Pump Back Cells #1 and #2. Water flows from the surface impoundment system to the pump pack ponds via a 12" butterfly valve located in the stop log structure in the ponds through a 12" filament-wound glass-fiber reinforced plastic culvert pipe to an outfall in the pump back pond. The elevation of the 12" butterfly valve is 177 feet, NGVD 29, and the outfall elevation is 175 feet, NGVD 29. Water from the Pump Back Cells gets pumped back to the plant for reuse in plant operations; the plant is a zero-discharge facility.

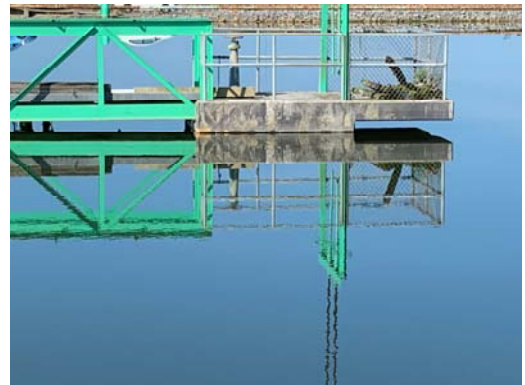
**Photograph 22**

Based on information provided by GRU, the valve located at Ash Cell #2 is currently not functioning, and that the operating linkage appears to have failed below the waterline. GRU is implementing a repair plan which includes isolating the inlet and outlet of the stop log structure to facilitate drainage and to repair the valve. Currently, a diesel driven power prime pump is being utilized to move water out of that impoundment, as needed to control level and to provide water to feed the plant. See **Photo 22 showing** the water level of Ash Cell #2 just below the stop log structure platform.

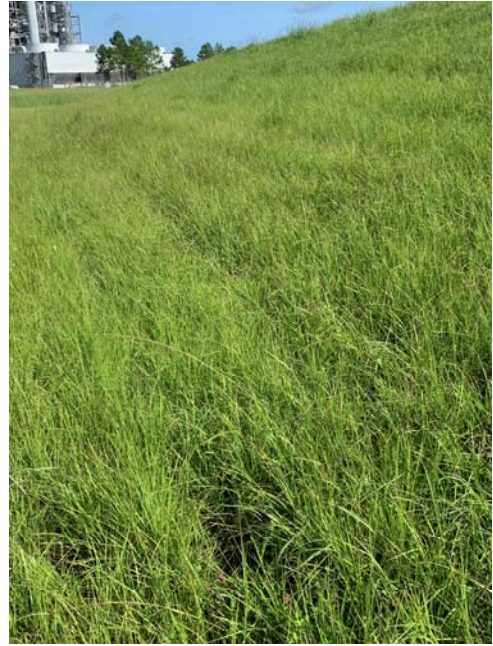
**Photograph 24**

The interior slope of the surface impoundment system was observed to be lined with riprap, which serves as slope protection, with moderate amounts of dormant vegetation (see **Photo 23**). The exterior slope has a grass cover and does not have signs of significant dips, sags or

other visual evidence of distress (see **Photo 24**). See **Appendix C** for the aforementioned photos.
