Gainesville Regional Utilities Deerhaven Generating Station

2019 Coal Combustion Residual Units Annual Inspection Report (Reporting Period: 13 December 2018 – 10 December 2019)

Innovative Technical Solutions
3720 NW 43rd Street, Ste. 103
Gainesville, Florida 32606

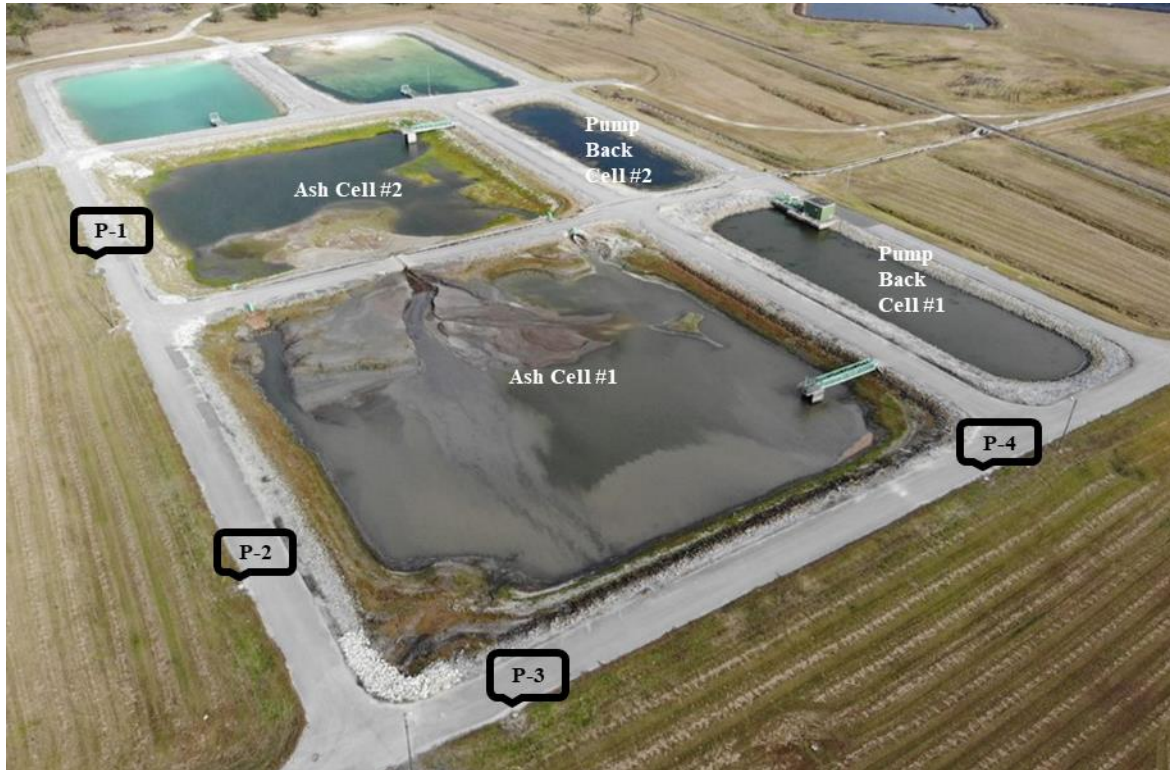
Figure 1. Layout of the CCR Surface Impoundment System and Adjacent Pump Back Ponds (Picture was taken by ITS on 20 December 2019)

A large portion of the CCR surface in the ash ponds was inundated at the time of this inspection (as shown in Figure 1 aerial image); the current CCR storage capacity of the surface impoundment systems could not be estimated. However, based on construction records, it is estimated that the CCR surface impoundment system has a total volumetric capacity of 17.3 million gallons (or approximately 85,400 cubic yards) not including the capacity associated with the 2 feet of freeboard.

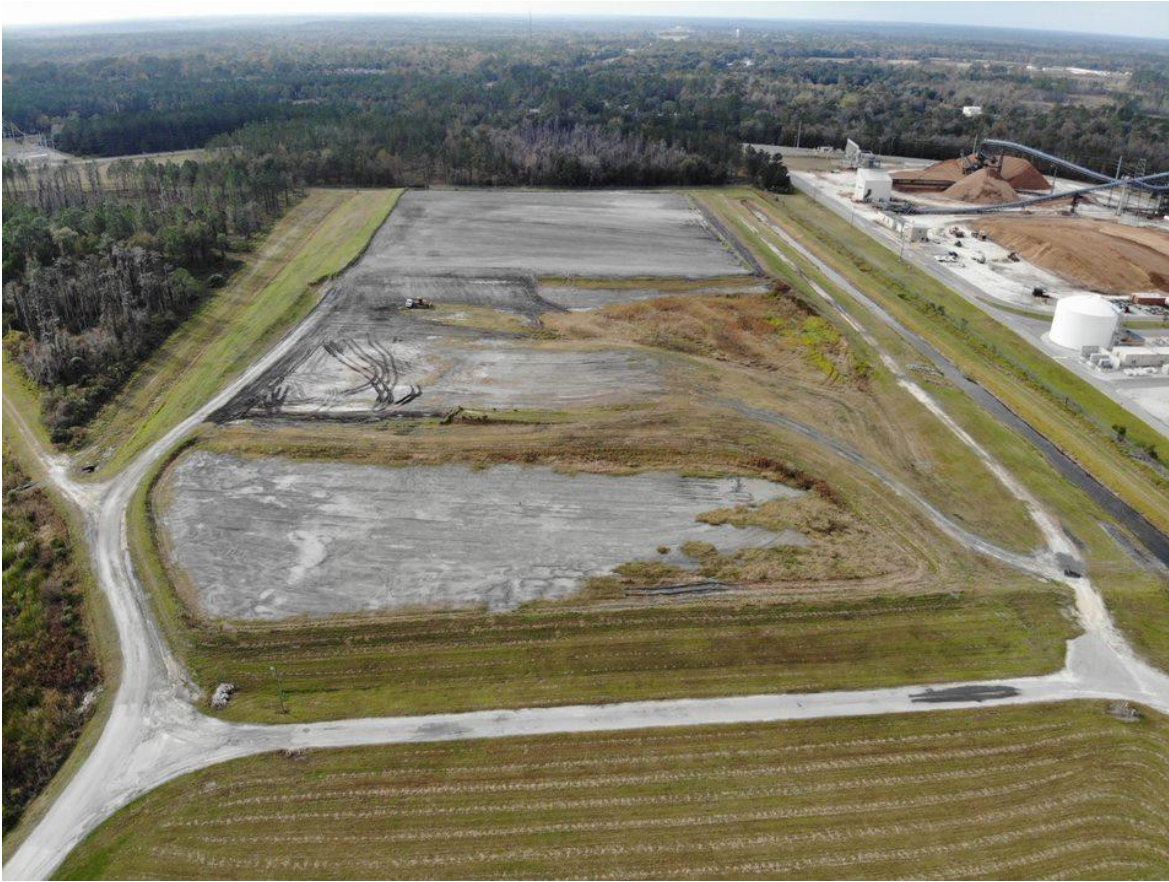
Figure 2. Aerial Image of CCR Landfill Facing West (Picture was taken by ITS on 20 December 2019)
