Gainesville Regional Utilities Deerhaven Generating Station

Coal Combustion Residual Units Annual Inspection Report (11 December 2019 – 10 December 2020)

Innovative Technical Solutions
3720 NW 43rd Street, Ste. 103
Gainesville, Florida 32606

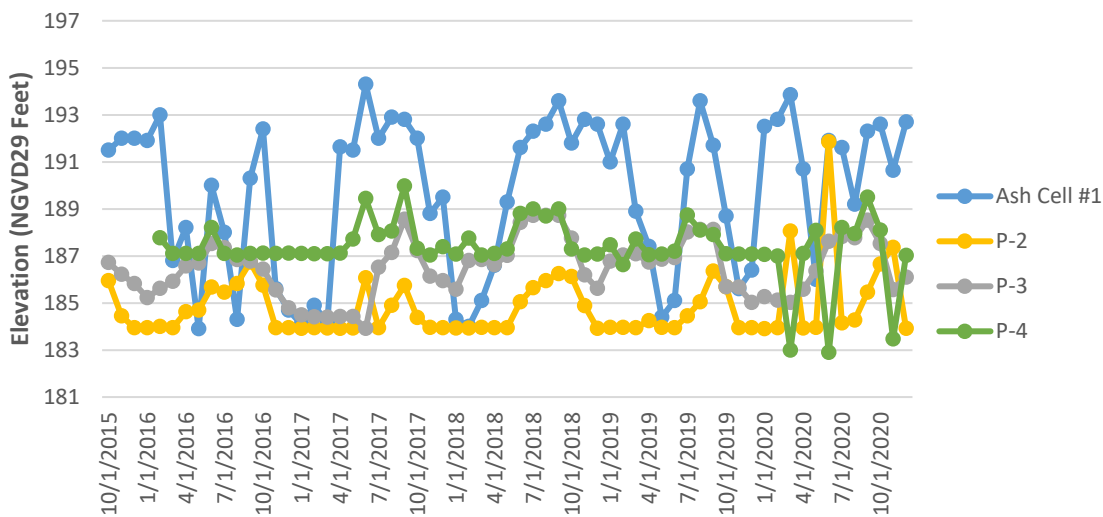
Figure 3. Liquid Elevations for Ash Cell #1 and Piezometers

During each monthly inspection, depth-to-liquid readings in the piezometers located on the embankments of Ash Cell #1 and Ash Cell #2 were measured. The water level measured in these piezometers are used to qualitatively assess potential embankment seepage areas; Piezometer P-2, P-3, and P-4 are used to monitor exterior embankments for Ash Cell #1, and P-1 is used to monitor the exterior embankment of Ash Cell #2. The liquid elevation in the piezometers was compared to the liquid elevation in each adjacent ash pond. Figures 3 and 4 present a comparison of the measured liquid levels for Ash Cell #1 and corresponding piezometers and Ash Cell #2 and corresponding piezometer(s), respectively. The measurements taken by ITS engineers on the day of the annual inspection were consistent with those measured by GRU during the most recent monthly inspection.
