I. Executive summary

The planned outage was completed at a cost of \$-----and required 19 days of downtime for Fuel yard and Boiler Outage. There was one safety incident with contractor working in fuel yard and no environmental incidents. All work and findings were routine with the exception of the following issue. The findings, which are warranty issues with the Siemens Turbine, will require further work in the April 2016 outage.

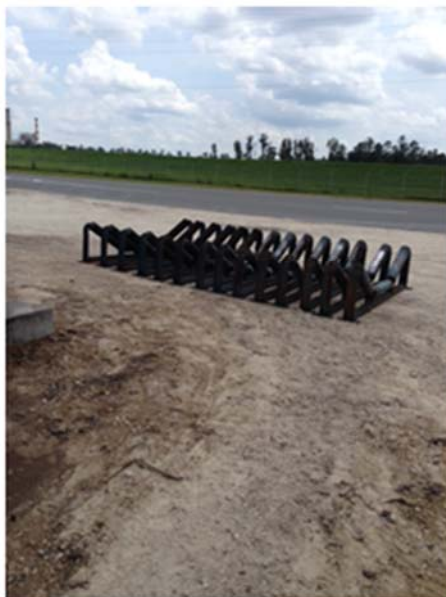
Rollers removed from #4 belt

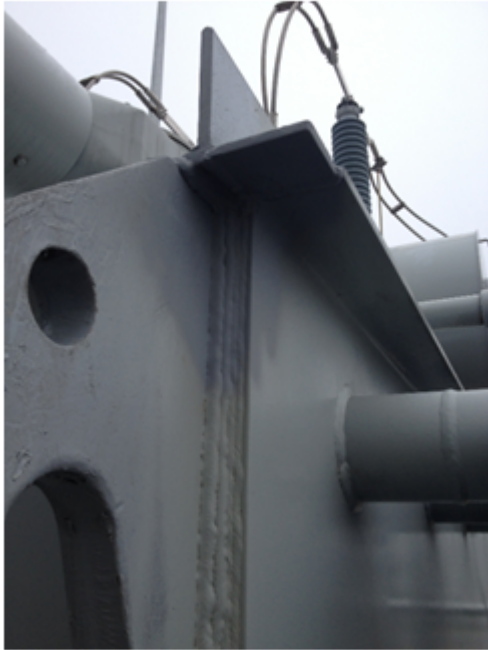
Leak #2 – SE corner

After (two days later):

Performed motor circuit evaluation offline motor testing; Equipment tested was ID Fan motor, PA Fan motor, SA Fan motor, FGR Fan motor, Feed Water Pumps motors A & B. Performed Infrared Thermography for all 480 volt motor controllers and breakers that were in service with current load in MCC/PDC rooms .There were no problems found while testing motors, all test data is within specs for motor tested. Worked annual PLC PM Inspections; Worked annual transformer PM inspections ; Worked annual generator step- up transformer PM; Worked 2 year generator PM inspection; Worked EMA SST common alarm back in, Sudden Pressure . Cleaned all MCC/PDC rooms.....Checked the slip rings on both fuel silo's A &B. Repaired GSU Transformer casing oil leak.

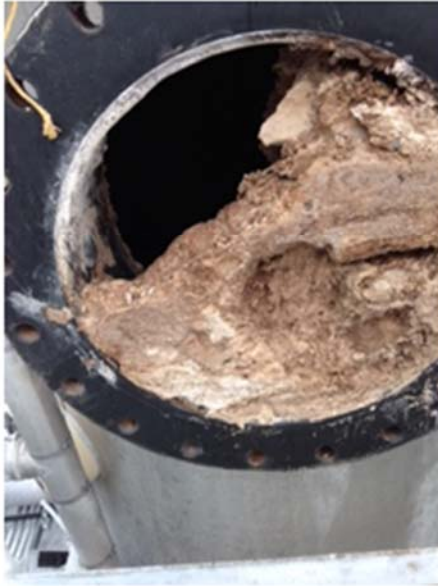
FOUND THE RUBBER LINING TO THE FLASH TANK COMING APART, HAD RUBBER SEAL REPAIRED BY CONTRACTOR.

ZDS Flash tank

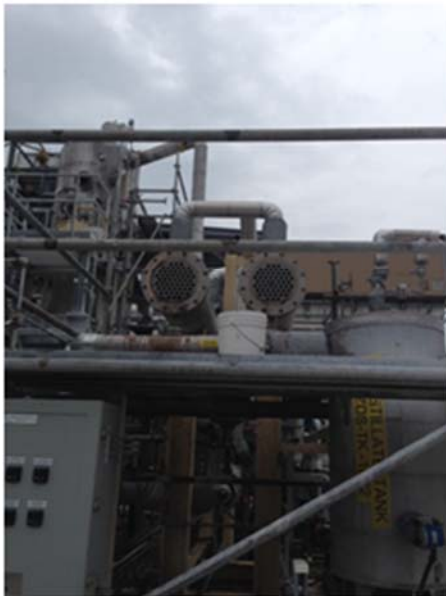
ZDS work

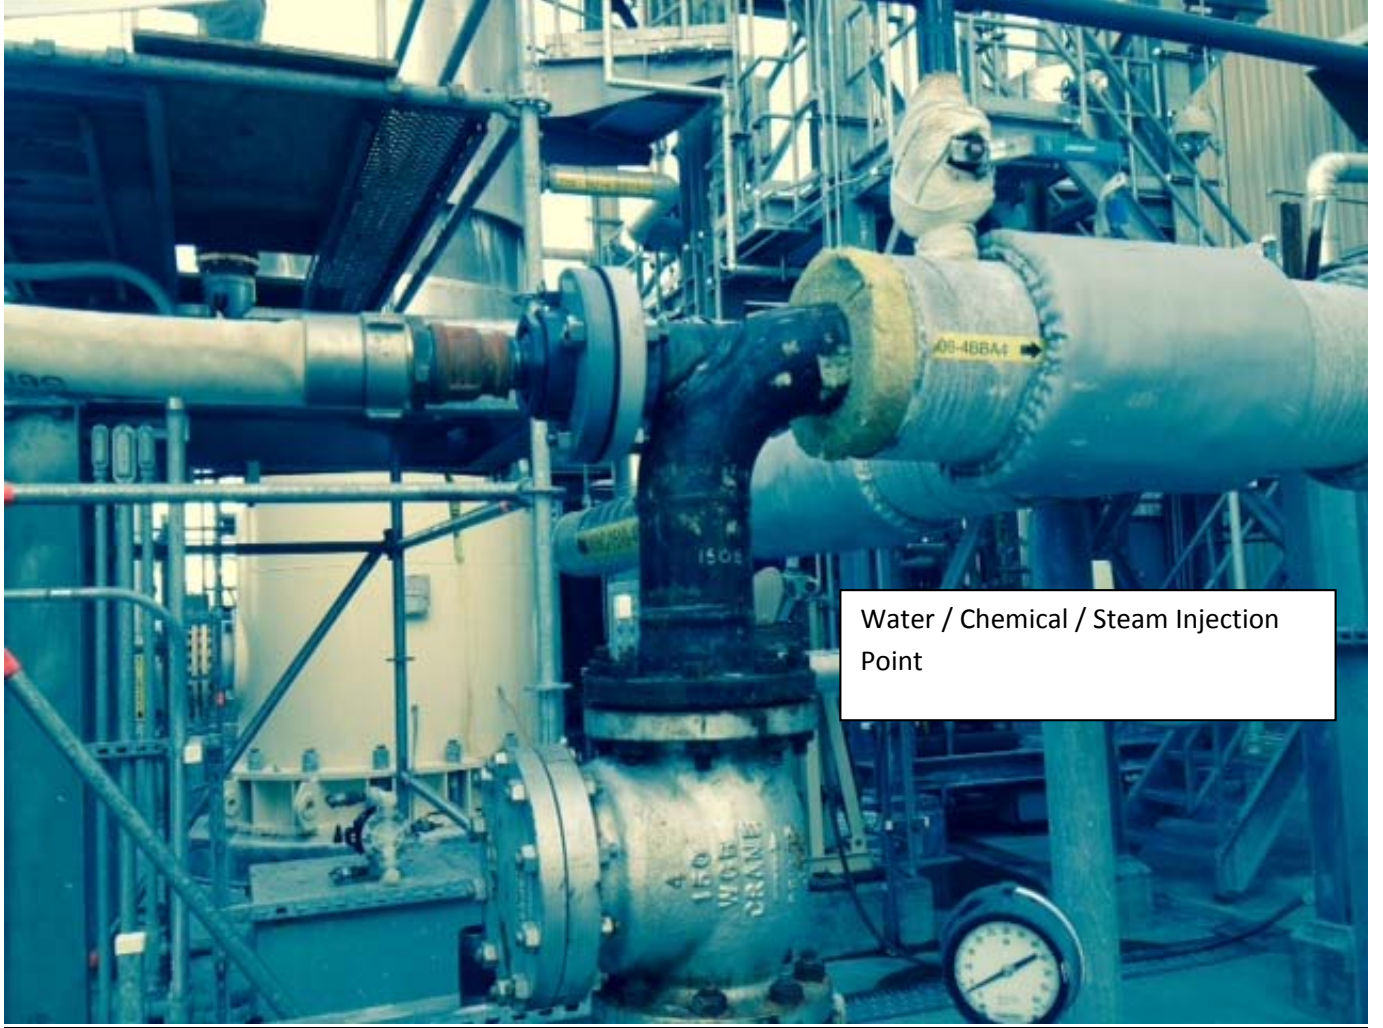
Vapor Compressor Expansion
Joint

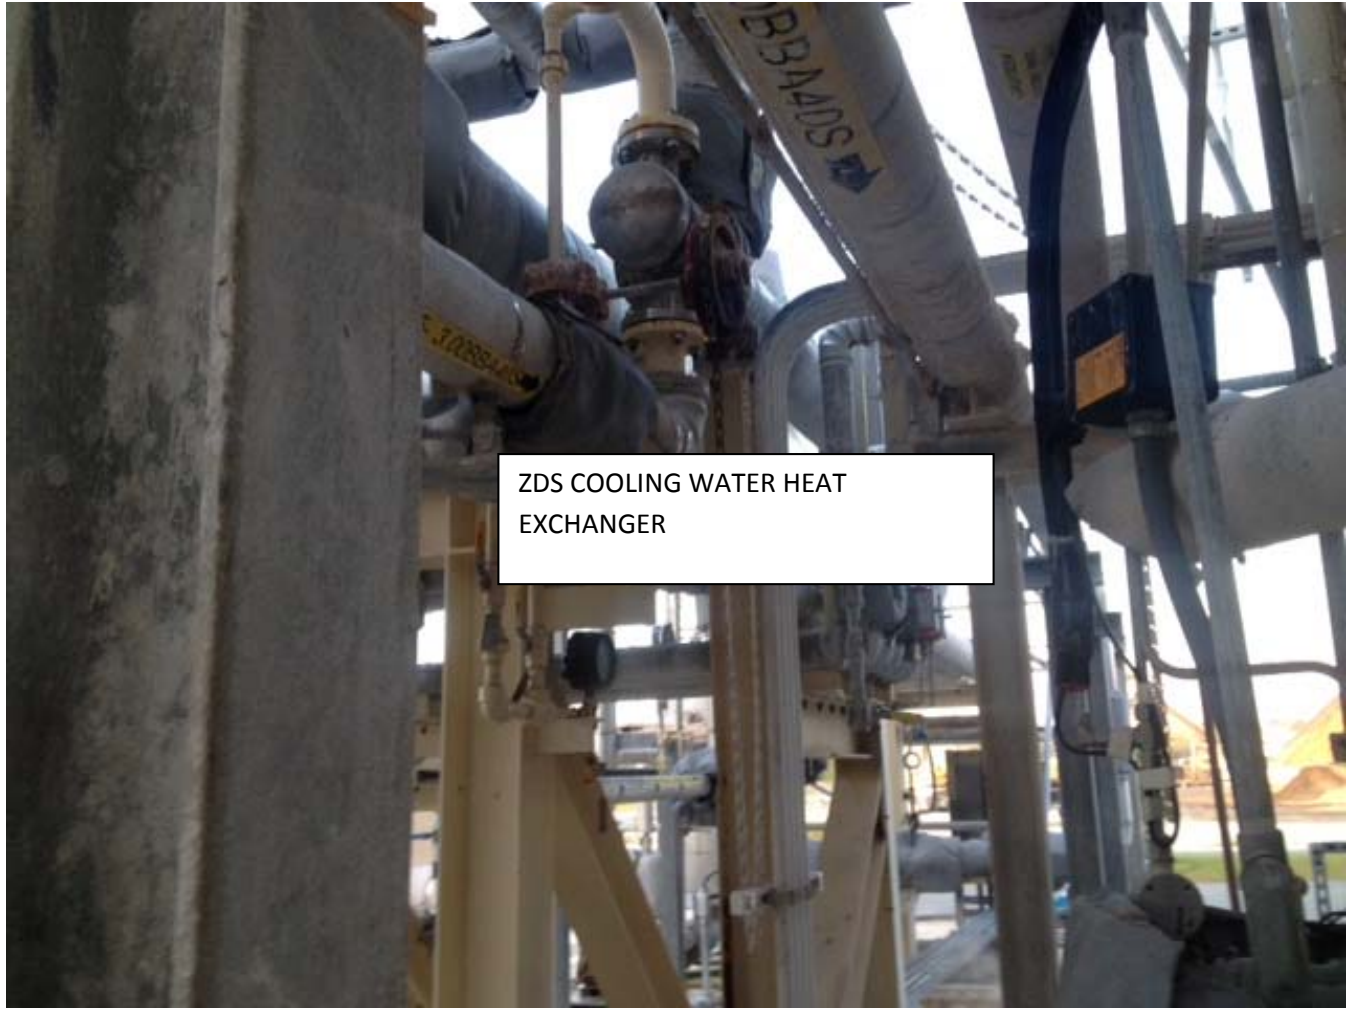
New flights and chain on fuel system

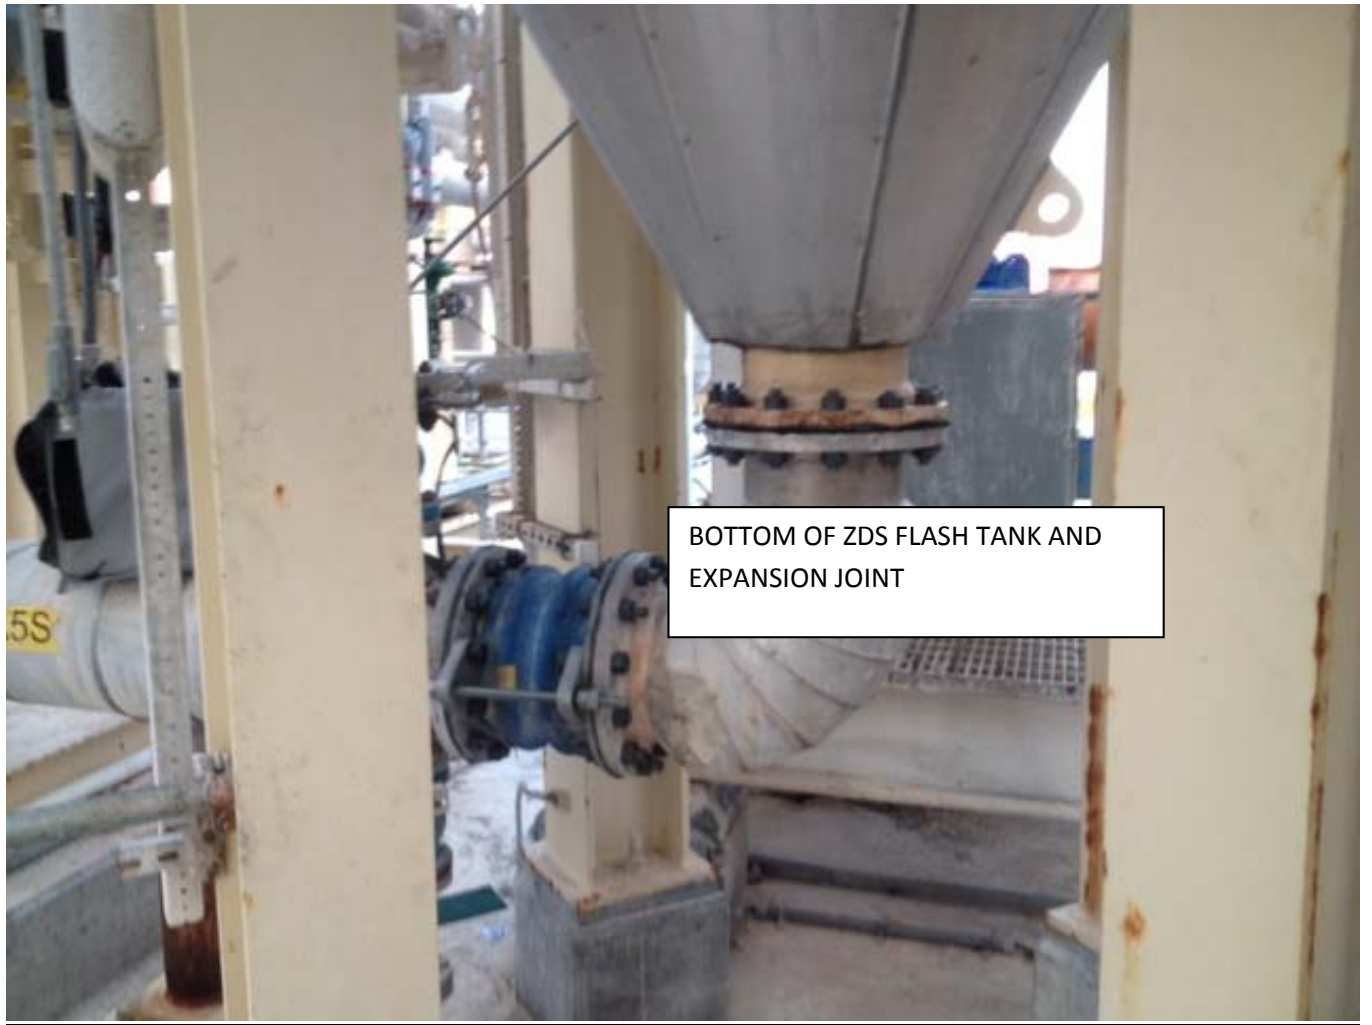
ZDS FLASH TANK

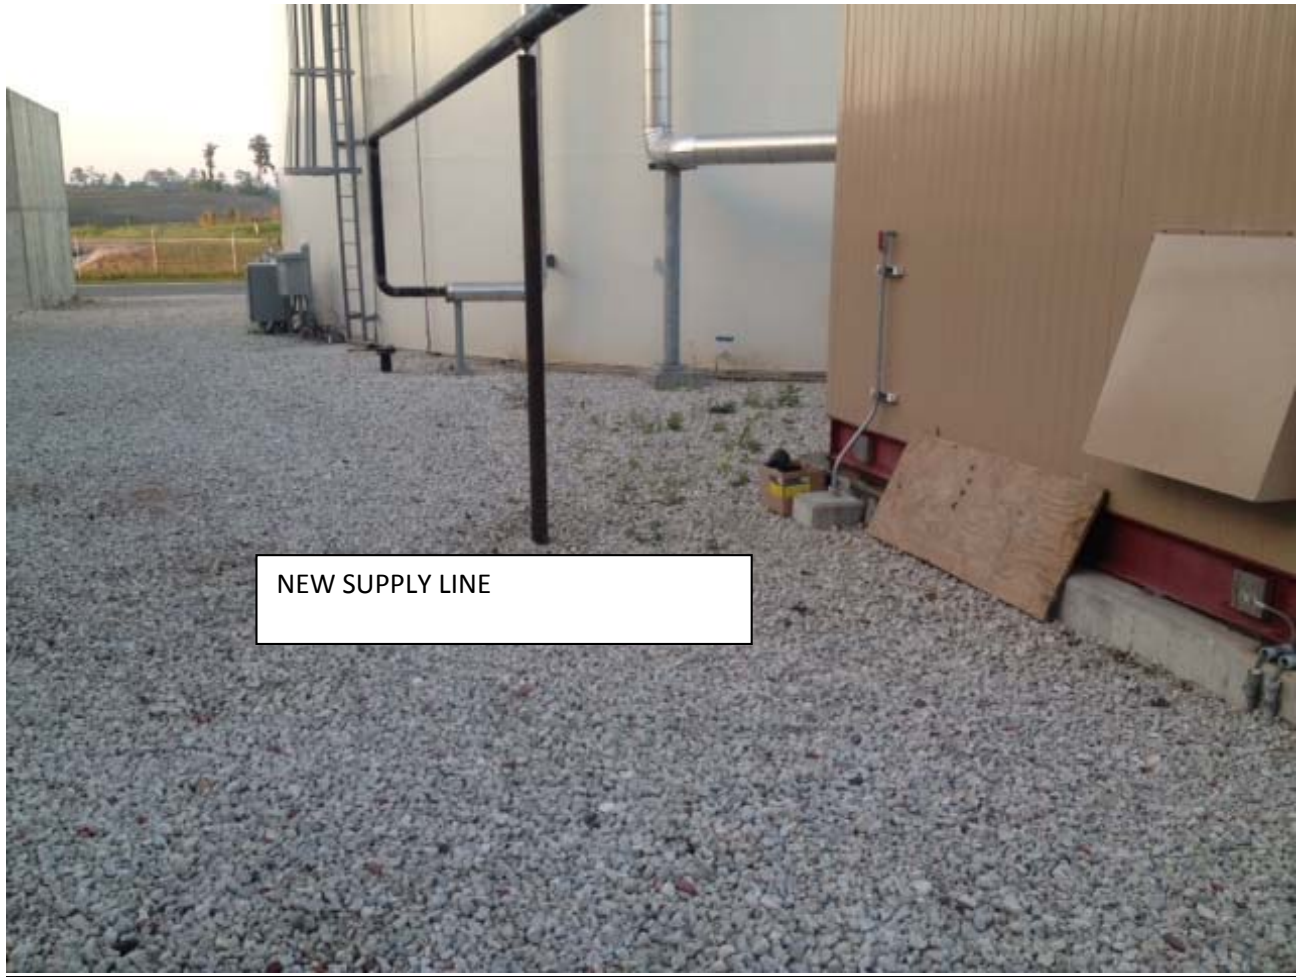
NEW SUPPLY LINE

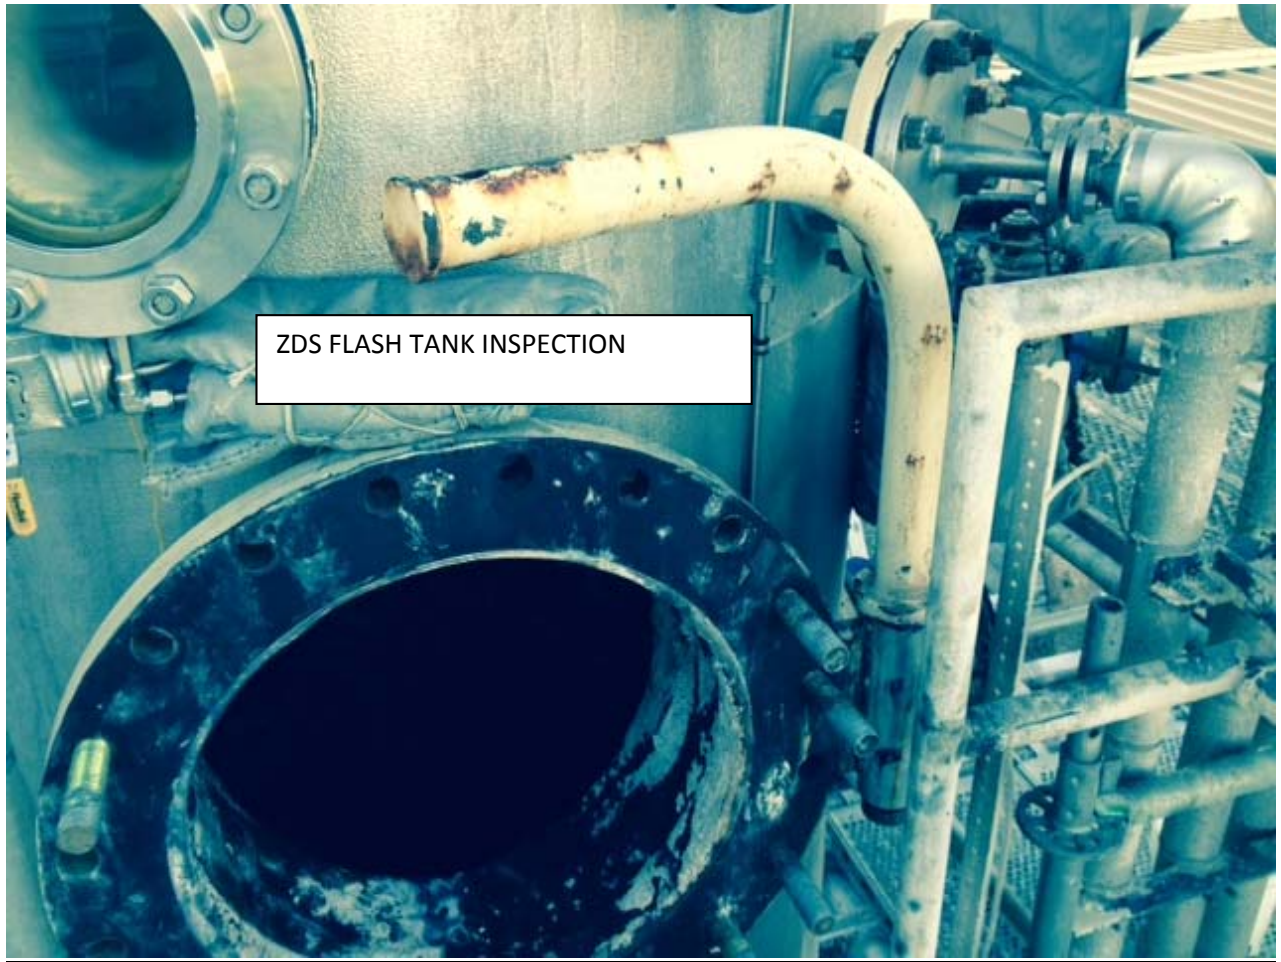
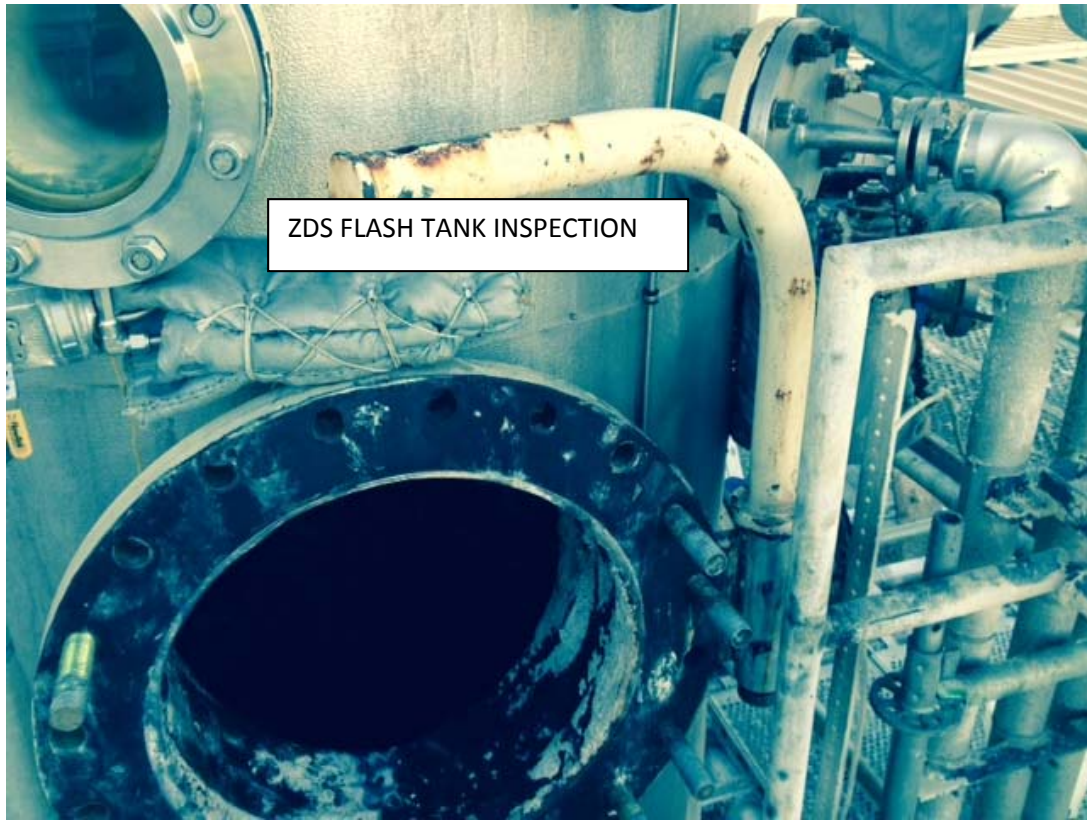
NEW ACCESS DOORS TO FUEL CHUTES

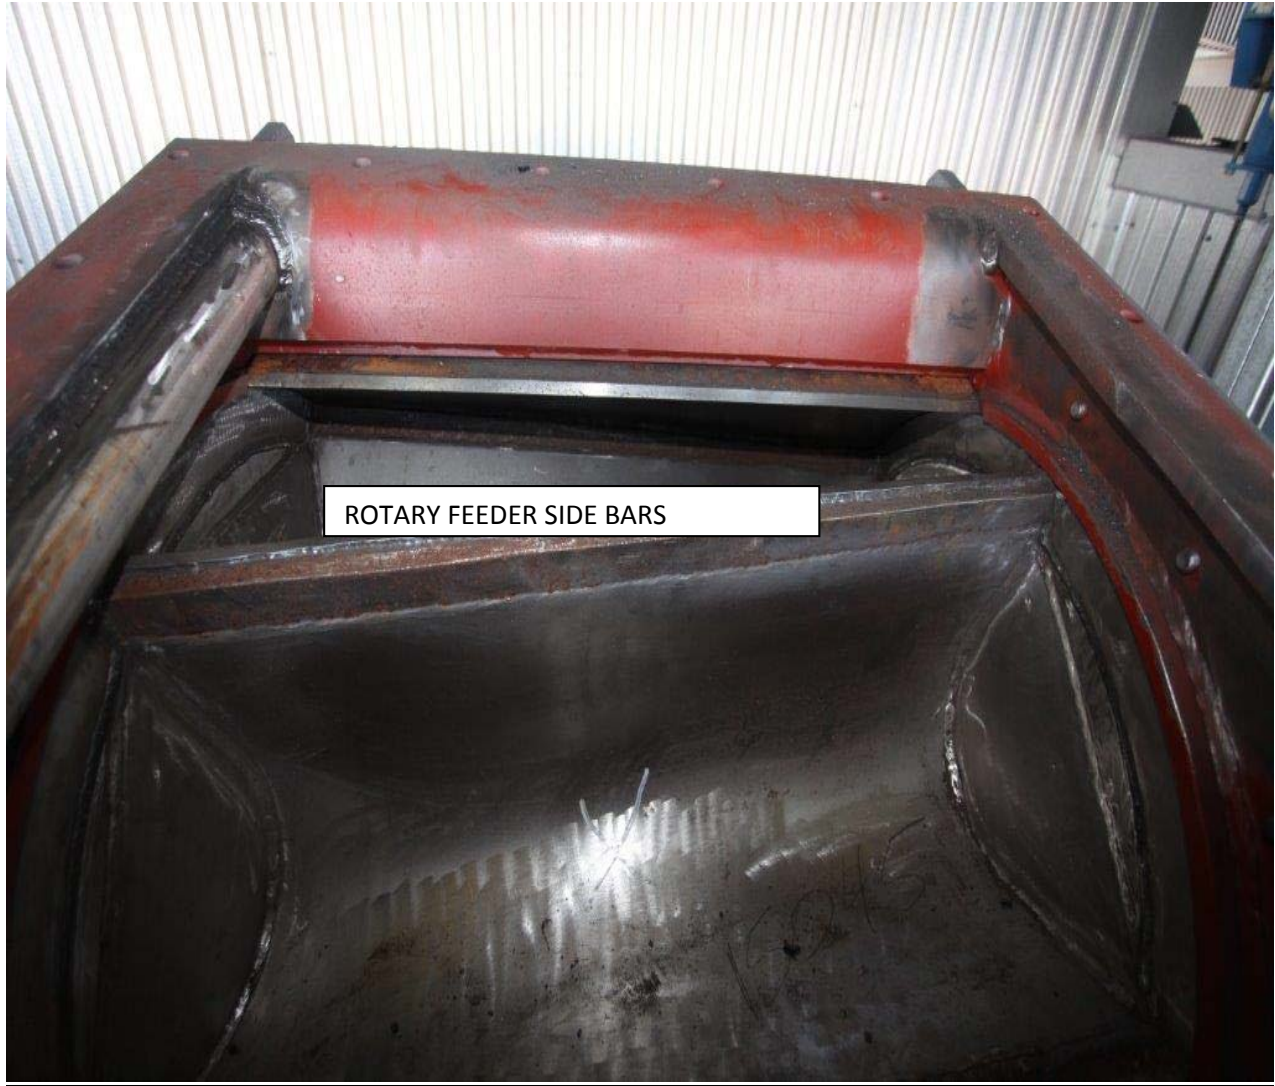
NEWLY INSTALLED DOUBLE BLOCK & BLEED AUX VALVE

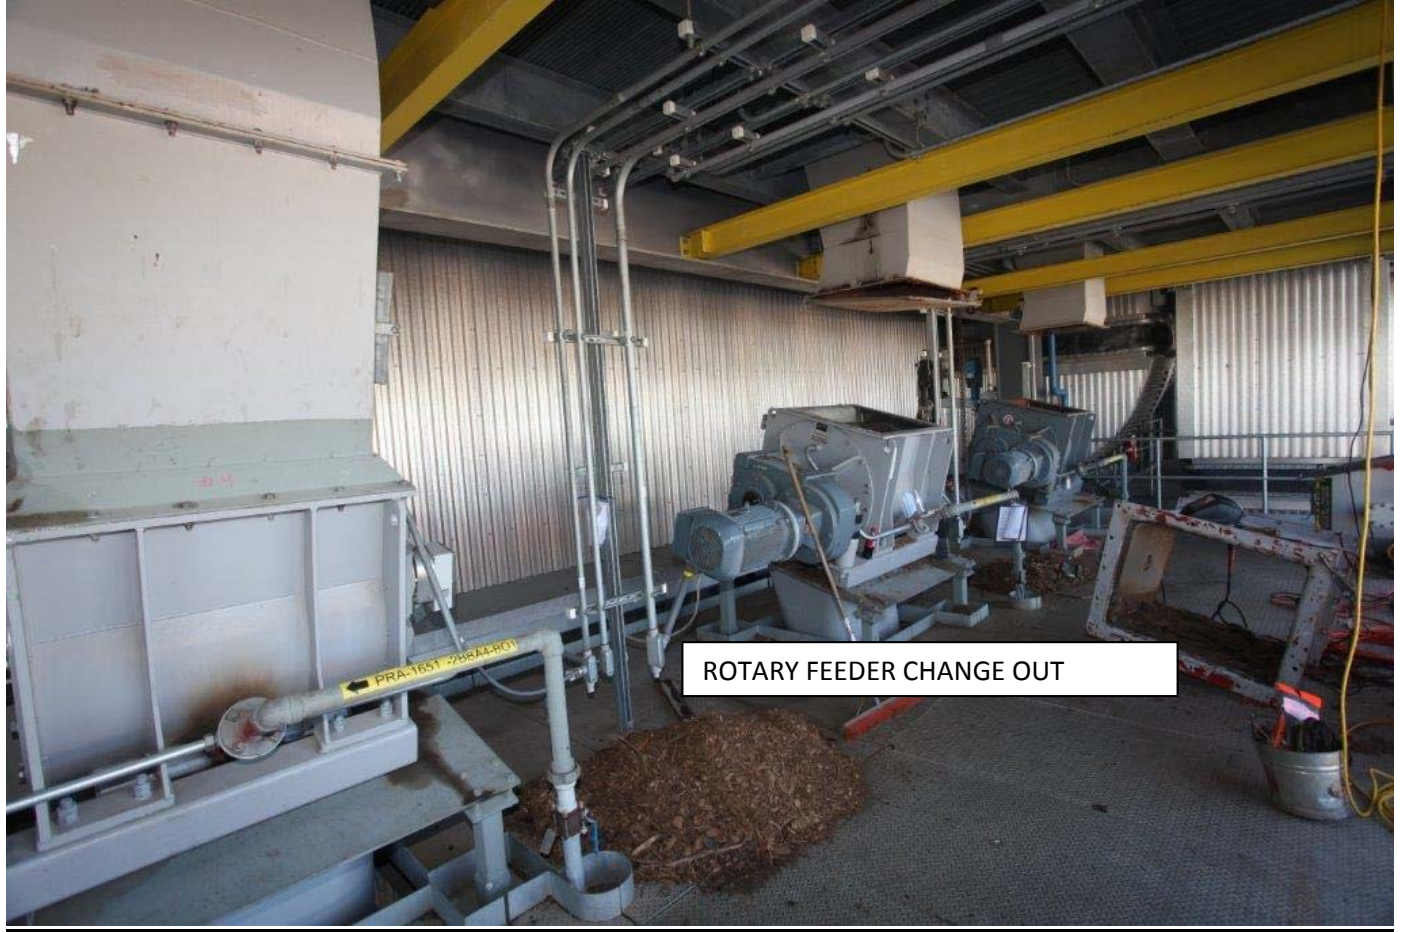
ROTARY FEEDER SIDE BARS

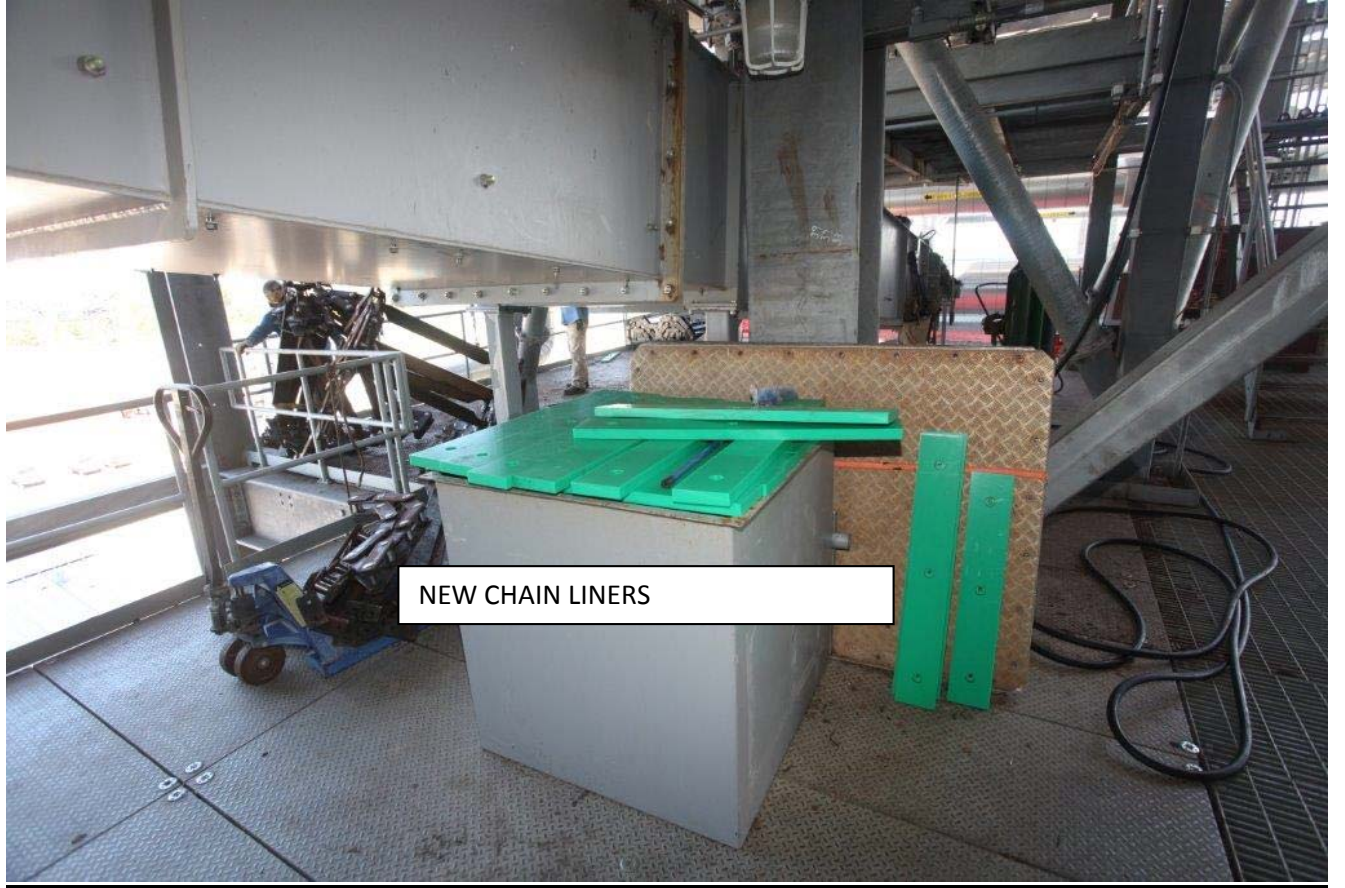
NEW CHAIN LINNERS

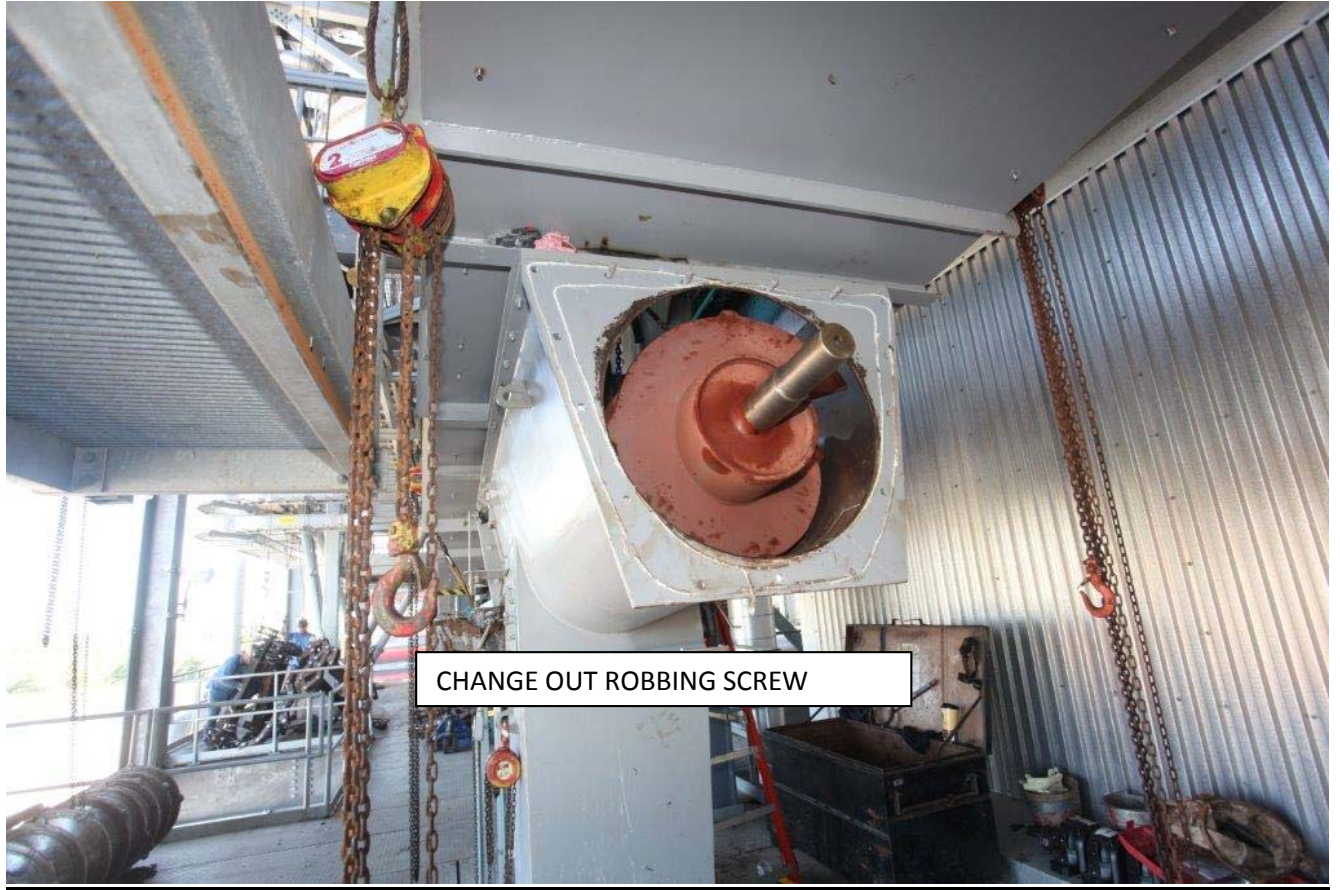
NEW CHAIN LINERS

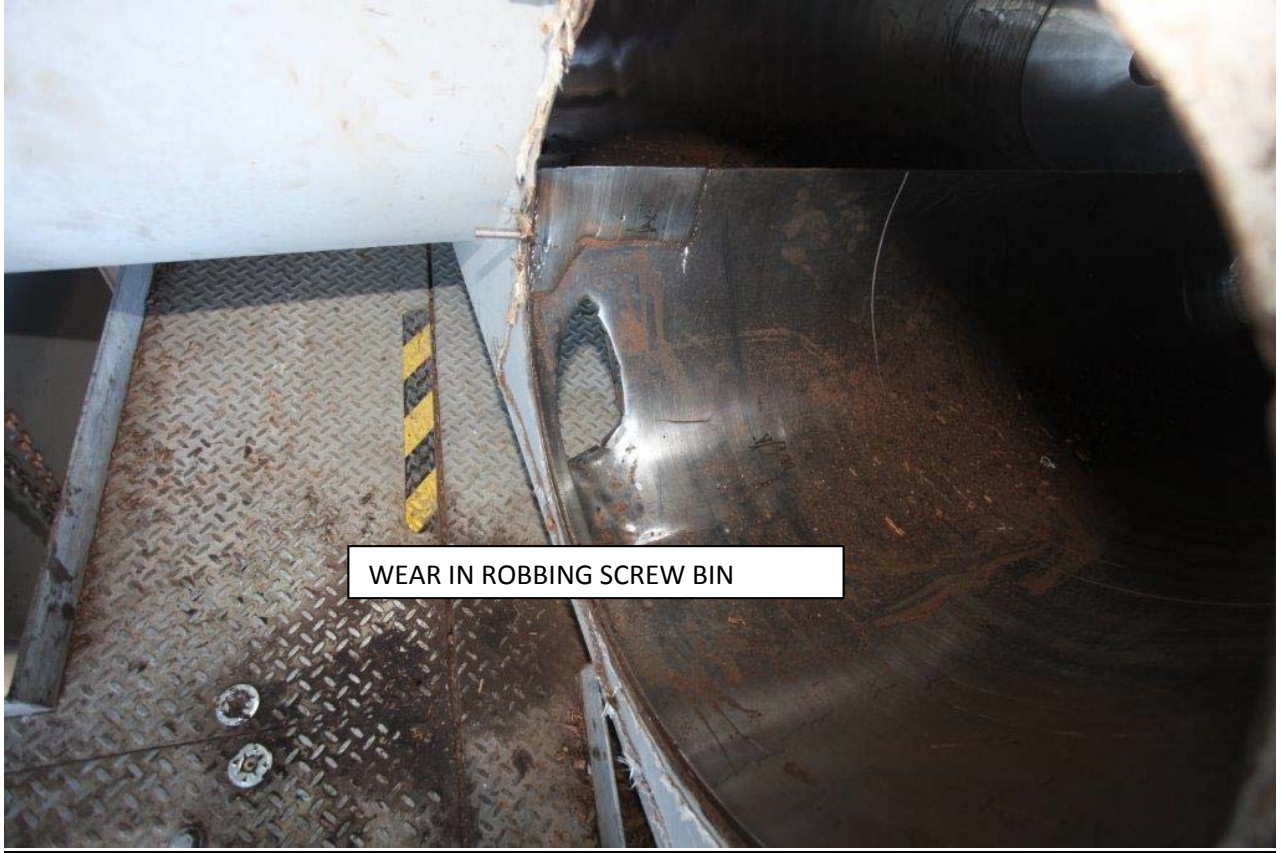
CHANGE OUT ROBBING SCREW

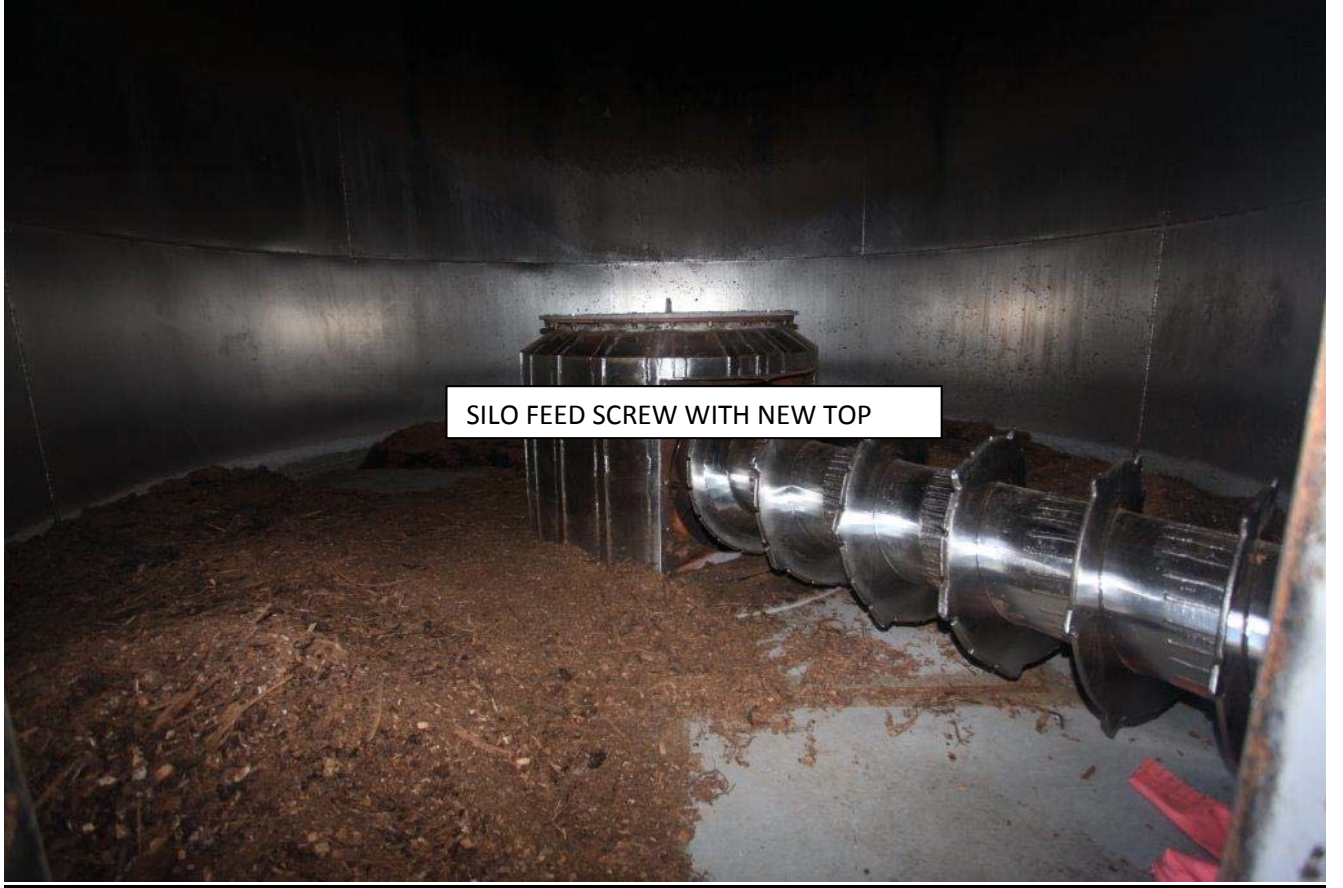
ROBBING SCREW CHANGE OUTS

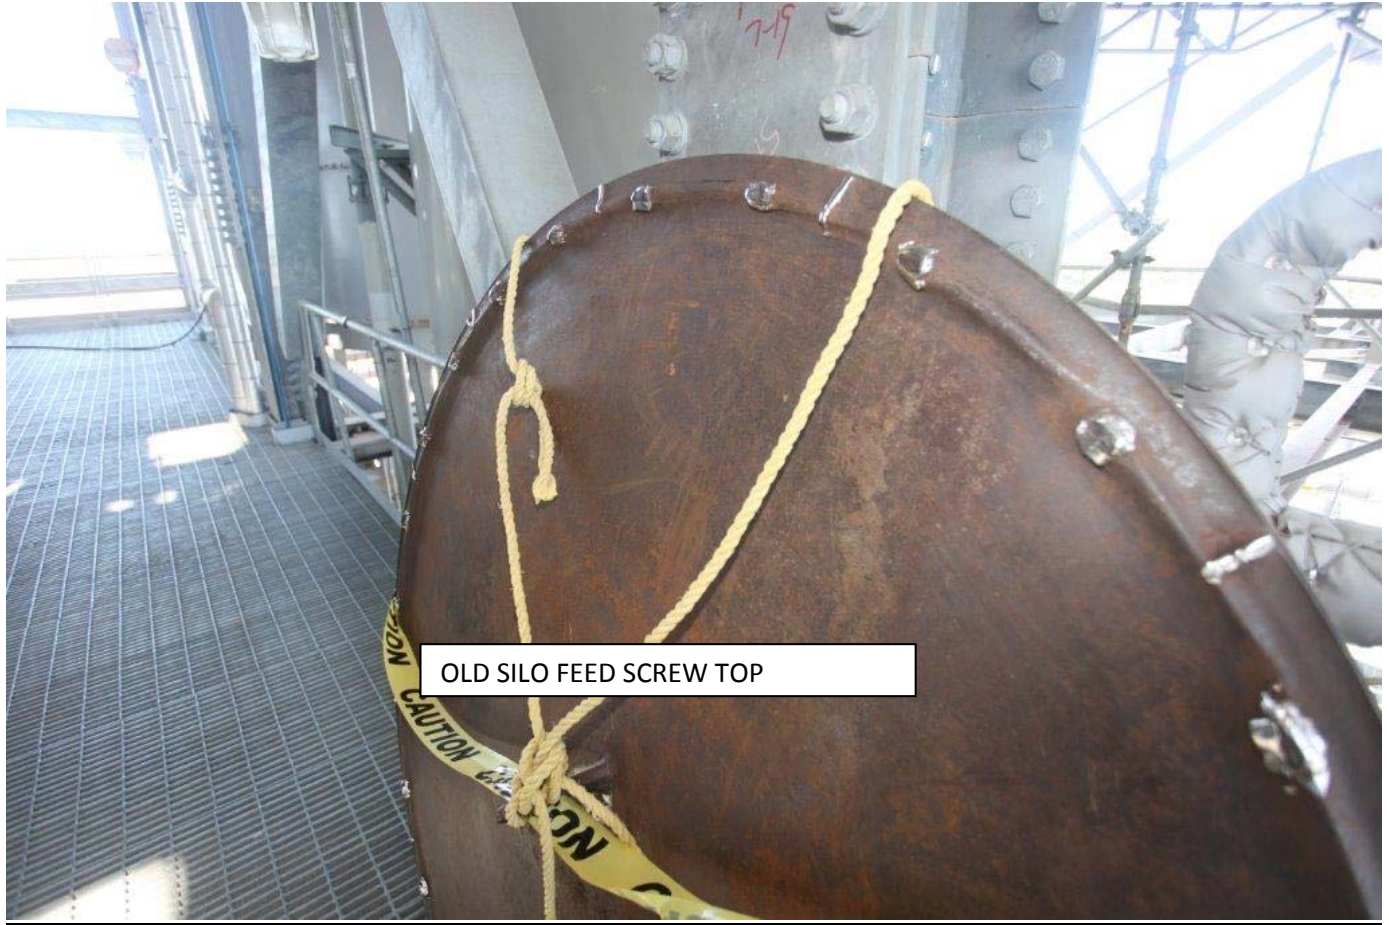
SILO FEED SCREW WITH NEW TOP

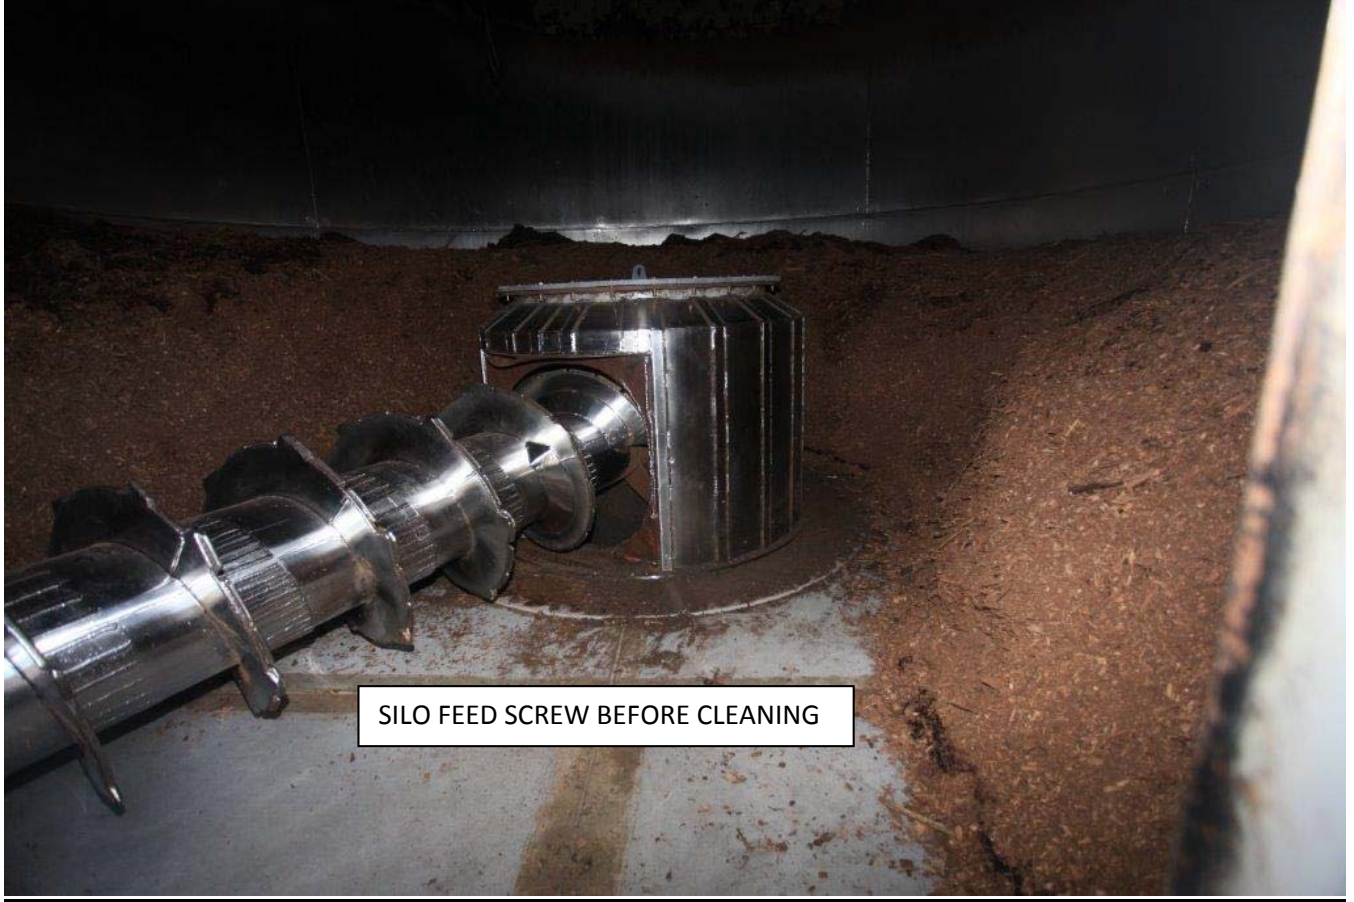
OLD SILO FEED SCREW TOP

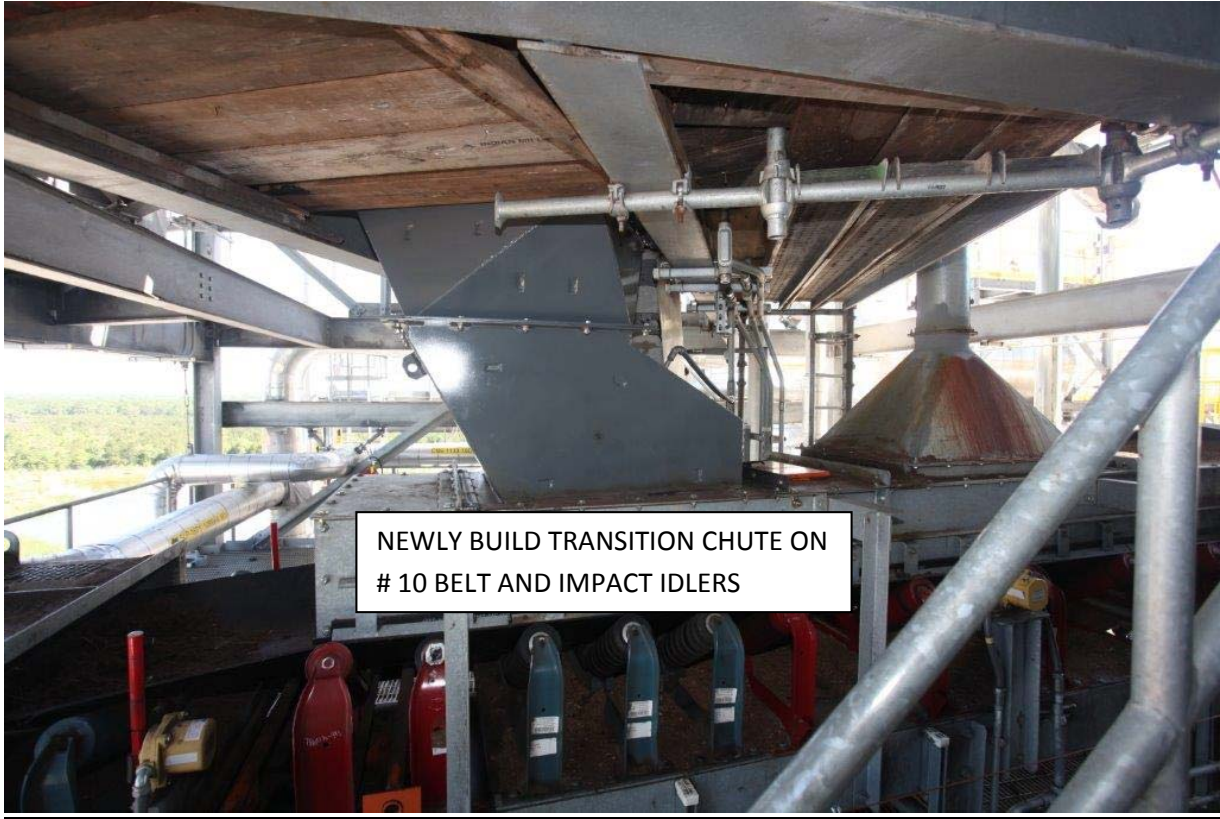
NEWLY BUILD TRANSITION CHUTE ON
10 BELT

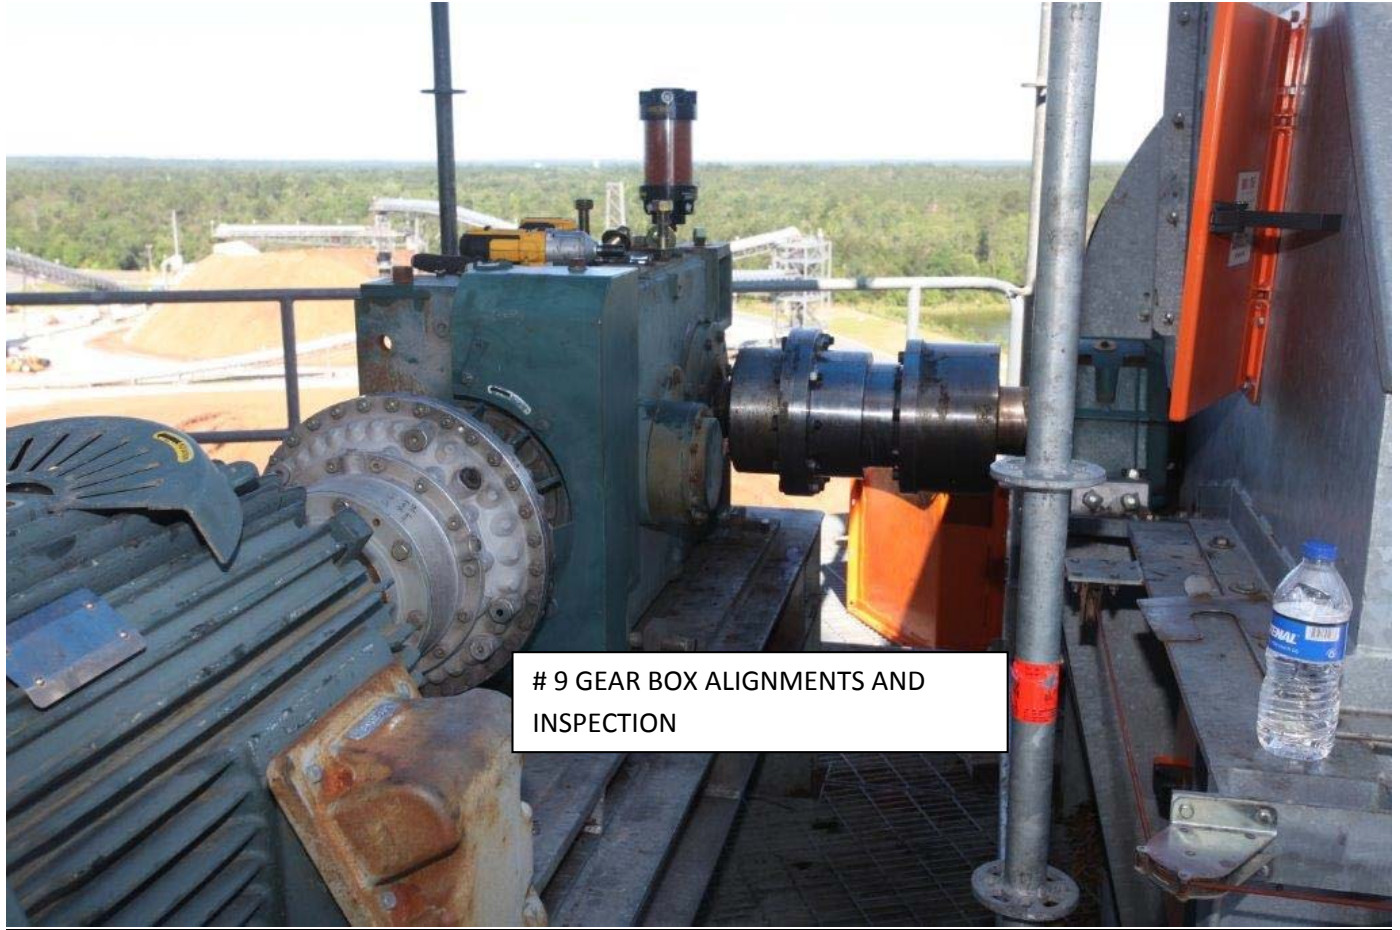
9 GEAR BOX ALIGNMENTS AND INSPECTION

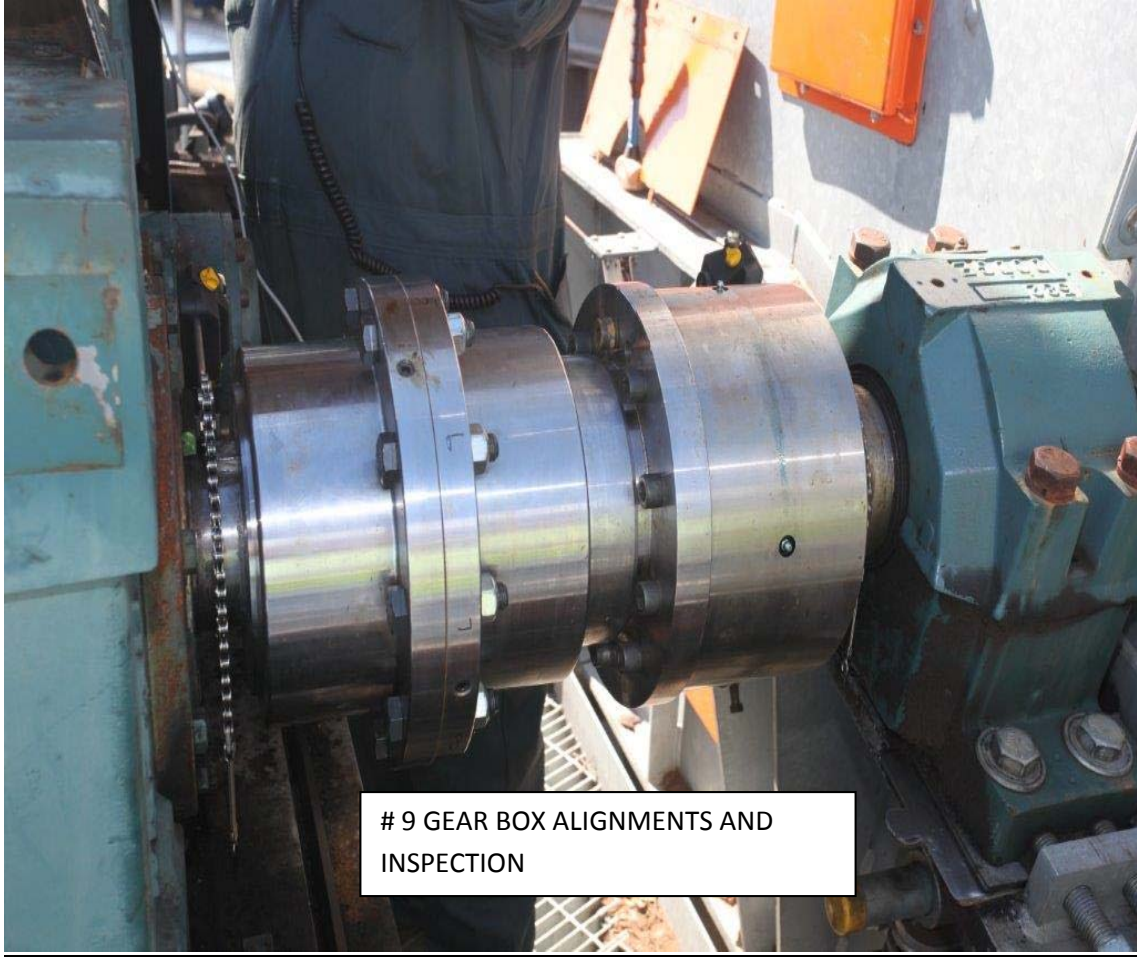
9 GEAR BOX ALIGNMENTS AND INSPECTION
