I. Executive summary

The planned outage was completed at a cost of \$-----and required 19 days of downtime for Fuel yard and Boiler Outage. There was one safety incident with contractor working in fuel yard and no environmental incidents. All work and findings were routine with the exception of the following issue. The findings, which are warranty issues with the Siemens Turbine, will require further work in the April 2016 outage.

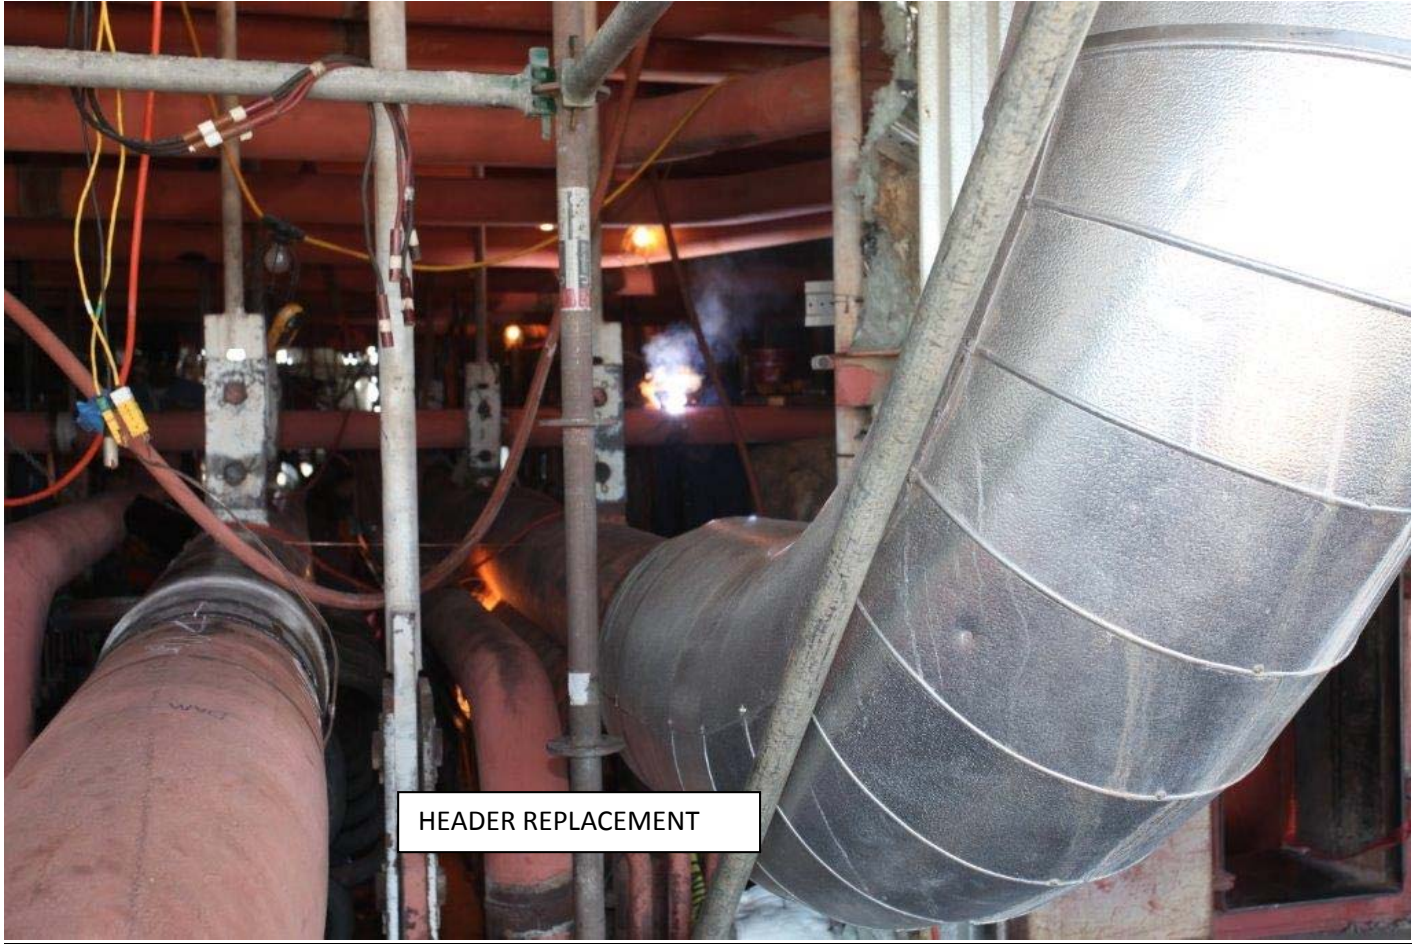
HEADER REPLACEMENT

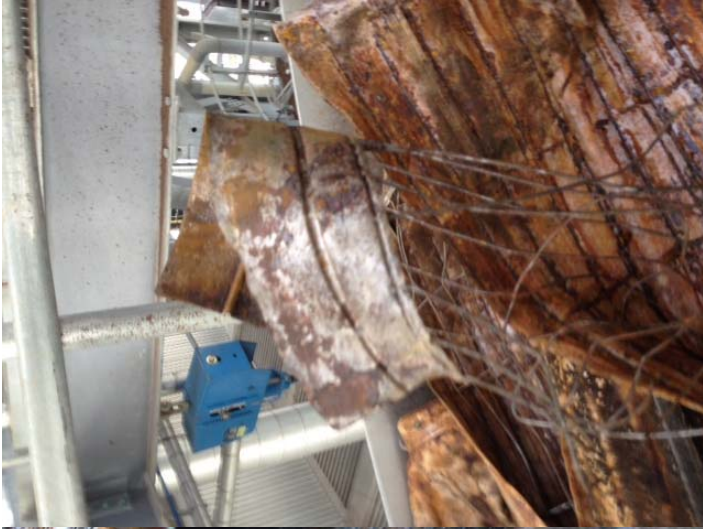
BAD BAGS PULLED FROM # 3 DUST COLLECTOR
